BOWLING GREEN DAM  
PIKE COUNTY, MISSOURI  
MO 10262

# PHASE I INSPECTION REPORT NATIONAL DAM SAFETY PROGRAM

PREPARED BY: U. S. ARMY ENGINEER DISTRICT, ST. LOUIS

DECEMBER 1978

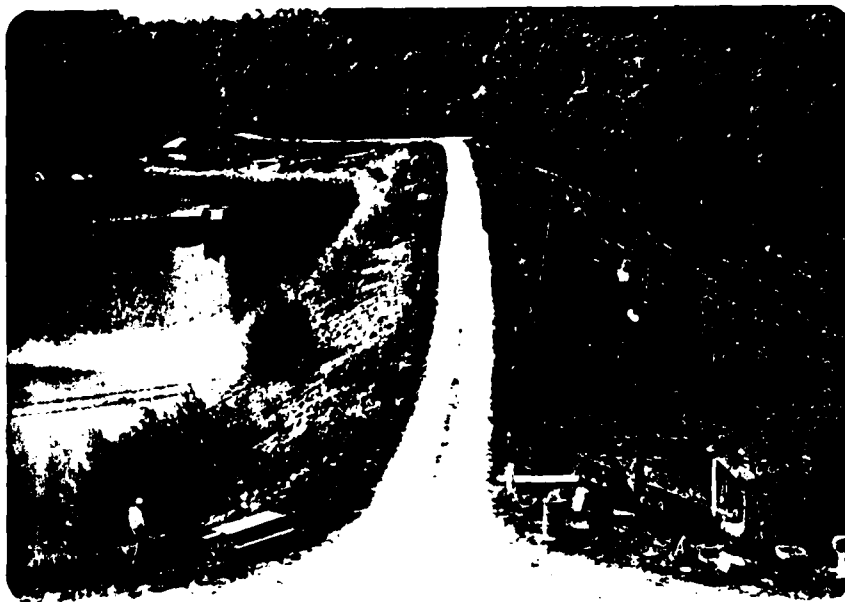
View of Dam - Looking West

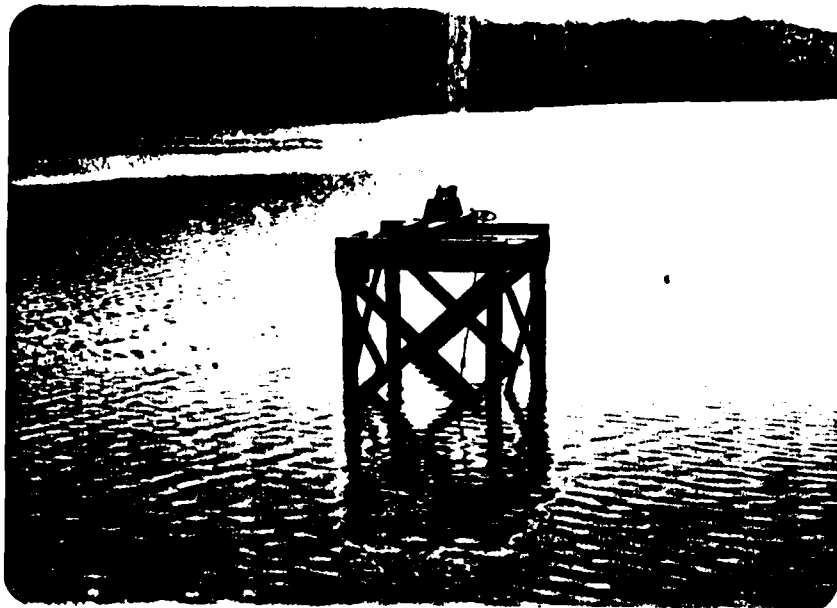
Intake Tower

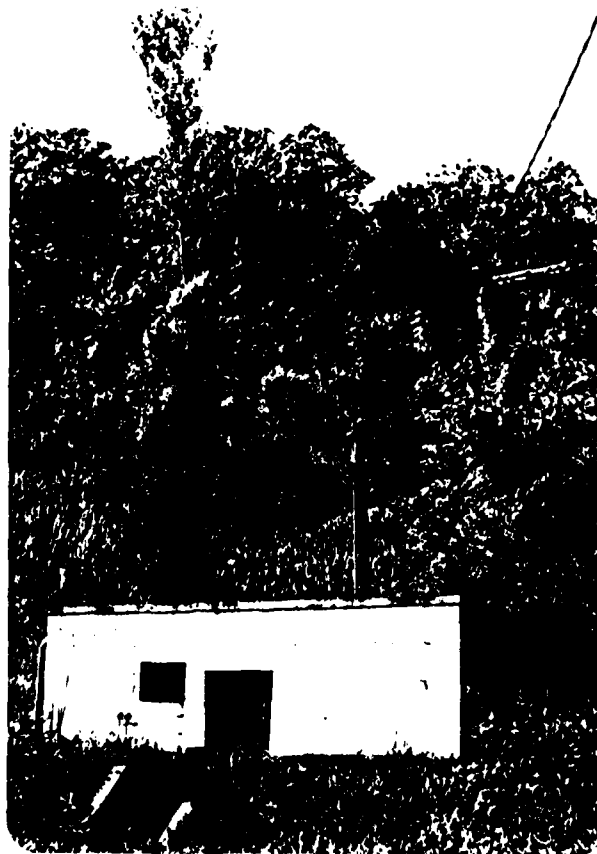
Pumping Station
