**LITTLE PRAIRIE DAM  
PHELPS COUNTY, MISSOURI  
MO 30090**

# **PHASE I INSPECTION REPORT NATIONAL DAM SAFETY PROGRAM**

Name of Dam: Little Prairie Dam  
State Located: Missouri  
County Located: Phelps County  
Stream: Unnamed Tributary to Bourbeuse River  
Date of Inspection: 24 August 1978

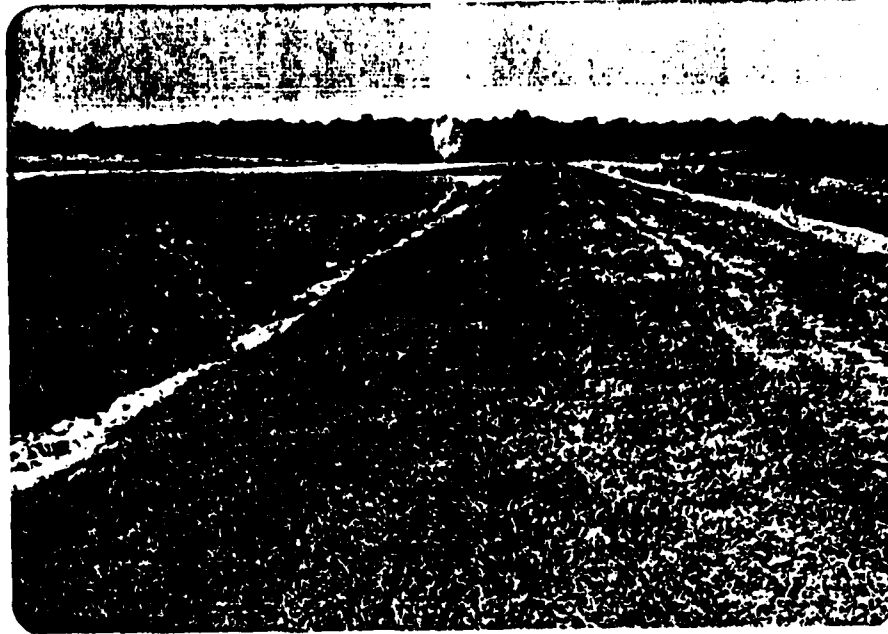
The horizontal alignment appeared as shown on the plans. No surface cracking or unusual movement was obvious. It should be noted, however, that the elevations along the top of the dam which were obtained in the field were approximately 0.5 ft to 0.8 ft higher than as indicated on the Plans for Construction (see Section 1.3.B of this report). All other elevations obtained in the field agreed fairly well with those indicated on the Plans for Construction.

Crest of Dam - Looking North

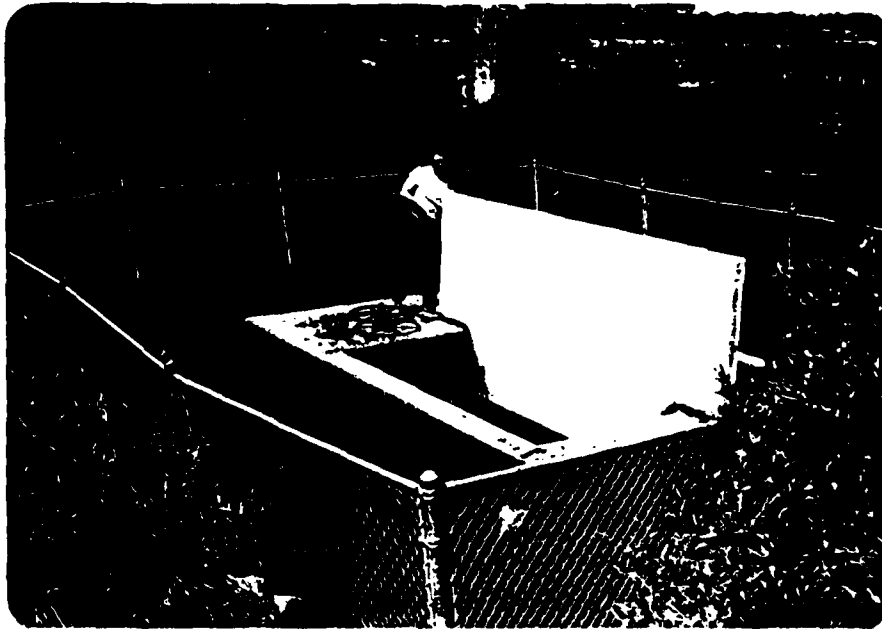
The riser structure was in good condition--no cracking or spalling of concrete was noted. The intake structure outside the chain link fence was surrounded on three sides by some brush. The two slide gates which are used for partial drawdown appeared to be in good condition on the dry side (the wet side could not be inspected). The lower slide gate (elevation 1024) appeared to have a small leak under the bottom.

Primary Spillway Structure

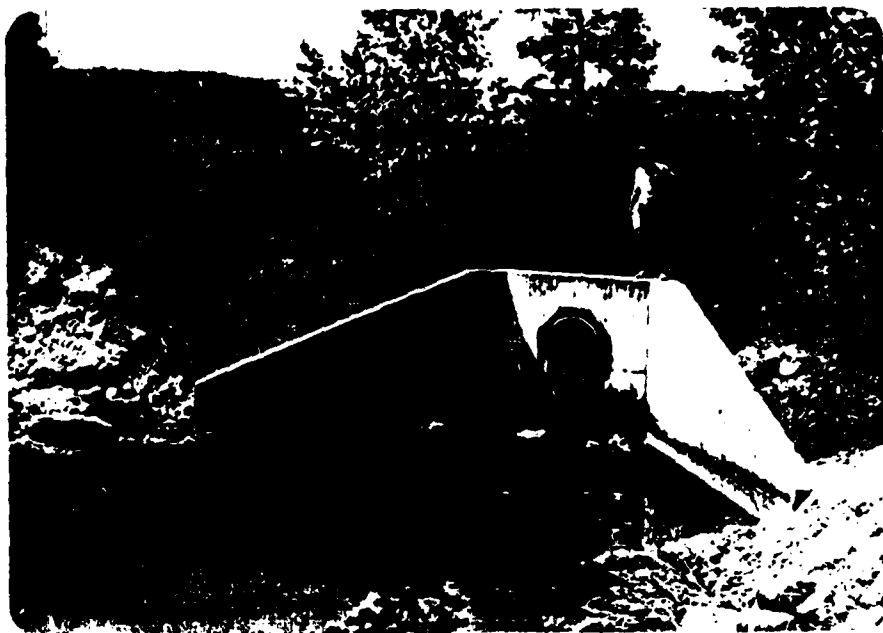
The plunge pool is lined with riprap, but some erosion and sloughing around the plunge pool was noticed. The outlet channel was in good condition. Some small trees and brush are present in the channel a few hundred feet beyond the plunge pool.

Outlet Structure - Primary Spillway

Small tree and brush growths noted in the discharge channel of the primary spillway should be removed, and all future growth should be removed on a yearly basis. Additional riprap could be placed around the plunge pool for protection during high discharge. Brush should be cleared around the primary spillway crest. Excessive growth in this area could cause entrance restrictions. Visually observed erosional areas are deficiencies which, if left uncontrolled or uncorrected, could lead to serious problems in the future. These deficiencies should be able to be corrected by normally scheduled routine maintenance.
