**ROY DAVIS DAM
REYNOLDS COUNTY, MISSOURI
MO 30056**

PHASE 1 INSPECTION REPORT

⑥ **NATIONAL DAM SAFETY PROGRAM.**

ROY DAVIS DAM
REYNOLDS COUNTY, MISSOURI
MISSOURI INVENTORY NO. 30056

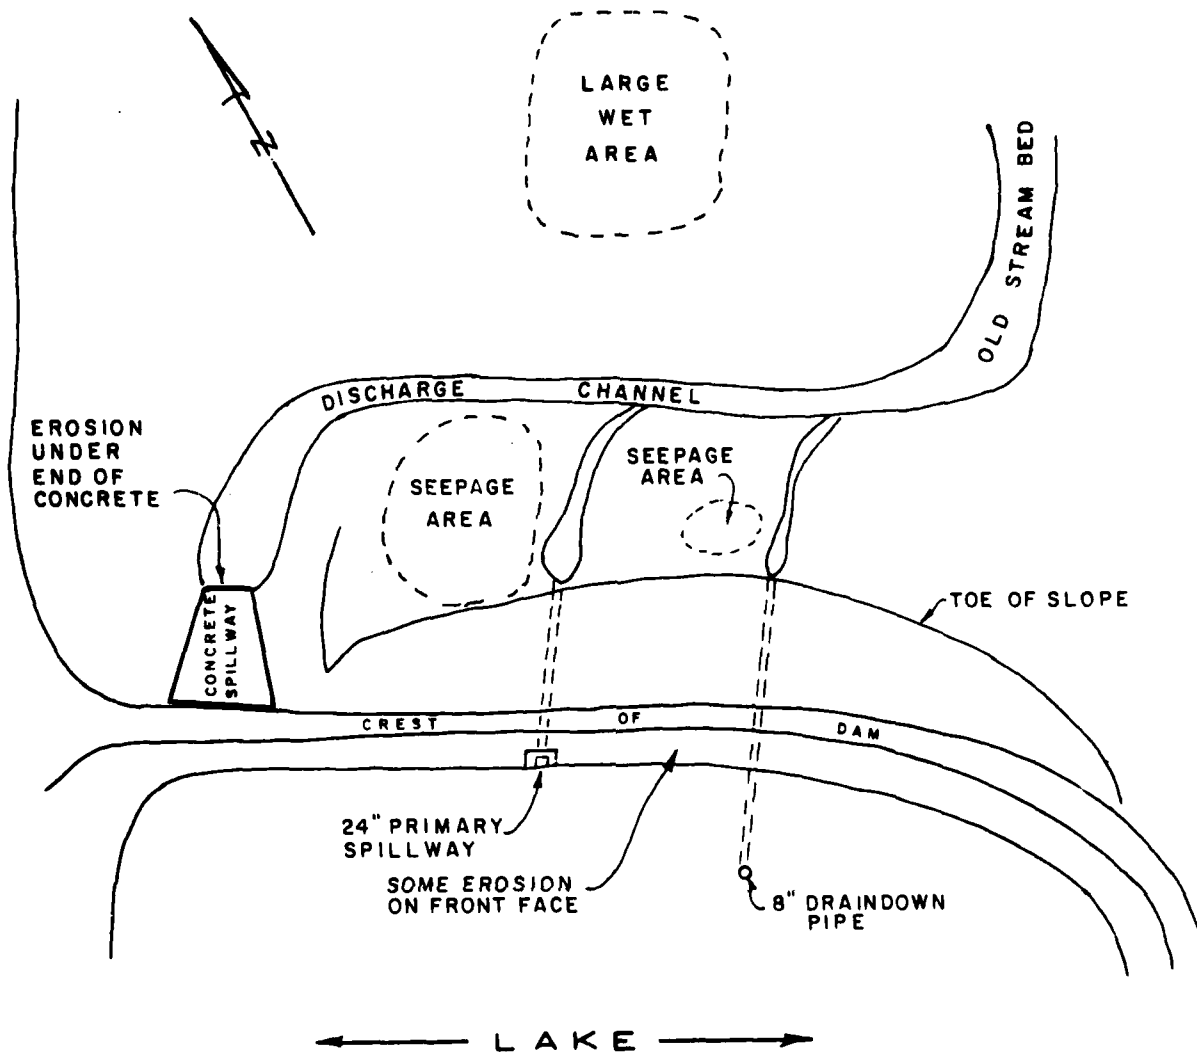
PLAN SKETCH
 INSPECTION OBSERVATION
 DAM No. MO. 30056

There are two apparent areas of seepage at the downstream toe. The areas are to the west of the 8 in. drawdown pipe outlet and to the west of the 24 in. primary spillway pipe (See sheet 4, Appendix A). The apparent seepage is manifested by wet, soft ground, cattails, and small pools of water with iron staining. No flow of water could be observed in either of these areas. The valley downstream of the dam (300 ft. past dam) has several areas of standing water and cattail growth. This wet area in the valley could be due to drainage from the hillside.
