BROWN LAKE DAM

CAPE GIRARDEAU COUNTY, MISSOURI

MO 31223

## PHASE 1 INSPECTION REPORT

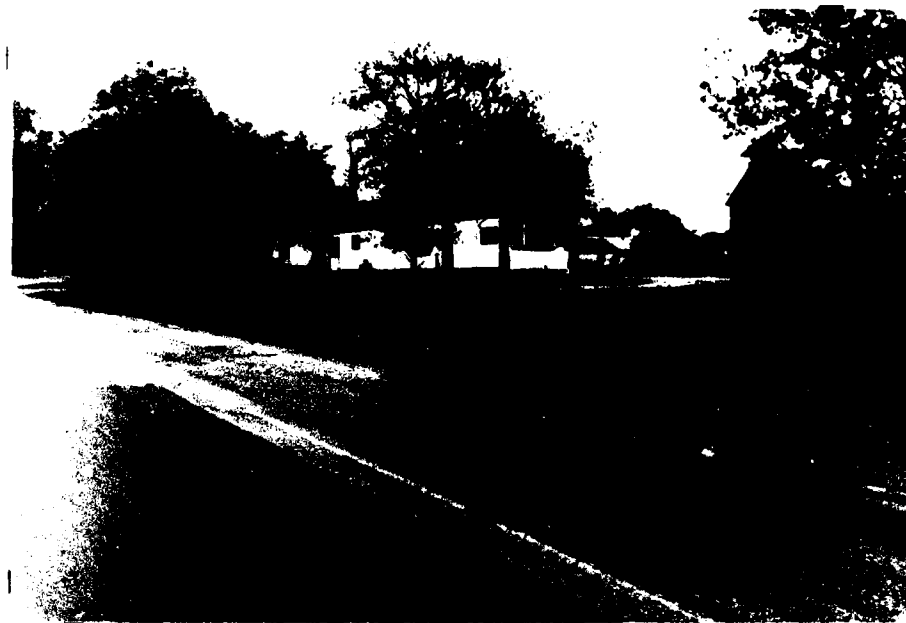
PHOTO NO. 22 - TRAILER LOCATED APPROX. 0.5 MILES DOWN-  
STREAM OF THE DAM. HOUSE IN THE BACK-  
GROUND.

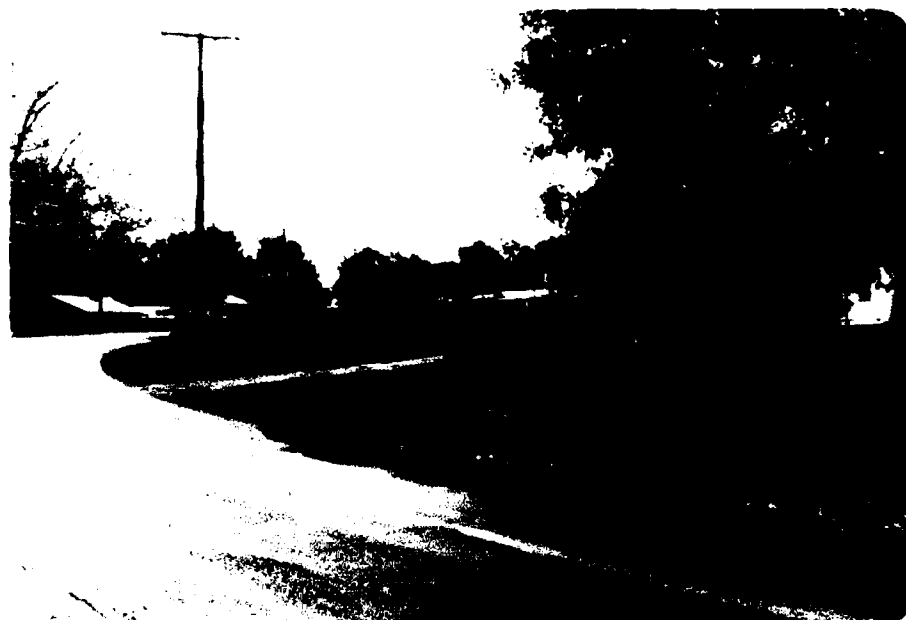
PHOTO NO. 23 - LOOKING NORTHEAST AT HOUSE BEHIND THE  
TRAILER IN PHOTO NO. 22.

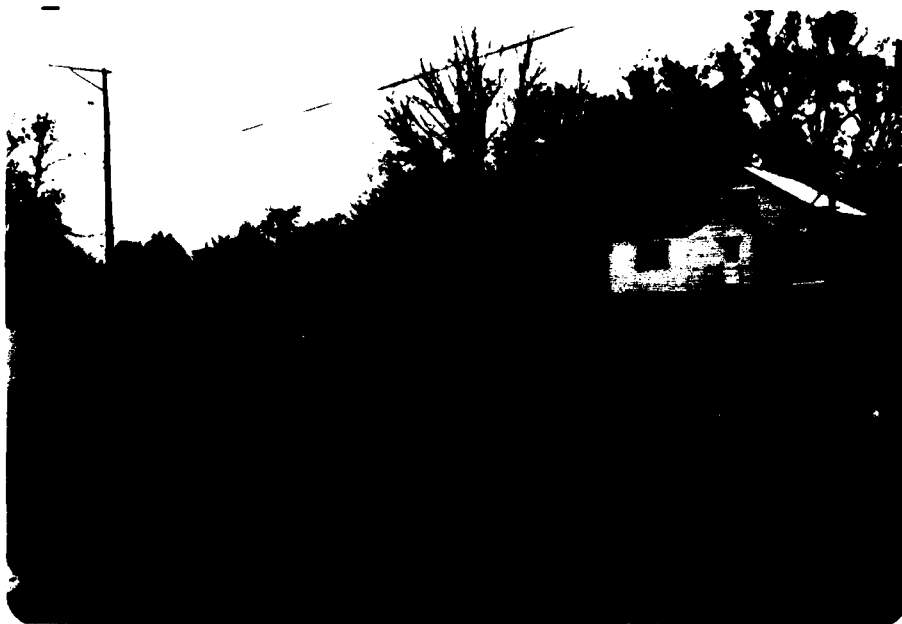
PHOTO NO. 24 - CHURCH LOCATED 0.8 MILES DOWNSTREAM OF DAM.

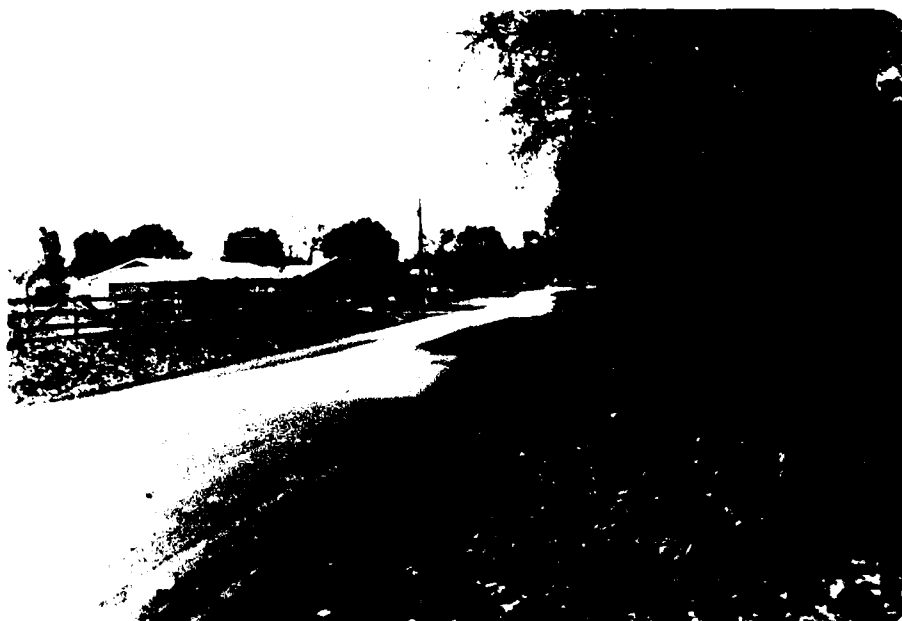
PHOTO NO. 25 - HOUSES EAST OF THE CHURCH LOCATED ABOUT ONE MILE DOWNSTREAM OF DAM.
