FAYETTE OLD CITY LAKE DAM  
HOWARD COUNTY, MISSOURI  
MO 10131

PHASE 1 INSPECTION REPORT  
NATIONAL DAM SAFETY PROGRAM

PREPARED BY: HOSKINS-WESTERN-SONDEREGGER, INC.  
FOR: STATE OF MISSOURI

SEPTEMBER, 1978

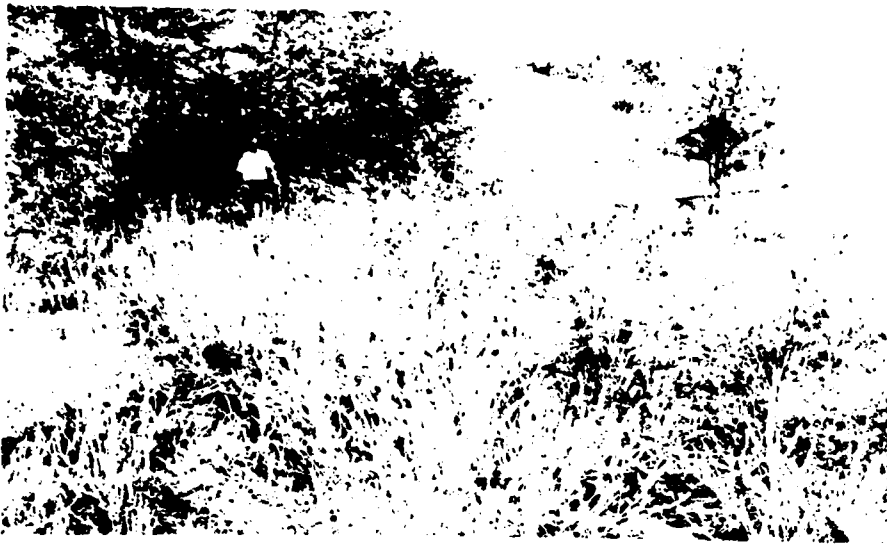
- (3) The approach channel is full of brush and weeds. The right upstream corner is filled with slough material from the slope above the spillway side.

PHOTO. NO. 2  
LOOKING UPSTREAM  
AT APPROACH TO  
SPILLWAY.

- a. Alternatives.
  - (1) The spillway should be repaired and cleaned out.
  - (2) Seepage and stability analyses should be performed for appropriate loading conditions (including earthquake loads). The services of an engineer experienced in the design of earth dams should be obtained to conduct these analyses. Based on the result of the seepage analysis the existing seepage should be eliminated or controlled.
- b. O & M Maintenance and Procedures.
  - (1) The erosion in the outlet channel for the spillway should be corrected and the channel stabilized.

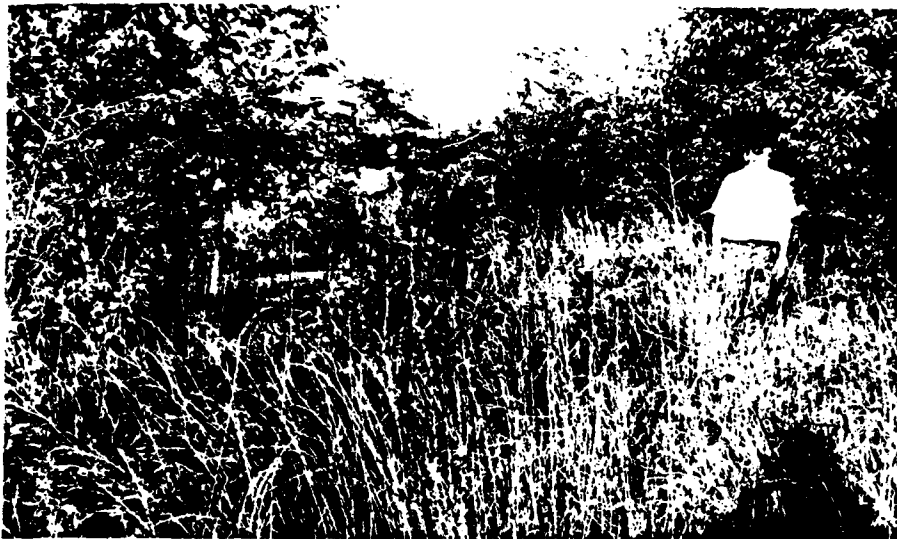
The earth plug in the entrance to the spillway and the vegetative growth in the spillway affect the hydraulic efficiency of the spillway. Wave erosion on the upstream face of the dam could lead to potential failure if left uncorrected.

PHOTO. NO. 9  
LOOKING DOWNSTREAM  
AT UPSTREAM  
APPROACH TO SPILLWAY.

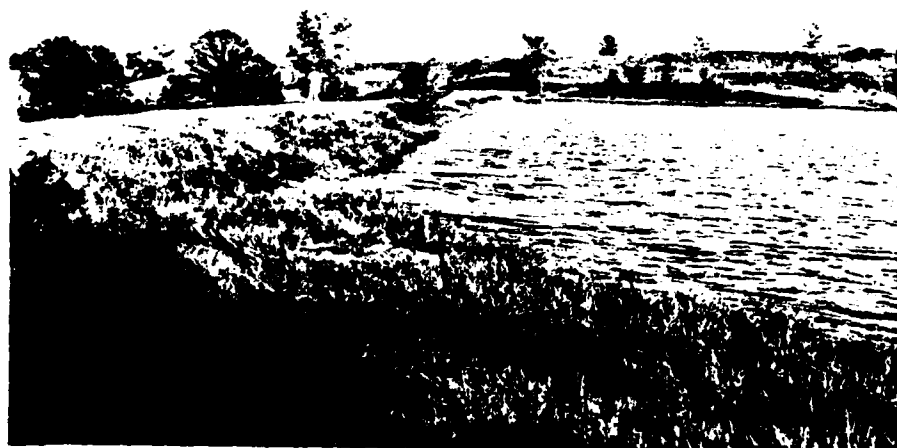
PHOTO. NO. 10  
UPSTREAM SLOPE  
OF DAM FROM  
LEFT END OF DAM.

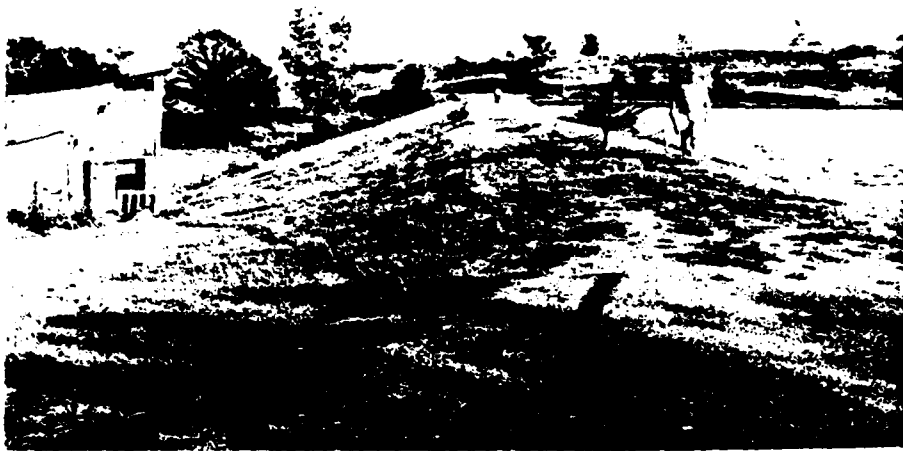
A few rodent holes were observed on the downstream slope. No slides or abnormal deformations were noted on the embankment.

PHOTO. NO. 11  
DOWNSTREAM SLOPE  
FROM LEFT END  
OF DAM.
