**SPRING LAKE DAM**

**CLINTON COUNTY, MISSOURI**

**MO. III22**

**PHASE 1 INSPECTION REPORT  
NATIONAL DAM SAFETY PROGRAM**

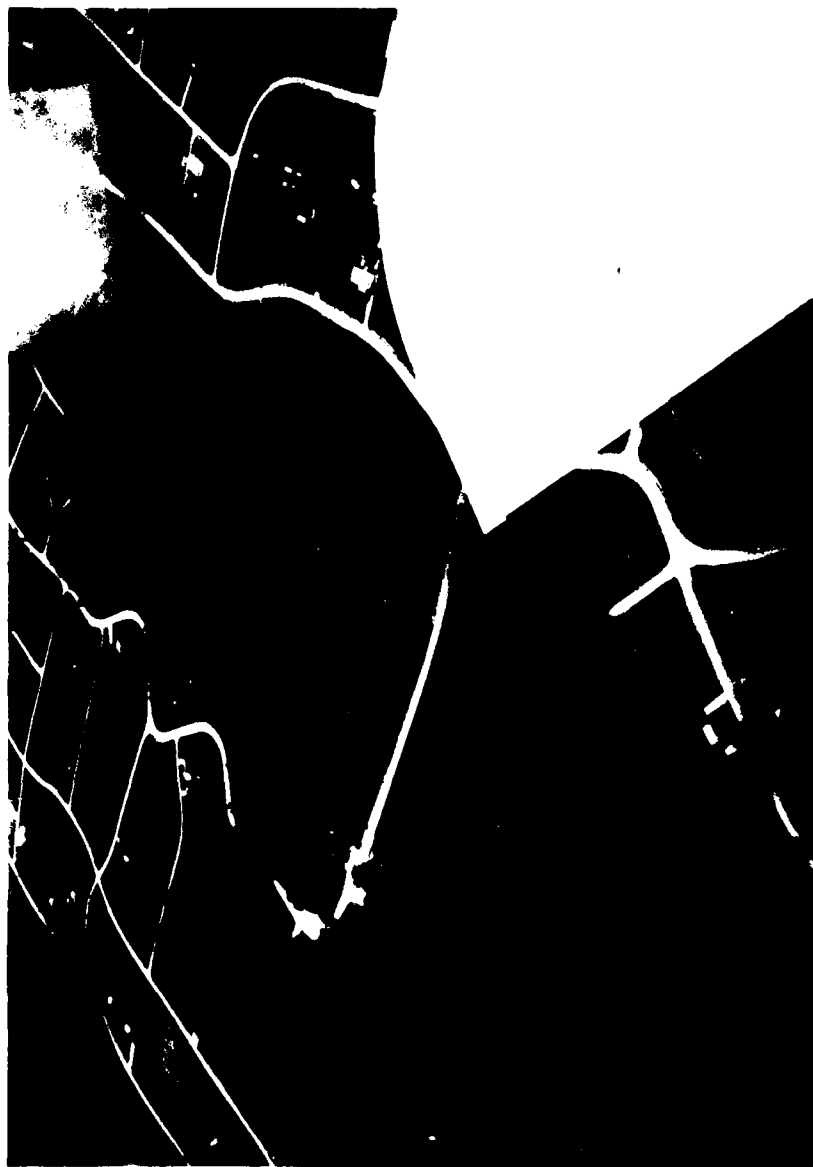
PHOTO NO. 1 - OVERVIEW

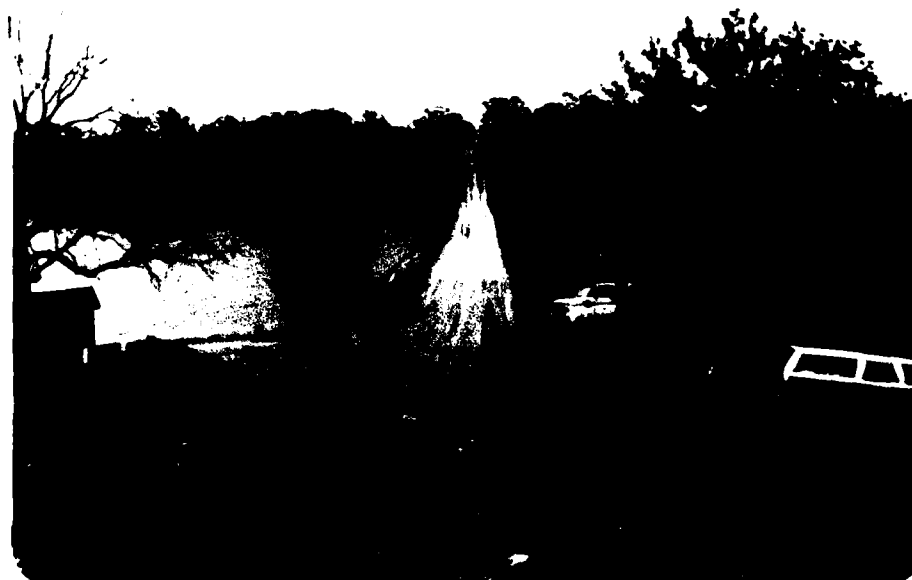
- (2) Upstream Slope. The upstream slope is well covered with durable limestone riprap having a maximum size of 8 to 10 inches and a nominal size of 1 to 1.5 inches. No deterioration of the riprap was noted. No slumps or deformations were observed. Photo No. 4 shows the upstream slope.
- (3) Crest. The crest serves as a roadway and is well covered with limestone gravel. Measurements along the crest, shown on Plate C-1, indicate that it is quite uniform in elevation with a maximum variation of one-half foot. No cracks, slumps or deformations were observed. Photo No. 3 shows the crest.

PHOTO NO. 3 - CREST FROM RIGHT ABUTMENT.

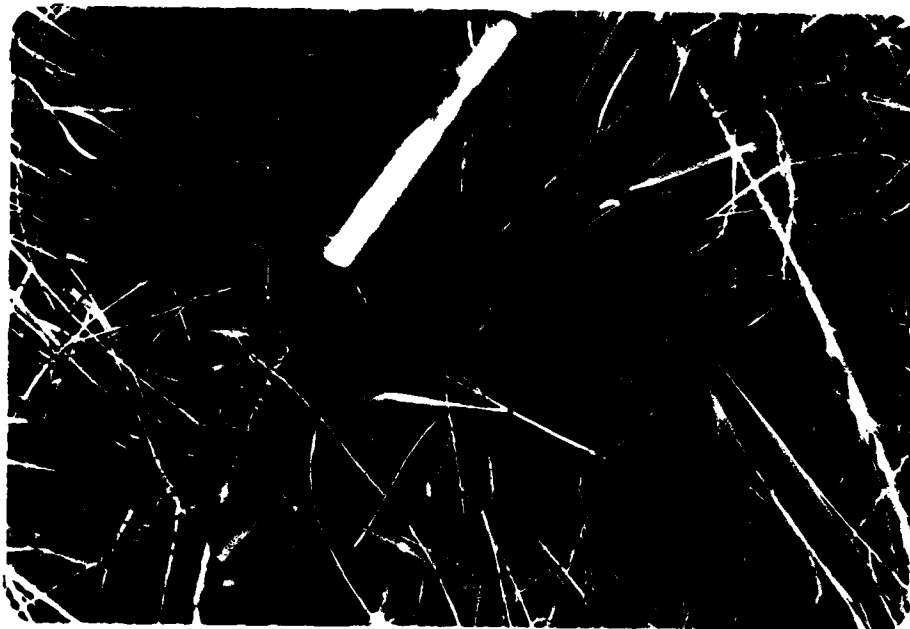
PHOTO NO. 14 - CLOSE-UP VIEW OF SEEPAGE SPOT.
