LAKE PAHO DAM

MERCER COUNTY, MISSOURI

MO 10108

PHASE 1 INSPECTION REPORT  
NATIONAL DAM SAFETY PROGRAM

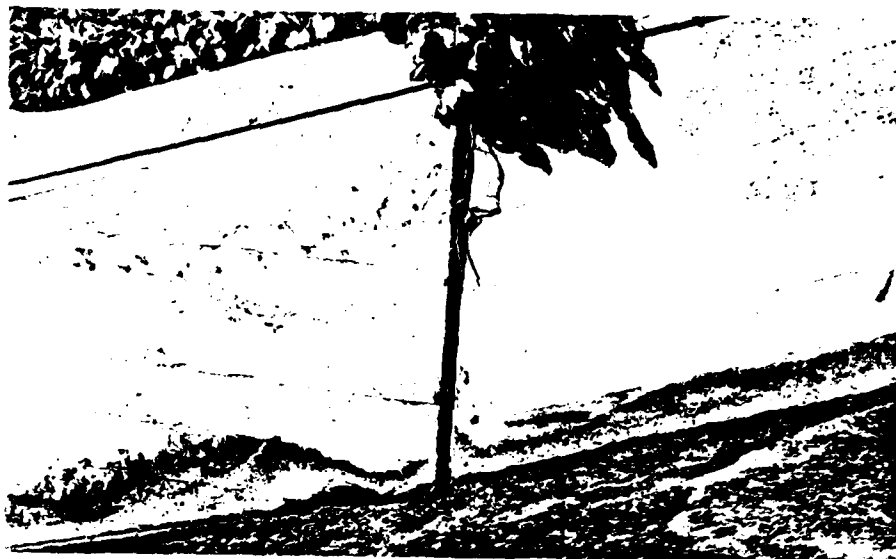
PHOTO NO. 5  
EXPANSION JOINT  
J-4 (LOWEST JOINT)  
JOINT OPEN  
APPROX. 1/2 INCH

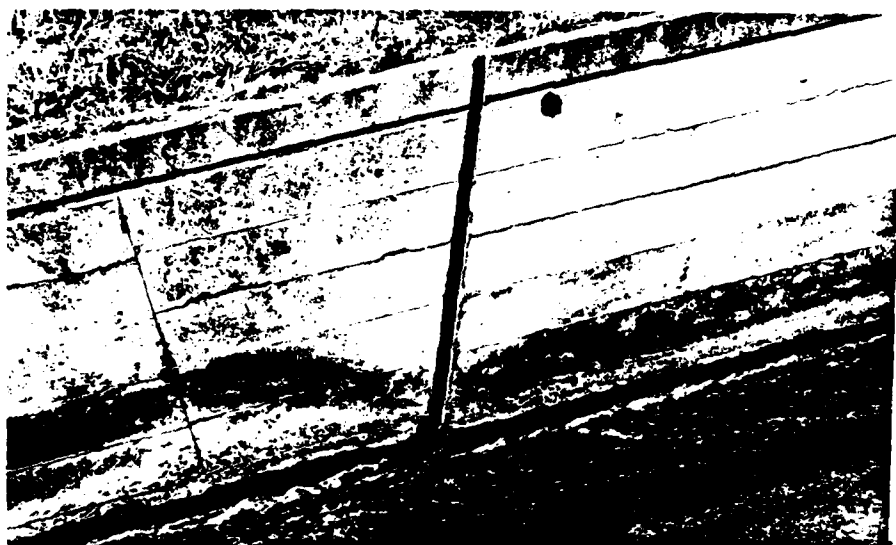
PHOTO NO. 6  
EXPANSION JOINT  
J-3 (RIGHT SIDE)  
JOINT OPEN APPROX.  
1/2 INCH. 3" X 3"  
HOLE AT BOTTOM  
OF JOINT

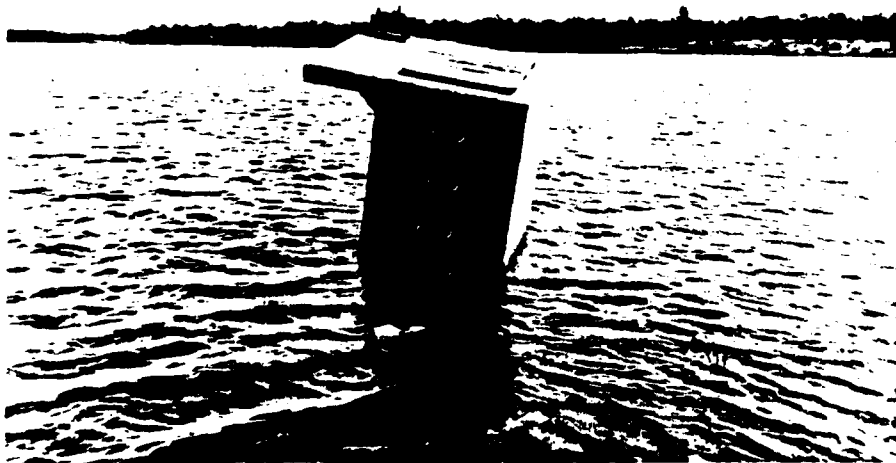
The control or inlet tower for this system is tilted about 10 degrees off of vertical towards the left (east) and downstream (south) as shown in photo No. 13. It was reported that this vertical deformation was caused by ice the first year after installation. A plan view and cross section of this system is shown in Appendix C.

The inlet tower of the controlled discharge system has been tilted for many years. This has had no apparent adverse effects on the operation of the facility. However, it was reported that this system is to be replaced.

PHOTO NO. 13  
OUTLET TOWER  
FROM SOUTH

It was reported that this system is to be replaced in the near future. Asbestos/concrete pipe was on-site for the new system at the time of the inspection.

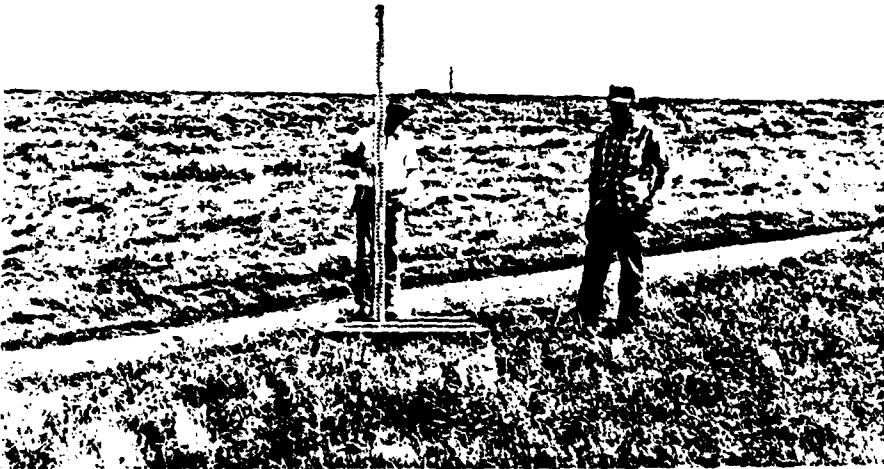
The area adjacent to the downstream toe is very seepy from about centerline station 3+50 to 7+00 (Stationing according to plans). No boils were observed in the seepy area. The seepage water is clear and seems to be ponded in the shallow ditch that extends along the toe. Outlets from the tile lines shown on the plans were not evident.

PHOTO NO. 16  
SEEPS ALONG  
TOE OF DAM  
LOOKING WEST  
FROM EAST END
