LAKE MARIE DAM

MERCER COUNTY, MISSOURI

MO 10154

PHASE 1 INSPECTION REPORT  
NATIONAL DAM SAFETY PROGRAM

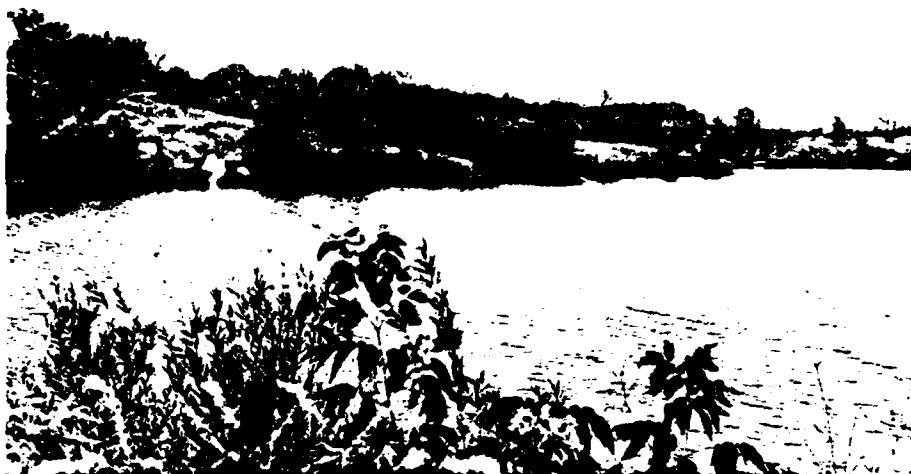
PHOTO NO. 5  
LOOKING UPSTREAM  
TO NORTHWEST  
FROM CENTER OF DAM

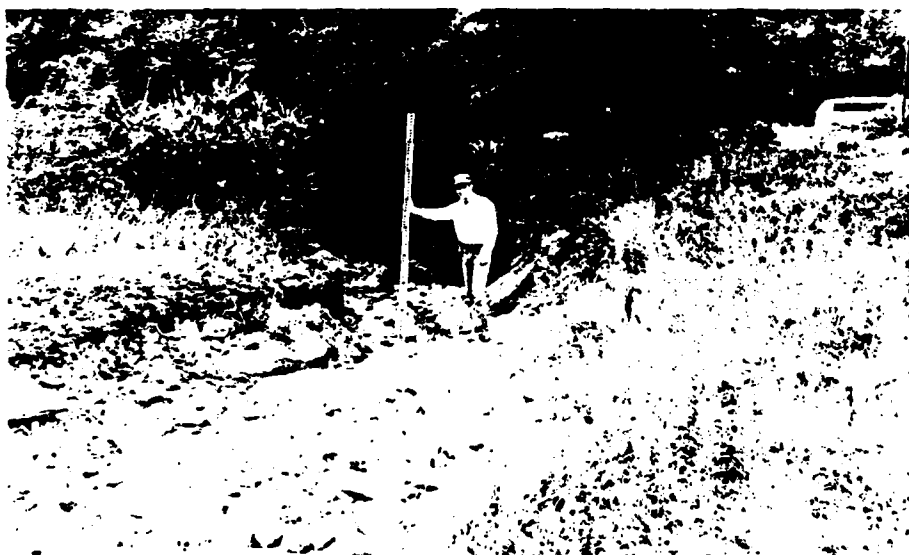
e. Downstream Channel. The bottom of the outfall or exit section of the spillway is plated with loose limestone rock for a distance of about 50 feet downstream from the centerline of the dam. Below this point the channel is badly eroded into silty and sandy clay materials. The eroded channel extends for a distance of 300 feet  $\pm$  where it passes under an access road and discharges into Hidden Valley Lake some 600 feet downstream from Lake Marie.

(2) The spillway exit channel is plated with loose limestone rock for 50± feet below center line of dam but is badly eroded below that.

PHOTO NO. 7  
LOOKING DOWN  
EMERGENCY SPILLWAY  
FROM CENTERLINE  
OF DAM

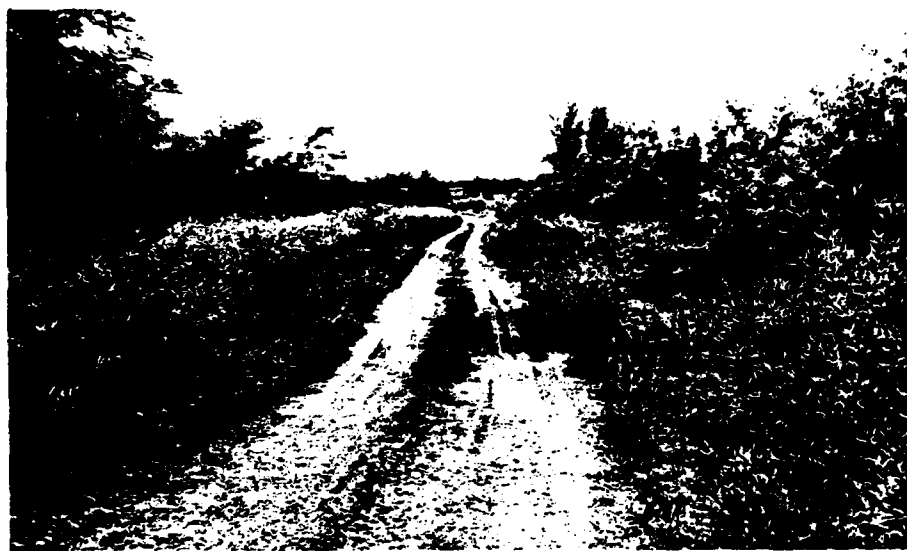
Rough measurements along the centerline of the dam indicate that the left (east) end of the embankment is 6 ft.  $\pm$  higher in elevation than the right (west) end. This is shown on the centerline profile in Appendix C.

PHOTO NO. 12  
CREST OF DAM  
TAKEN FROM EAST  
LOOKING WEST
