CARDEN LAKE DAM

CRAWFORD COUNTY, MISSOURI

MISSOURI INVENTORY NO. 30987

PHASE 1 INSPECTION REPORT  
NATIONAL DAM SAFETY PROGRAM

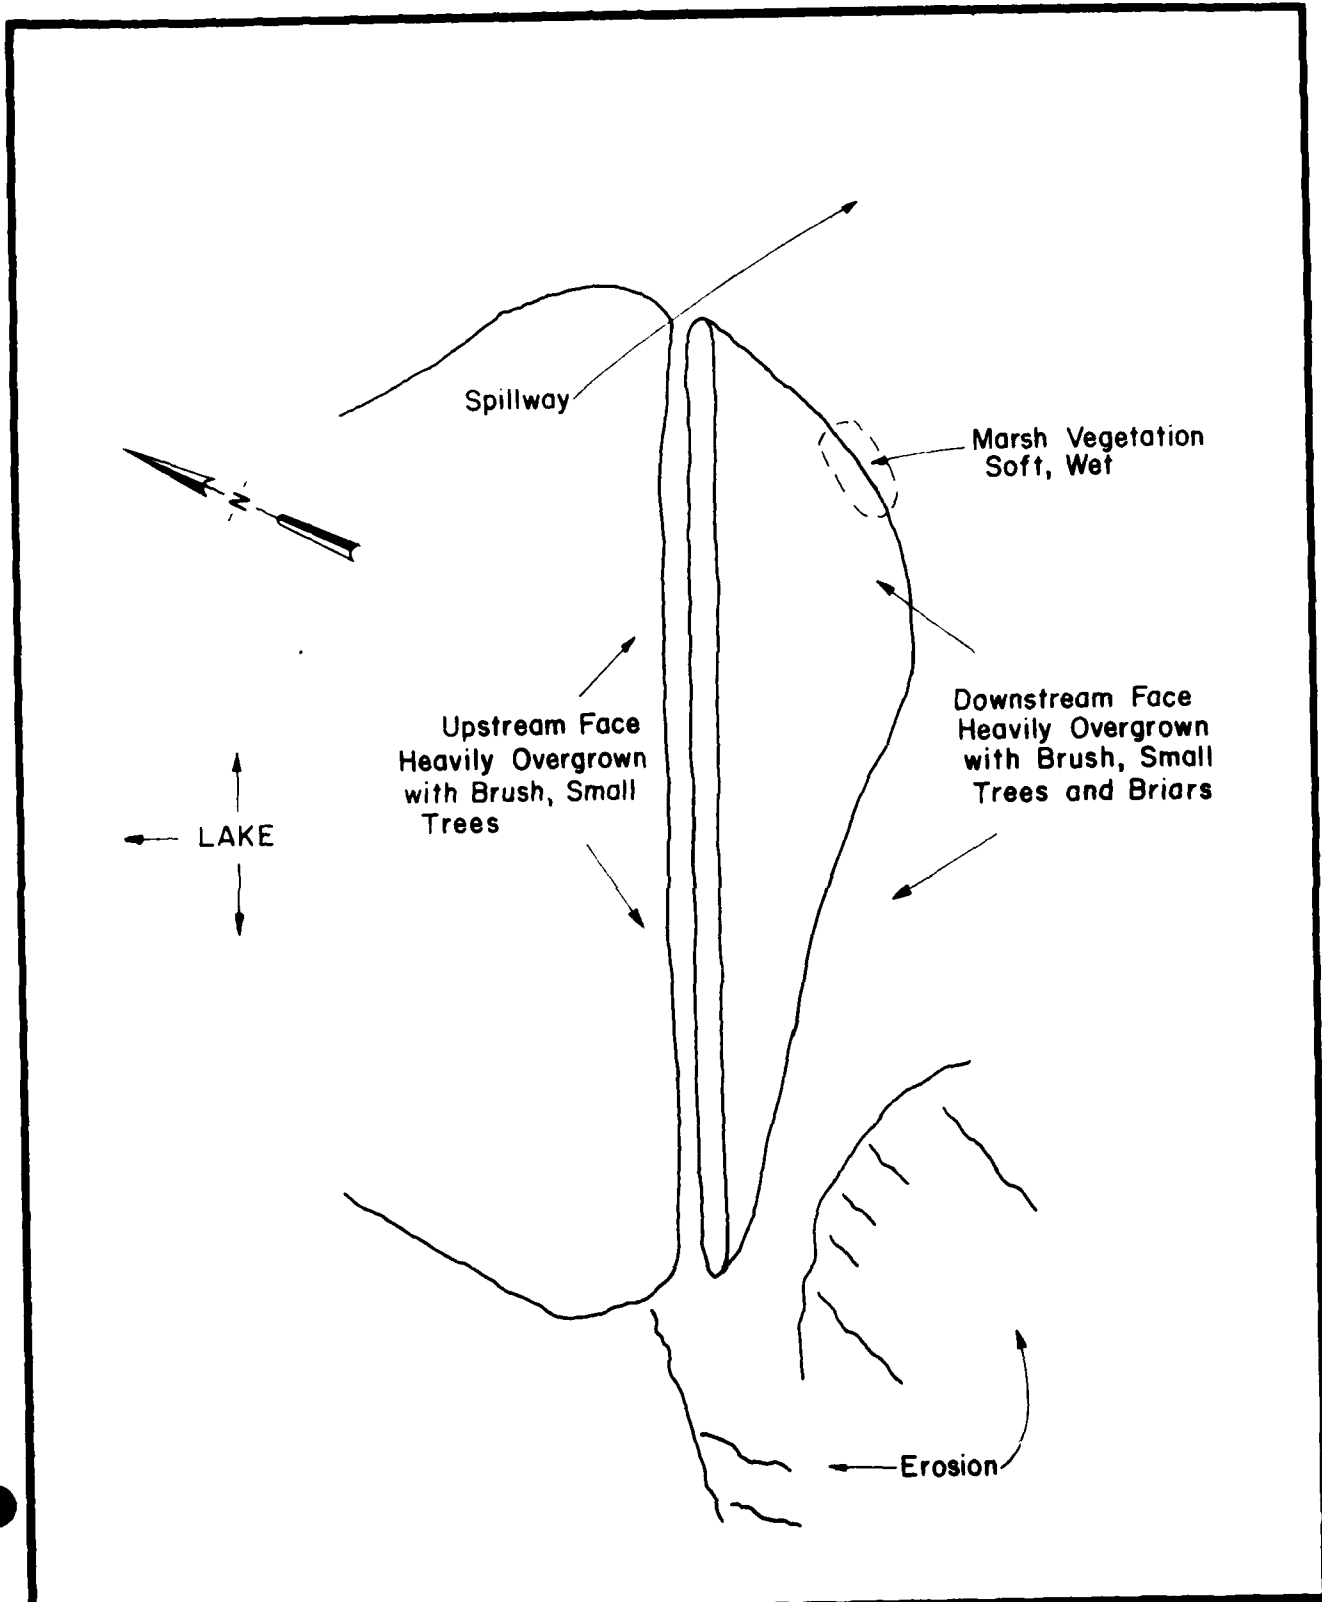
PLAN SKETCH OF FEATURES

A large erosion area was noted in the right abutment (see Sheet 5 of Appendix A). This area is somewhat apart from the dam and would not appear to affect the embankment stability.
