BINDER LAKE DAM

COLE COUNTY, MISSOURI

MO. 30051

PHASE 1 INSPECTION REPORT  
NATIONAL DAM SAFETY PROGRAM

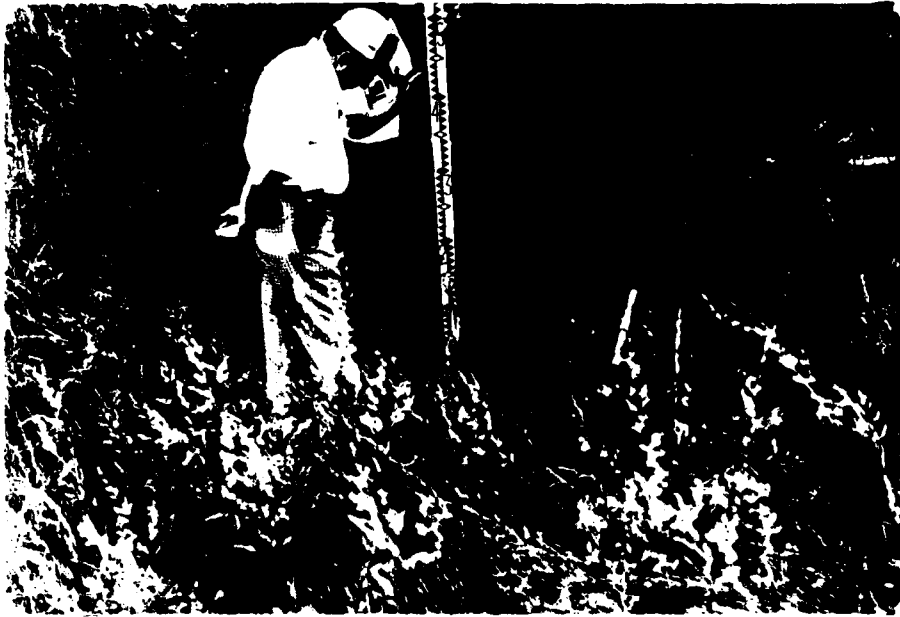
PHOTO NO. 14 - OUTLET END OF 18" CAST IRON DRAWDOWN PIPE
