**OKAYDY RESERVOIR DAM  
HOWARD COUNTY, MISSOURI  
MO. 10001**

**PHASE 1 INSPECTION REPORT  
NATIONAL DAM SAFETY PROGRAM**

**JUNE, 1979**

PREPARED BY  
HOSKINS-WESTERN-SONDEREGGER, INC.  
CONSULTING ENGINEERS  
LINCOLN, NEBRASKA

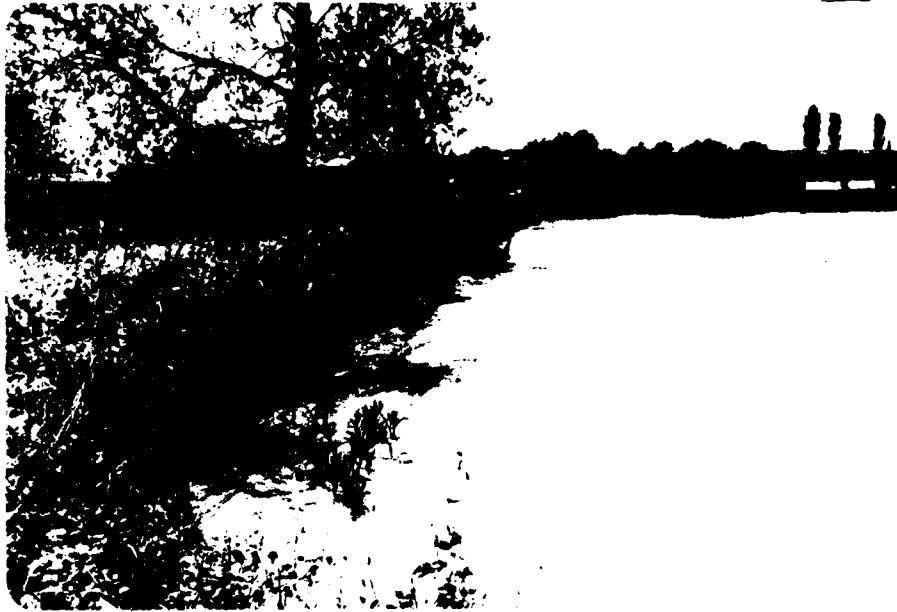
- (2) Upstream Slope. The upstream face slopes on 2.2 to 2.5H on 1V from the crest elevation down about 3 feet (elev. 618 feet  $\pm$ ) where it breaks to near vertical to the water surface at elevation 615.2 feet. Some riprap consisting of old concrete slabs and rubble was observed at or just above the water line. The slope above the riprap is fairly well vegetated with grass. A few small trees and shrubs are growing along the water line. Some erosion is noticeable above the riprap and two areas near Stations 2 + 10 and 1 + 20, show significant erosional damage with material removed almost to the crestline (see Photos 5 and 6).

PHOTO NO. 6 - ERODED UPSTREAM FACE AT STA. 1 + 20±.

- (1) Trees and shrubs should be removed from the upstream face of the dam and measures taken to prevent their recurrence.
- (2) The beaver dam, trees, and shrubs should be removed from the inlet of the spillway.
- (3) Obstructions (trees, etc.) should be removed from the outlet channel of the spillway to the extent that the spillway will operate effectively under the design flood.
- (4) Erosion on the upstream face should be corrected and measures taken to stabilize the slope with riprap or other means.
- (5) A program of regular inspection and maintenance should be initiated to control vegetative growth and erosion on the embankment slopes and to eliminate or control the beaver activity.

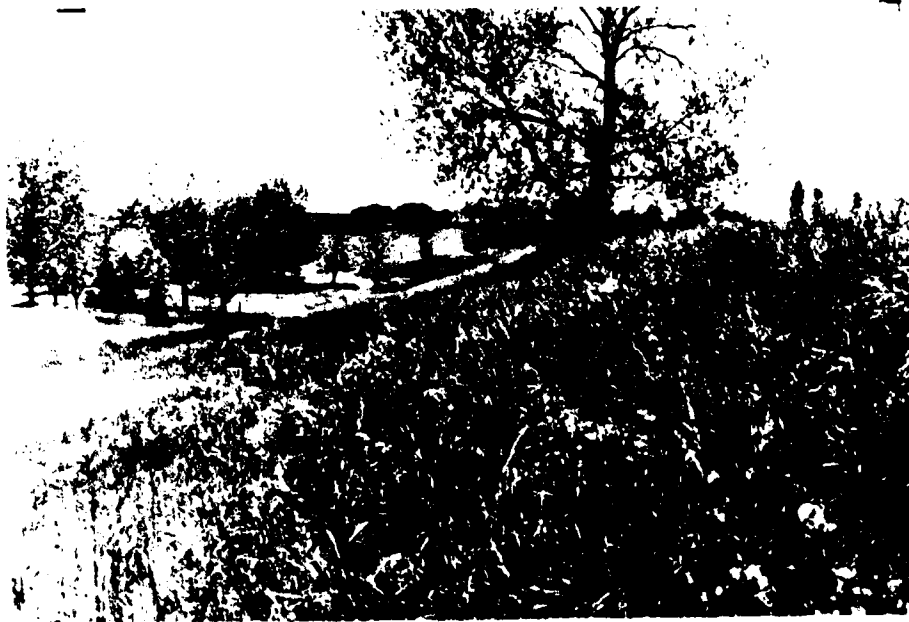
- (3) Crest - The crest is well vegetated with adapted grasses and was recently mowed. One large tree is growing on the downstream crest line near station 2 + 00. This tree was evidently left in place when the dam was enlarged in 1954. The profile of the crest is fairly uniform with one slight depressional area (0.3 to 0.5 ft. low) around Station 2 + 00. No cracks, rodent holes or lateral deformations were noted.

- a. In general, maintenance of the dam and spillway appears to be good. Tree growth and erosion on the upstream face should be controlled, but it is doubtful that the one large tree on the crest will cause any significant damage to the dam.

PHOTO NO. 10 - DOWNSTREAM SLOPE FROM LEFT END.  
NOTE LONE TREE.
