# MISSISSIPPI-KASKASKIA-ST. LOUIS BASIN

GOOSE CREEK LAKE DAM  
ST. FRANCOIS COUNTY, MISSOURI  
MO 30297

## PHASE 1 INSPECTION REPORT NATIONAL DAM SAFETY INSPECTION

JUNE 1981

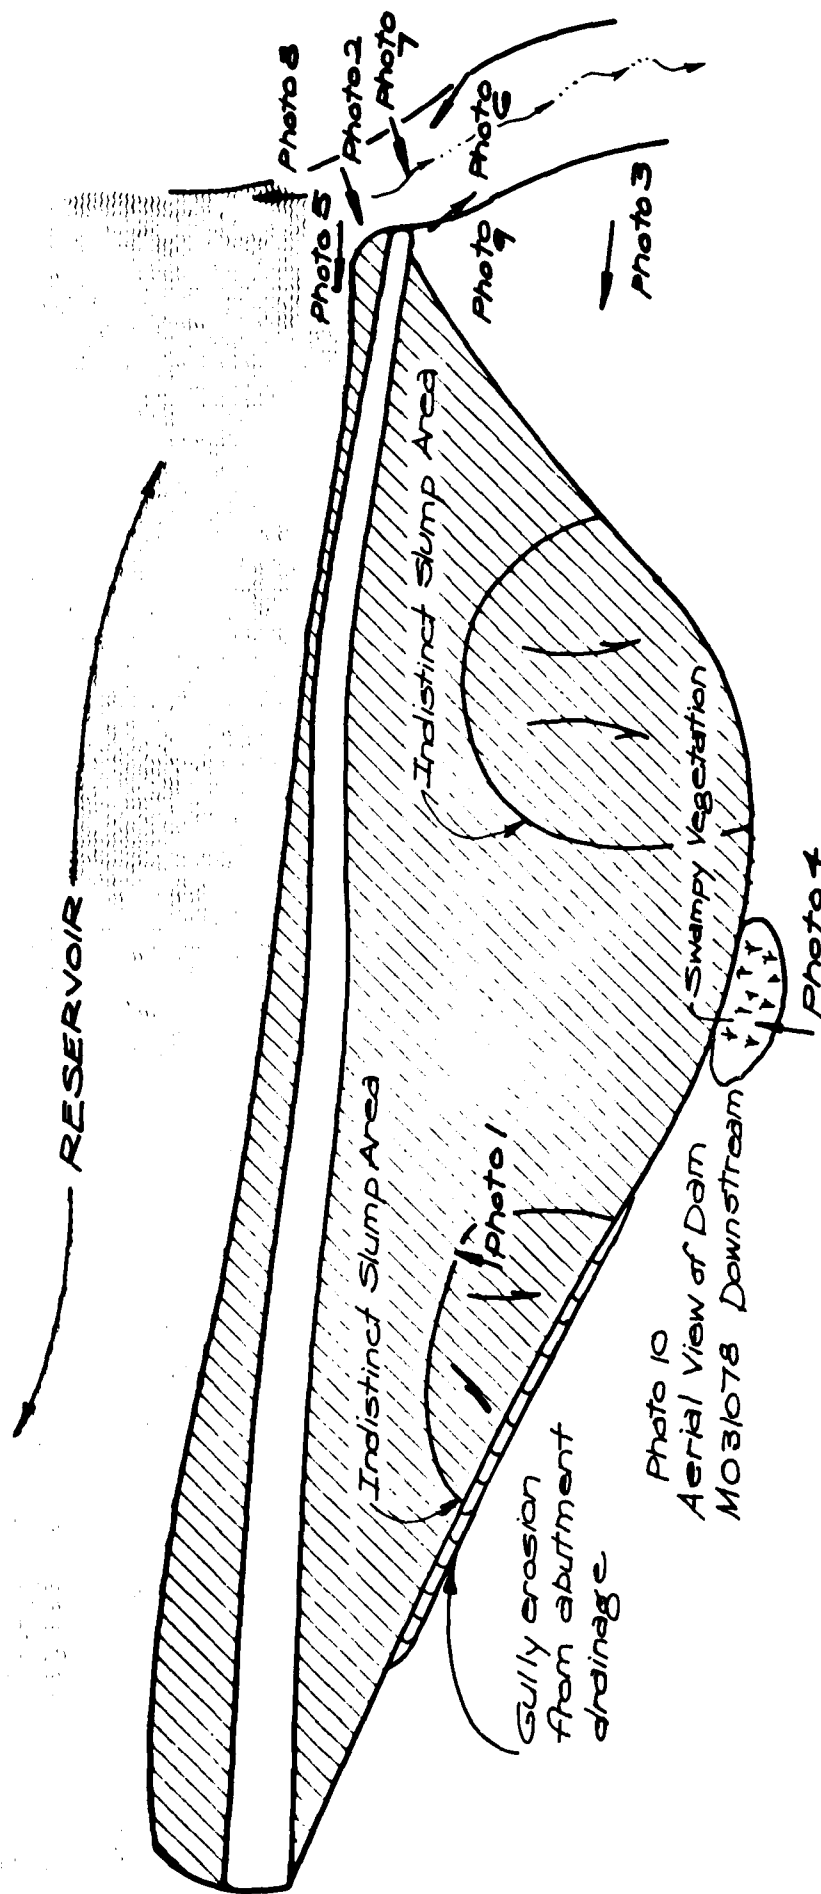
Fig. A-1

No cracking was identified on the dam. However, two areas of indistinct scarp-like features were noted (see Fig. A-1). One area approximately 50 ft wide and extending about half up the slope of the dam appears to be a shallow slump associated with the oversteepening at the toe of the right side of the dam. A second area approximately 100 ft wide and extending about two-thirds up the slope near the left end of the dam also appeared to be a shallow slump. Some of the small trees in the body of this slump were inclined down slope. The lack of distinct scarps or other slump features indicates these are likely older slumps that have not moved recently. However, the areas should be periodically inspected to identify any renewed movement.

Two indistinct slumps were noted on the downstream slope. These slumps lack well defined scarps or other distinct slump features, suggesting they are old shallow slumps. Although these slumps do not appear presently active, periodic inspection is recommended to detect renewed movement, if any. The spillway was excavated in weathered bedrock at the left abutment and does not appear subject to significant erosion during flood flows. The downstream channel below the spillway was excavated in weathered bedrock and residual soil. Erosion and slumping of the banks of this channel were noted during the visual inspection. However, the slumps appear to be small and are not considered sufficient to be a significant obstruction to flow.

1. Inspect the embankment for evidence of cracking or slumping, settlement of the dam crest, or other evidence of slope instability. These inspections should specifically include the areas of shallow slumping noted in this Phase I inspection report (Fig. A-1).
