**LAWLESS LAKE DAM
IRON COUNTY, MISSOURI
MO 31717**

**PHASE 1 INSPECTION REPORT
NATIONAL DAM SAFETY INSPECTION**

JUNE 1981

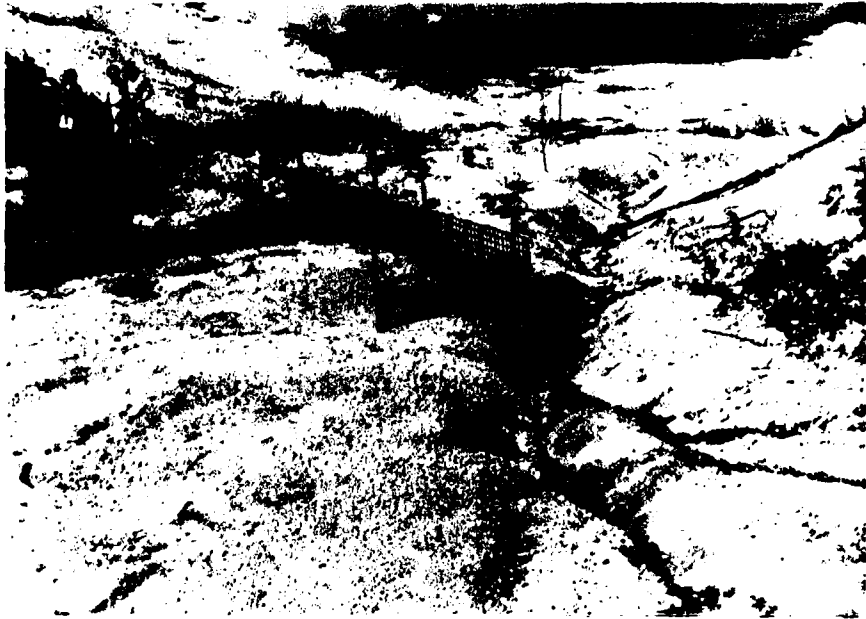
5. Auxiliary spillway, looking northeast. Note fish control fence and erosion gully leading into reservoir.

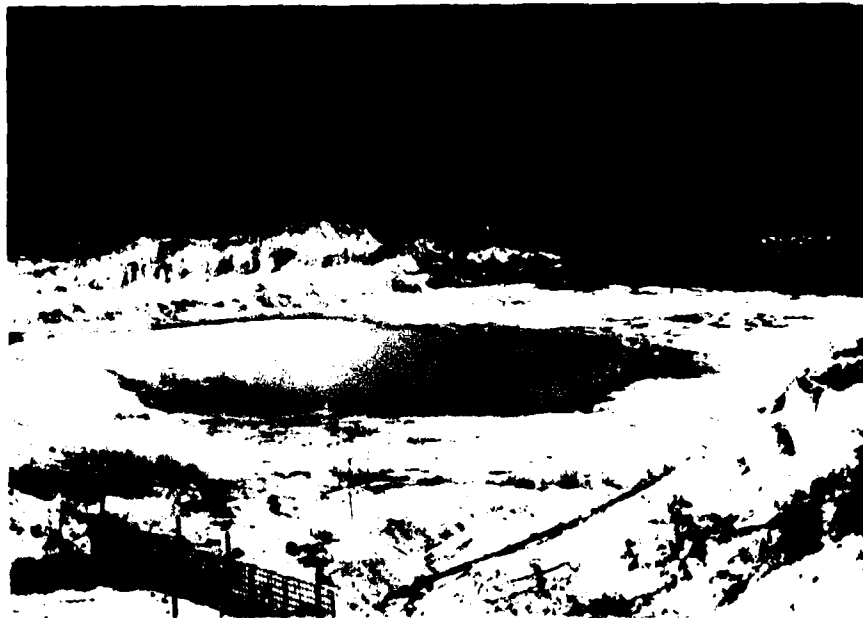
inspection, the reservoir bottom was visible. It appeared to be about 5 ft above the natural valley floor. This may be partially due to sedimentation and partially due to the clay liner reported to have been added by the owner to decrease leakage.

6. Reservoir area, looking northeast. Note low water level and near-vertical cut slopes. Also note erosion gully from left abutment into reservoir (bottom of photo).
