**POTOSI LAKE DAM  
WASHINGTON COUNTY, MISSOURI  
MO 30477**

**PHASE 1 INSPECTION REPORT  
NATIONAL DAM SAFETY INSPECTION**

**SEPTEMBER 1980**

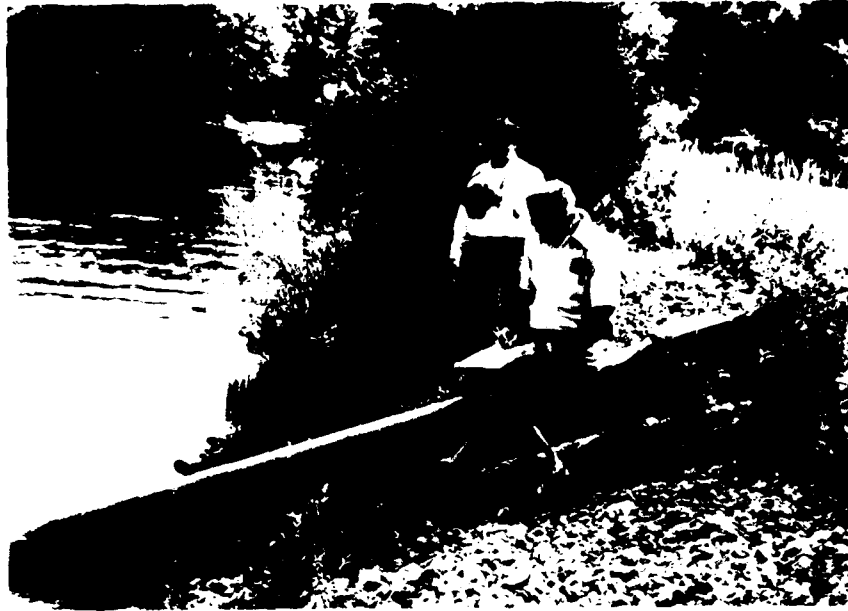
3. **Siphon.** The siphon consists of a 12-in. dia steel pipe with an air vent at the throat (Photo 1; Appendix A). The throat crest is above the dam crest elevation. Therefore, the siphon must be started manually as it will not flow until the lake elevation reaches a level above the vent. The outlet is at the dam toe. The lower leg passes under the road and rests on the downstream slope of the dam. Details of the inlet are not available. The exposed portions of the siphon appeared to be in good condition.

1. Upstream dam slope showing siphon inlet and gravel wave protection.
