**RUSSELL ELSEY DAM
WASHINGTON COUNTY, MISSOURI
MO 30102**

**PHASE 1 INSPECTION REPORT
NATIONAL DAM SAFETY INSPECTION**

SEPTEMBER 1980

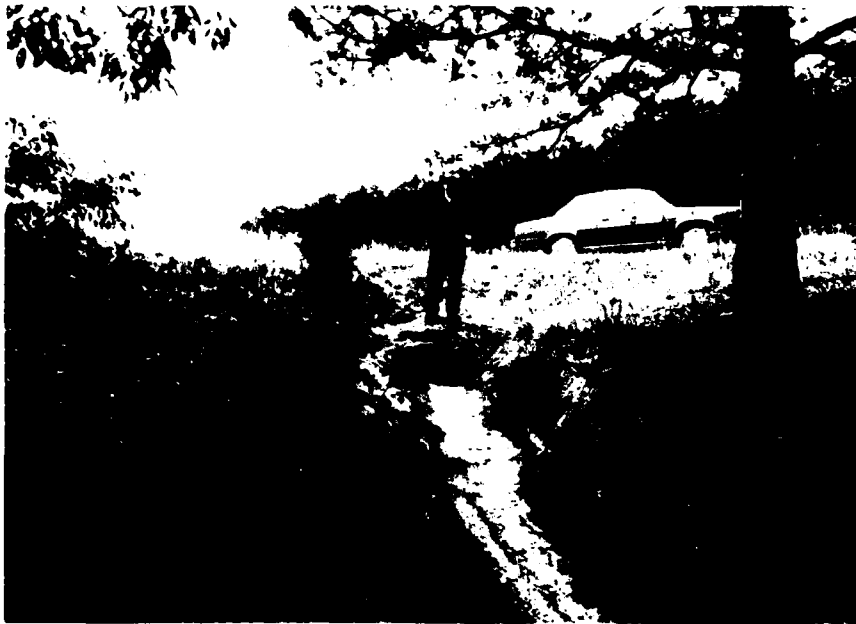
- h. Normal operating procedures. No operating records were found. Flood flows pass uncontrolled over the spillways. Normal pool elevation is controlled by two overflow pipes near the main spillway (See Photo 2).

4. Overflow outlets. Two pipes (one 12-in. and one 14-in. diameter) near the main spillway inlet serve to regulate the normal pool elevation during periods of moderate inflow. A crude trash rack protects the inlet. The pipes and the concrete-lined discharge channel appeared to be in good condition.

2. Exit for low flow outlet and concrete-lined channel.
