**MISSISSIPPI - ST. FRANCIS BASIN**

SLIME POND DAM  
MADISON COUNTY, MISSOURI  
MO 30611

**PHASE 1 INSPECTION REPORT  
NATIONAL DAM SAFETY INSPECTION**

APRIL 1981

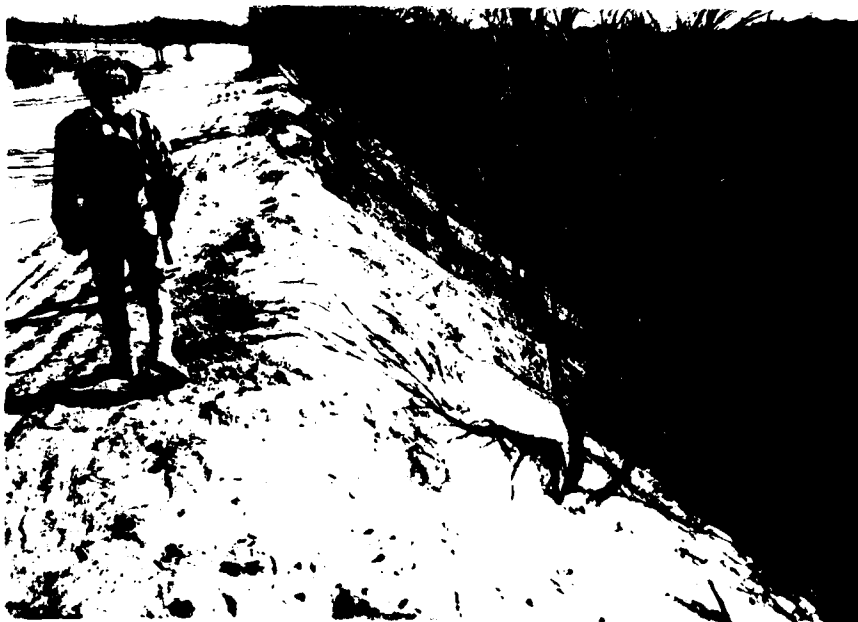
- a. Visual observations. The visual inspection of Slime Pond Dam identified several features which could affect the structural stability of the embankment. No evidence was noted of slumping or cracking of the embankment; however, the downstream slope was noted to be quite steep, on the order of 1.4(H) to 1(V), and could be subject to slumping and slope failure. No slope stability analysis was available for this dam, but the visual inspection suggests this steep downstream face is only marginally stable in its present condition.

2. Crest and downstream slope of dam. Note steep slope and tree and brush vegetation. Looking southeast along face of dam.
