**SMITTY'S CATFISH POND DAM
MADISON COUNTY, MISSOURI
MO 30613**

**PHASE 1 INSPECTION REPORT
NATIONAL DAM SAFETY INSPECTION**

APRIL 1981

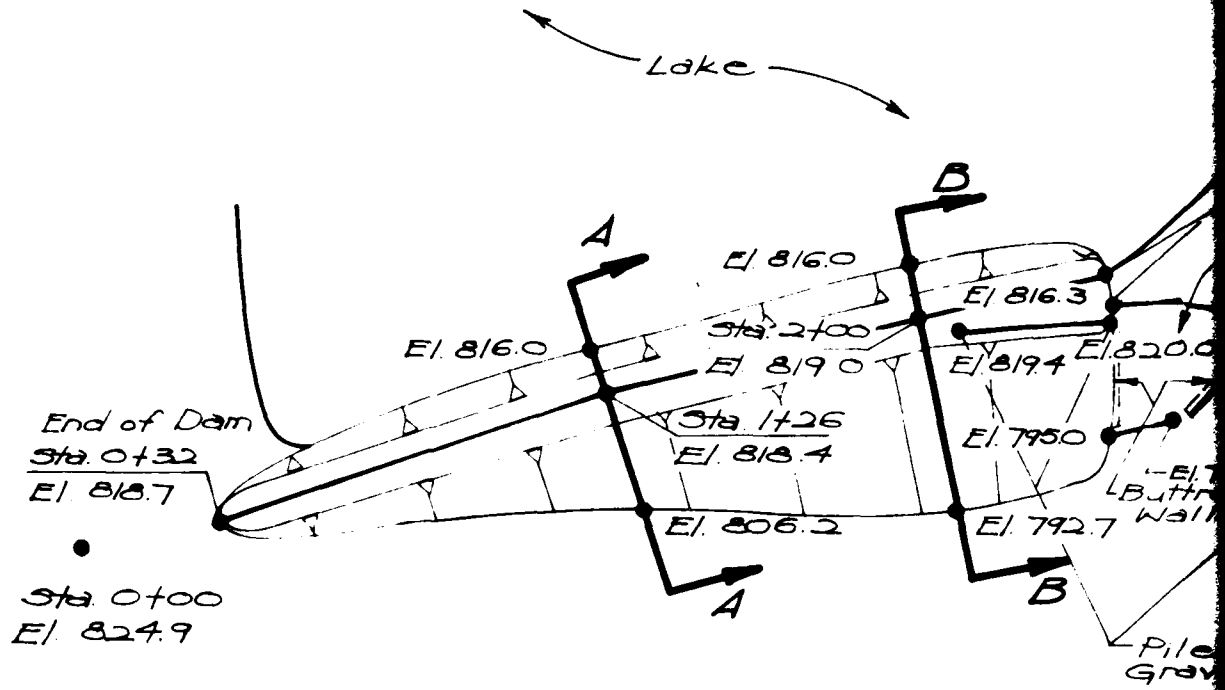
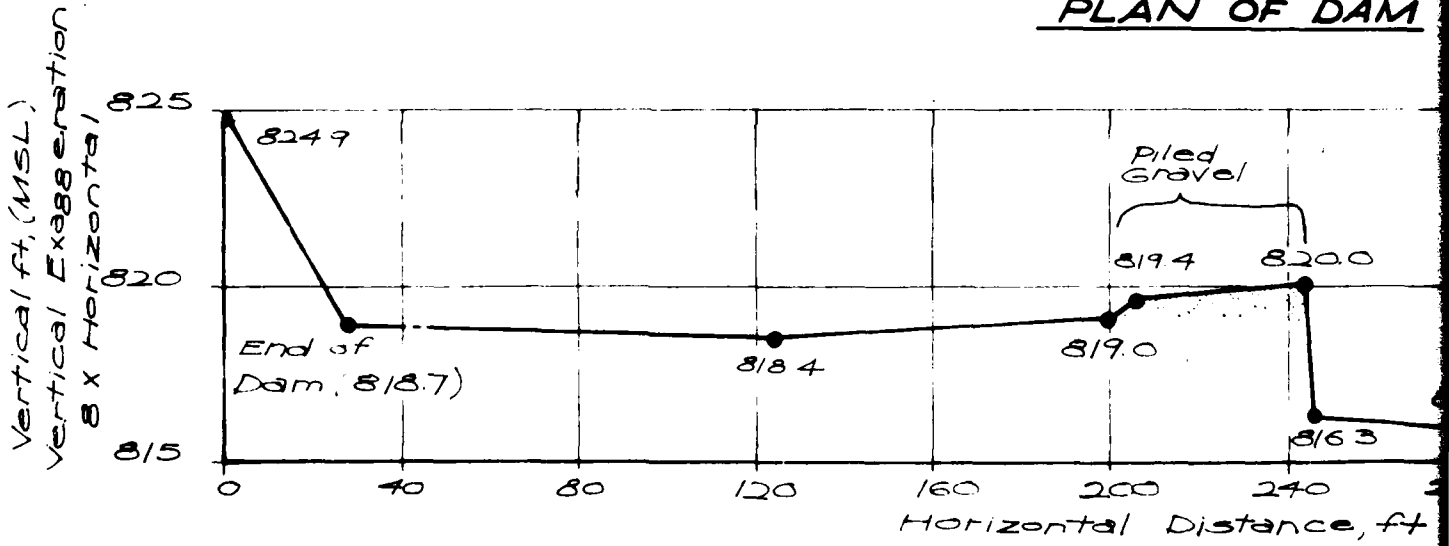
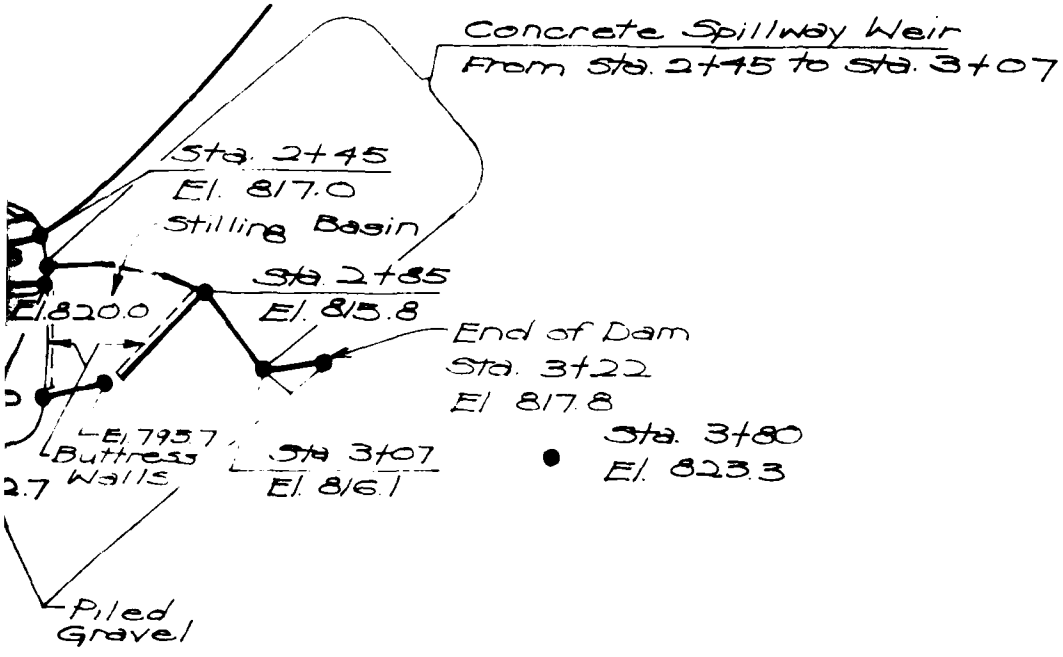
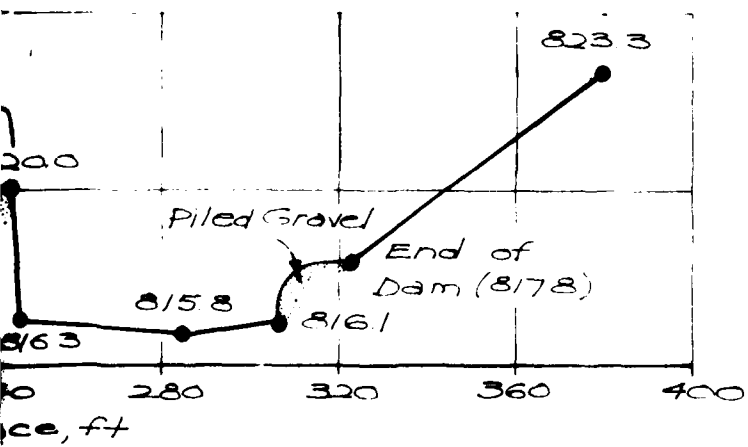
DAM AND SPILLWAY PLAN AND PROFILE	
SMITTY'S CATFISH POND DAM	
MO 30613	Fig. 3-A

A slump was noted on the downstream slope of the embankment, in the vicinity of Sta 2+00 on Fig. 3A, possibly as a result of the steep slope. The slump was recent, evidenced by a distinct scarp and lobate toe. The volume of the slump was estimated at 2 to 3 yd³.

- d. Overtopping potential. One of the primary considerations in the evaluation of this dam is the assessment of the potential for overtopping and consequent failure by erosion of the embankment. Because the spillway of the dam is concrete, erosion at the spillway due to high velocity discharge is not expected to be a major consideration. The junction of the spillway and left abutment is also concrete covered and consists of outcropping bedrock. This area is also considered not to be subject to significant erosion. The lowest portion of the crest of the dam, near the center of the embankment (Fig. 3A), was considered the minimum top of dam for the overtopping analysis.
