UPPER VALLE MINES DAM
Jefferson County, Missouri
Missouri Inventory No. 30370

Phase I Inspection Report
National Dam Safety Program

Woodward-Clyde Consultants
Chicago, Illinois

for
Governor of Missouri
December 1980

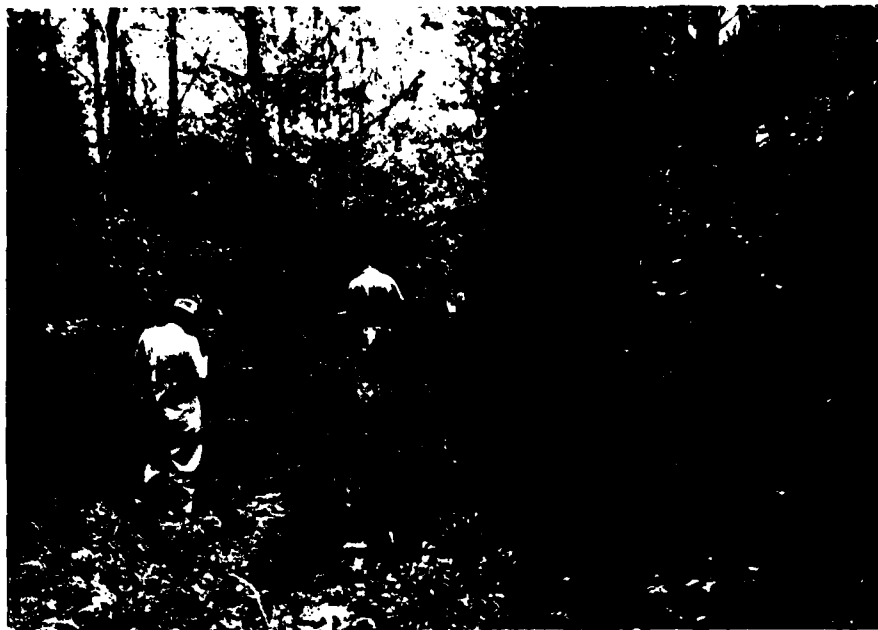
1. View along crest of dam. Note dense vegetation on upstream face (right) and downstream face (left). Looking east.

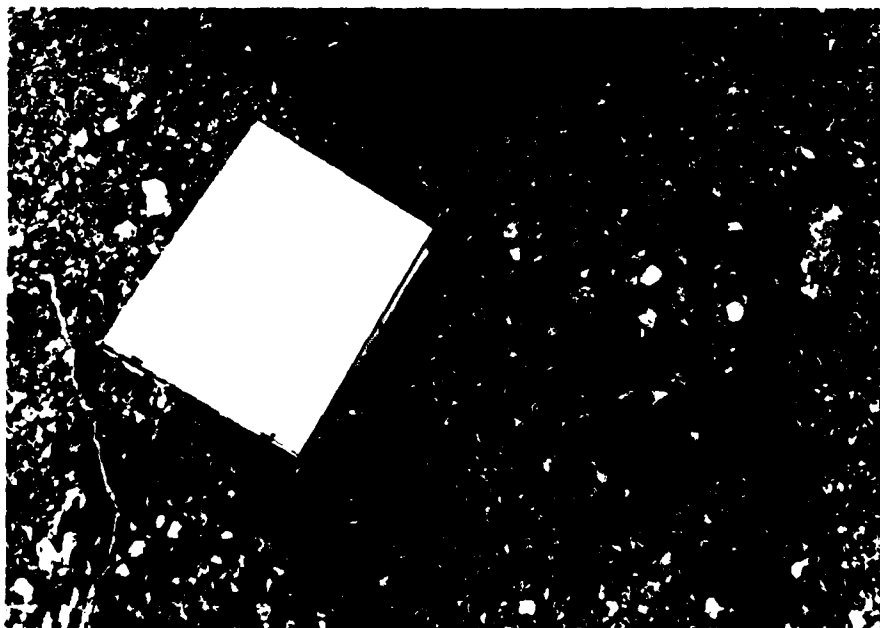
Minor gully erosion was noted on the exposed portion of the downstream face. The dense vegetation probably offers some erosion protection. The chat mantle, exposed at the east end of the embankment, is judged to be highly erodible for flow velocities of 5.0 ft/sec or greater, such as that created on the steep downstream face during potential overtopping (Photo 4).

4. Exposed chat, gravel-sized tailings; near east end of embankment.

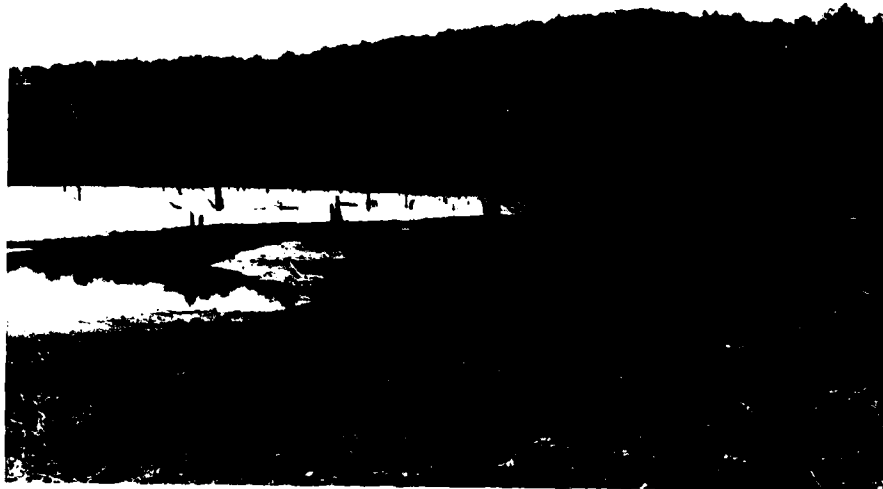
7. Reservoir area showing shallow pool and tailings deposits. Looking south.

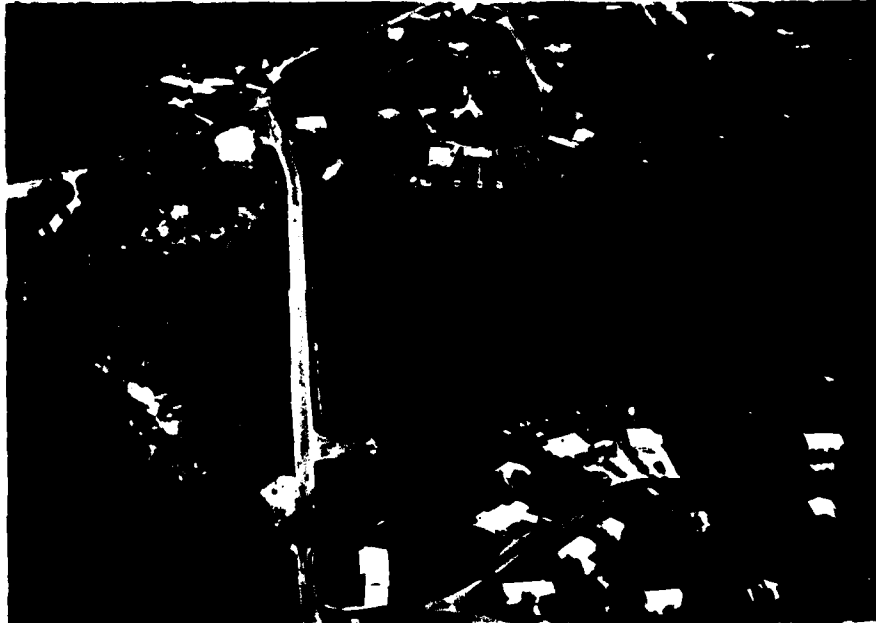
The amount and duration of total outflow for this dam will jeopardize the safety of the downstream residents and dams. The total outflow from this dam is likely to inundate some downstream structures as shown in Photos 9, 10 and 11. The severity of inundation and damage is unknown without further studies.

11. Valle Lake Dam approximately two miles below
Upper Valle Mines Dam, within downstream
hazard zone. Looking east.
