**WILLIAMS DAM**

**JEFFERSON COUNTY, MISSOURI**

**MO 30384**

**PHASE 1 INSPECTION REPORT  
NATIONAL DAM SAFETY PROGRAM**

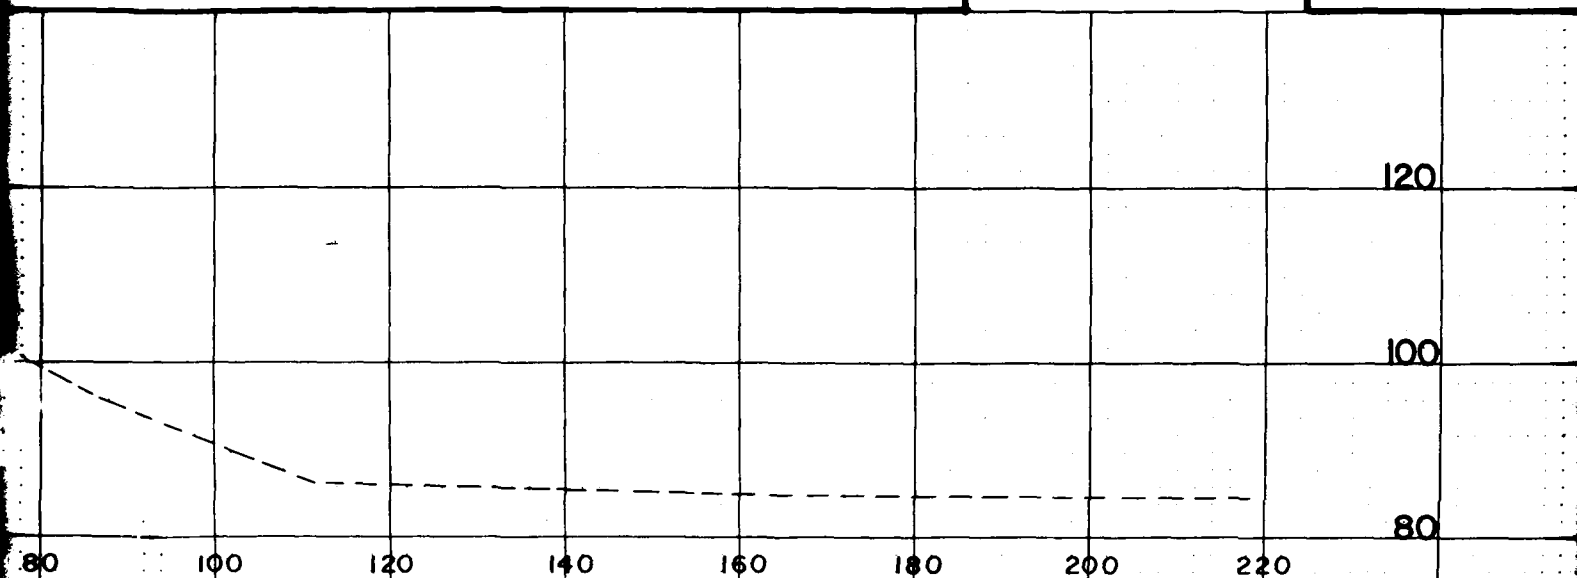
PROFILE OF  
WEST SPILLWAY

(3) The west spillway crest is at too high an elevation to be effective in discharging water before the dam is overtopped.
