**KOMER LAKE DAM**

**BUCHANAN COUNTY, MISSOURI**

**MO. 10995**

# **PHASE 1 INSPECTION REPORT NATIONAL DAM SAFETY PROGRAM**

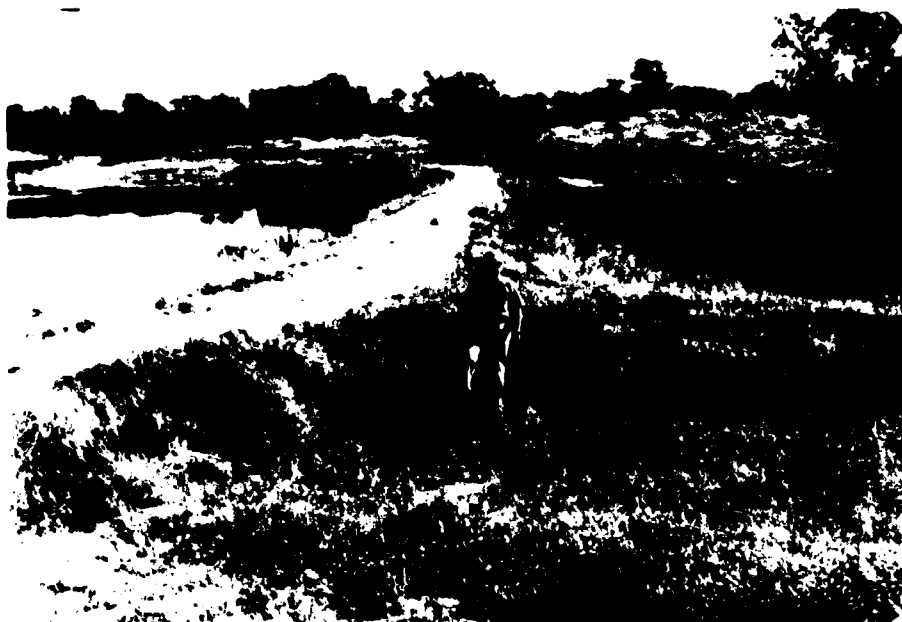
Materials in the dam are silty loess (CL-ML). The soil deposits in the dam area consist of upland soils of the Sharpsburg-Grundy-Adair-Shelby soil association. This soil association is common in a landscape in which moderately deep loess overlies glacial till.
  - (2) Upstream Slope. The upstream slope is fairly well vegetated with grass and small willows. No slumping or significant erosion was noted on the upstream slope. Photo No. 4 shows the upstream slope.
  - (3) Crest. The crest is sparsely vegetated and serves as a dam road. Measurements indicate that the crest elevations are relatively uniform with a slightly lower area toward the right end of the dam (See Plate C-1). No cracks or slumps were noted on the crest. Photos 3 and 6 show the crest.

PHOTO NO. 6 - CREST OF DAM TAKEN FROM RIGHT END. FOOT ON TOP OF BARREL EMERGENCY SPILLWAY.

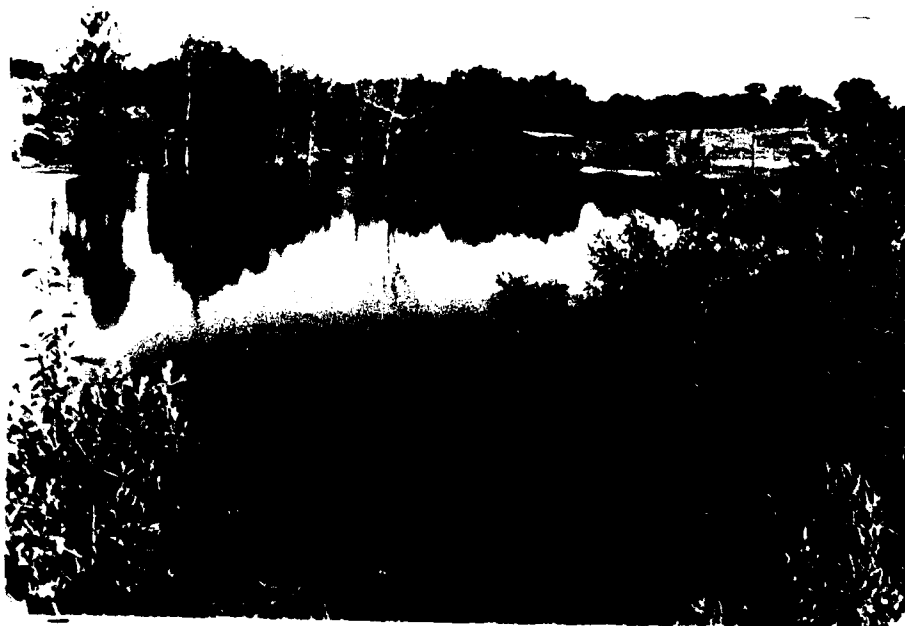
- d. Reservoir Area. The reservoir area is fairly well vegetated around the water line. No slumps, slides or severely eroded areas were observed around the shoreline. Photo 11 shows a portion of the reservoir.
- e. Downstream Channel. The channel downstream from the pipe spillway is badly clogged with trees and brush. However, this growth should not interfere with discharges from this small pipe spillway. Photo 12 shows the valley downstream from the pipe spillway.

PHOTO NO. 11 - VIEW UPSTREAM TAKEN FROM PRINCIPAL SPILLWAY LOCATION.
