RISS LAKE DAM

MO 20128

PHASE 1 INSPECTION REPORT  
NATIONAL DAM SAFETY PROGRAM

SEPTEMBER, 1978

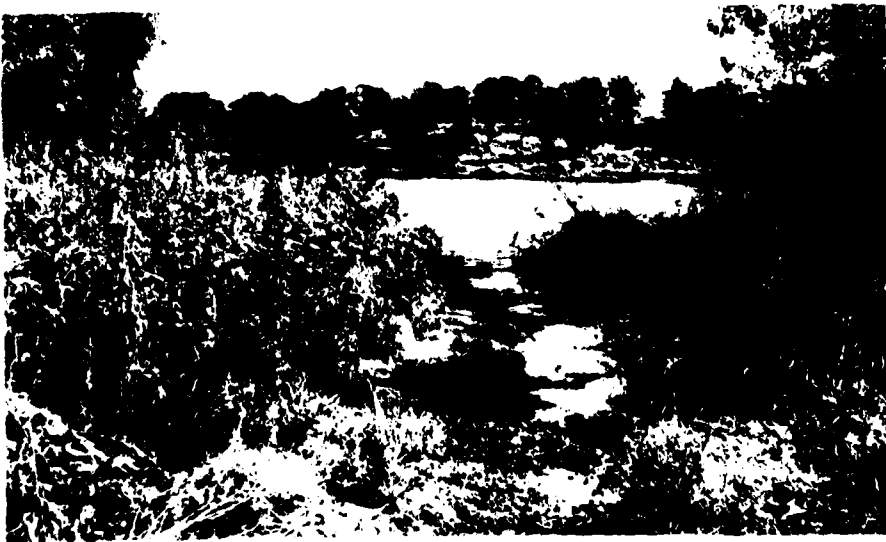
- c. Appurtenant Structures. The spillway consists of an earth channel, with a broomed concrete invert, that drops sharply down the left abutment. The spillway channel follows the route of the original spillway channel, but the flowline has eroded up to 20 feet vertically at some locations. The original limestone masonry walls of the spillway channel remain, generally intact, high above the existing flowline. It was reported that head-cutting erosion of the spillway channel began shortly after construction and reached the dam during high flows in 1977. At that time, erosion of the channel lowered the lake level about 7 feet. The spillway was then repaired in order to bring the lake back to its normal level. A plug of compacted soil was constructed in the eroded spillway channel. The plug is about 100

feet long, gently sloping on top, and steeply sloping on the downstream side. The concrete spillway invert is constructed on this earth plug and stops when it reaches the eroded spillway channel. At station 2+80 there is an 8-inch steel siphon that has been installed as a drawdown works. The intake is reported to be about 20 feet below the normal pool level. Where the siphon passes through the embankment, its top is at the normal pool level. After emerging from the embankment, the pipe rests on the downstream slope with an unprotected discharge about 30 feet below the downstream toe. The siphon was carrying no flow at the time of the inspection. The uncontrolled spillway and the drawdown siphon are the only structures to control pool levels at this dam.

PHOTO NO. 9  
LOOKING UPSTREAM  
IN SPILLWAY
