NO NAME-448

ST. CHARLES COUNTY, MISSOURI

PHASE 1 INSPECTION REPORT NATIONAL DAM SAFETY PROGRAM

SEPTEMBER 1978

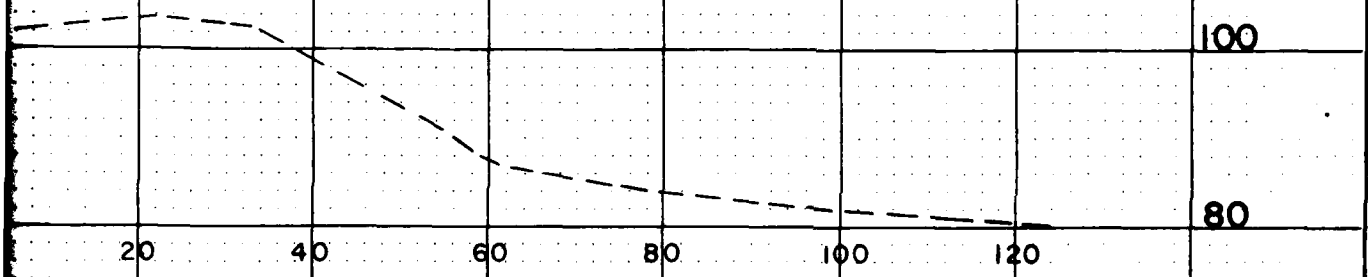
**SECTION OF DAM AT
LOW POINT OF CREST
STA. 1+50**

The lack of a spillway or even provision for control of overtopping flow at the low point of the dam are deficiencies which, if uncorrected, could result in failure of the dam by overtopping.
