LAKE CHAMPETRA DAM

BOONE COUNTY, MISSOURI

# PHASE 1 INSPECTION REPORT NATIONAL DAM SAFETY PROGRAM

PREPARED BY  
HOSKINS-WESTERN-SONDEREGGER, INC.  
CONSULTING ENGINEERS  
LINCOLN, NEBRASKA

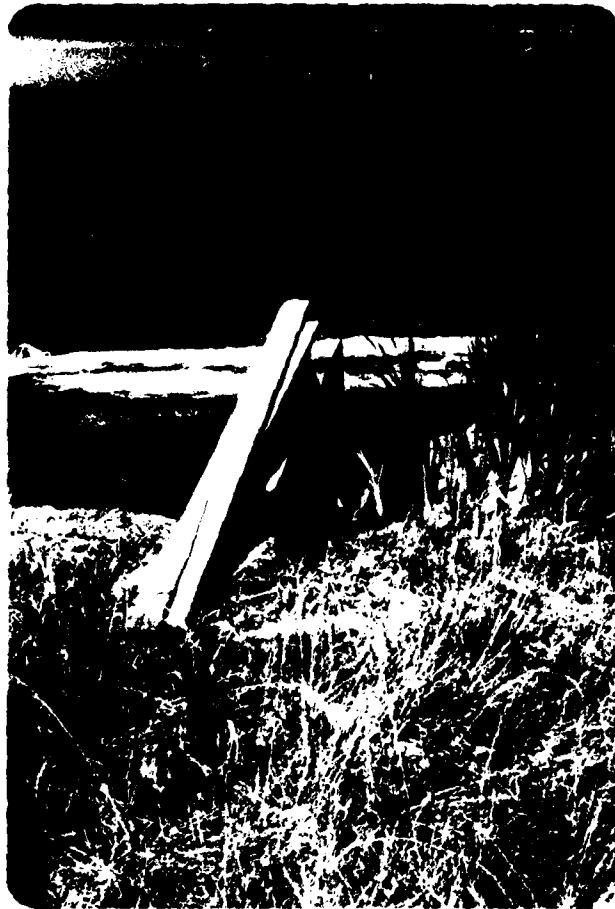
- (1) The principal spillway at the time of the inspection was not operating effectively. In fact, the top of the riser was submerged. A subsequent visit to the site showed that the inlet to the 12-inch steel pipe conduit at the bottom of the riser was almost completely plugged with a tree stump and trash. The owner was notified of this condition by letter. There is no trash rack over the top of the riser. No deterioration was noted in the steel riser or conduit.
- (2) The emergency spillway is well vegetated. The exit channel just downstream from the crest is partially blocked by the storage of a float boat or diving platform. It did not appear that the spillway had operated. No slides, slumps or erosion was noted in the spillway. Discharges from the spillway should not endanger the dam.

- c. Visual Observations.
  - (1) The steel pipe principal spillway was observed to be plugged with a tree stump and roots, severely limiting the spillway capacity. A letter was written to the owner strongly suggesting this condition be corrected.

PHOTO NO. 6 - INLET END  
OF PRINCIPAL SPILLWAY

There does not appear to be a maintenance plan for this structure. Maintenance of the spillways is deficient. The principal spillway should be opened, and a suitable trash rack should be installed to prevent future plugging. The obstruction in the emergency spillway channel should be removed. The trees should be removed from the downstream slope and measures taken to prevent their recurrence.

1. The principal spillway should be opened up and measures (trash rack) installed to prevent recurrence of plugging.
2. Obstructions in the emergency spillway should be removed and measures taken to keep the channel open.
3. The small trees and shrubs should be removed from the downstream slope of the dam and measures taken to prevent recurrence of growth.
