LAKE TIMBER RIDGE DAM

GASCONADE COUNTY, MISSOURI

**PHASE 1 INSPECTION REPORT  
NATIONAL DAM SAFETY PROGRAM**

PREPARED BY  
HOSKINS-WESTERN-SONDEREGGER, INC.  
CONSULTING ENGINEERS  
LINCOLN, NEBRASKA

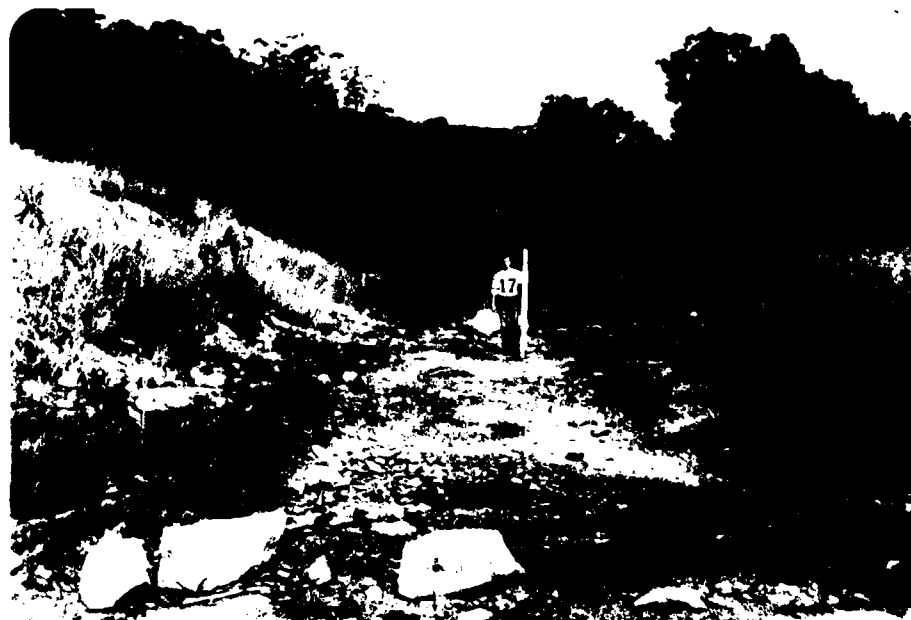
- (1) The principal spillway consists of a channel cut through limestone and shale on the left abutment. The approach channel and control section are open with limestone bedrock exposed in most of the bottom. The lower end of the control section is restricted by a roadway across the spillway consisting of a concrete slab over five concrete pipe culverts 12 inches in diameter. Some deterioration was noted in the concrete filleting around the upstream and downstream ends of the culverts. (Photos 10 and 12) The exit channel is eroded through CL-CH Soil and Shale and outlets over a near vertical drop of 8 feet  $\pm$  where the channel bottom has stabilized on limestone bedrock (photo 11). Discharges from this spillway would not encroach upon the dam. The reservoir level was slightly below the inlet elevation of the spillway when inspected.

PHOTO NO. 7 - DOWNSTREAM IN SPILLWAY ON LEFT SIDE

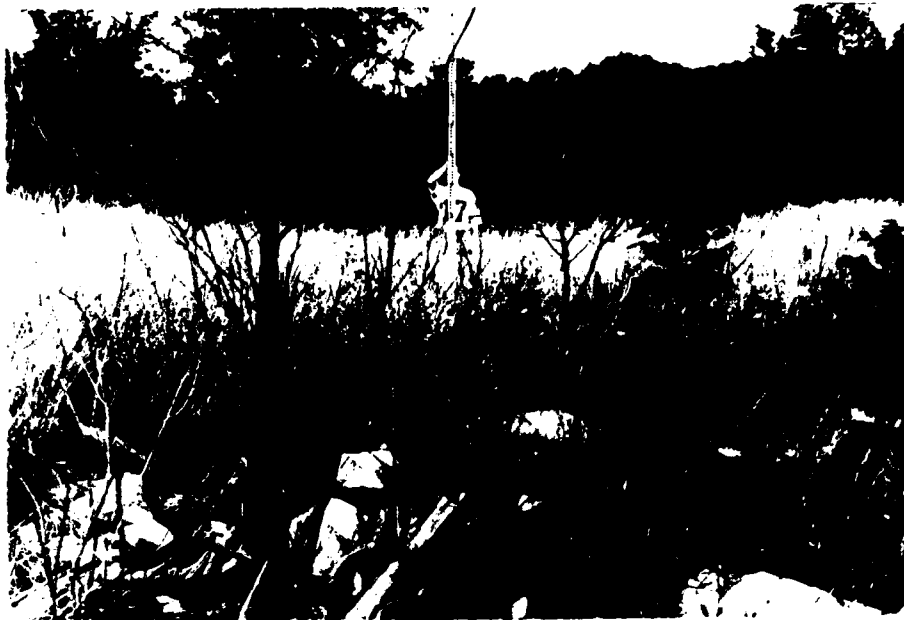
- (2) The emergency spillway consists of a shallow earth channel excavated through the right abutment. The inlet section is riprapped with a few small trees growing at the water edge. The control section and outlet channel are densely vegetated with adapted grasses. The outlet channel drops off onto the stable abutment some 100 feet downstream from the control section. No erosion was noted in the spillway. The water level was approximately 2 feet below the control elevation when inspected. Trash in the inlet section indicated that the reservoir level had been up to within 8 to 12 inches of the control elevation.

PHOTO NO. 18 - DOWNSTREAM IN RIGHT SPILLWAY
