**THE PLACE DAM  
WASHINGTON COUNTY, MISSOURI  
MO 30996**

**PHASE 1 INSPECTION REPORT  
NATIONAL DAM SAFETY INSPECTION**

**DECEMBER 1980**

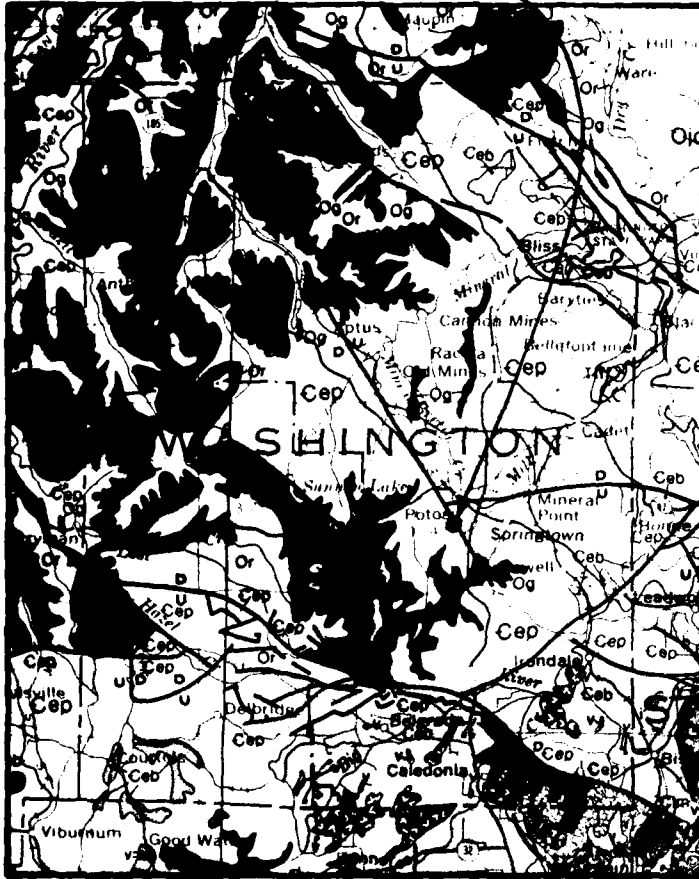
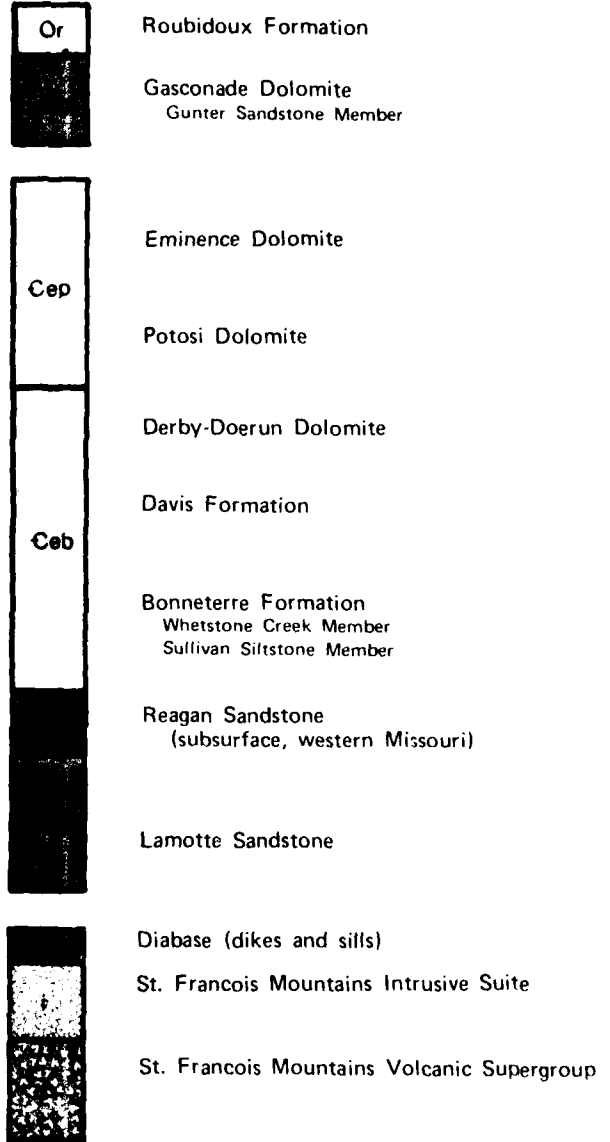
<h1>REGIONAL GEOLOGIC MAP</h1>	
<h2>THE PLACE DAM</h2>	
MO 30996	Fig. 4

The Aptus Fault is mapped on the Geologic Map of Missouri (1979) as directly beneath the dam (Fig 4). However, the scale of the map (1 in. equals 8 mi) does not allow for precise location of the fault trace. No evidence of the fault was noted during the field inspection. The fault is approximately 15 mi long, trending northwest-southeast. The fault is mapped as northeast side up.

This fault, like others in the Ozark region, appears confined to the Paleozoic bedrock and is likely Paleozoic in age. The area is not considered seismically active. However, the presence of a fault in the immediate vicinity, and perhaps underlying the dam, suggests further study is necessary to evaluate such possible hazards as the potential for groundwater solutioning along the fault in the foundation of this dam.

2. A study should be conducted of the Aptus Fault, as described in this report in Section 2.5, Project Geology, to determine the location of the trace of this fault and to evaluate whether or not it represents any potential safety hazard to the dam.
