**HORNSEY BROTHERS DAM  
WASHINGTON COUNTY, MISSOURI  
MO 30101**

# **PHASE 1 INSPECTION REPORT NATIONAL DAM SAFETY INSPECTION**

**PREPARED BY: U.S. ARMY ENGINEER DISTRICT, ST. LOUIS**

**NOVEMBER 1980**

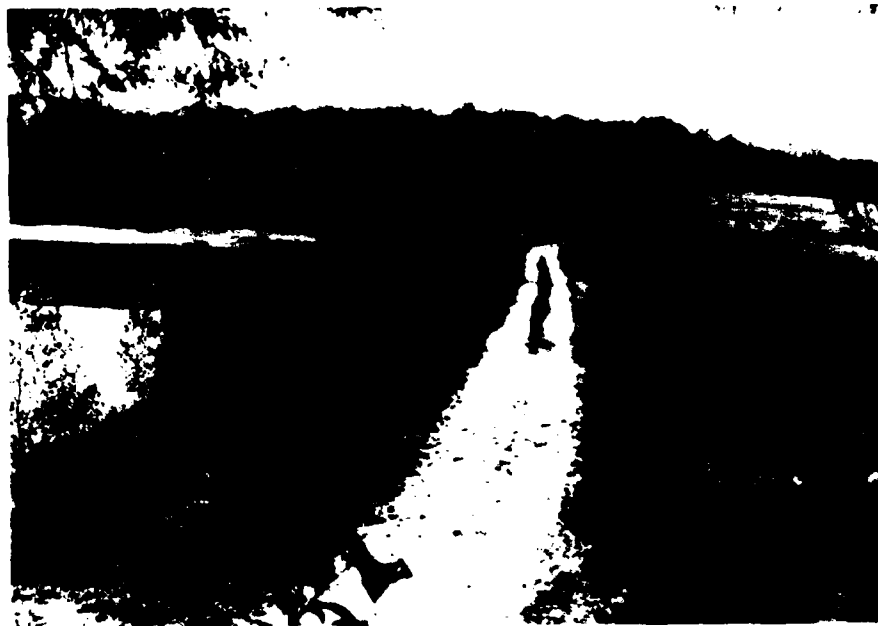
2. Roadway and dam crest from right abutment. Looking northwest. Note vegetation on upstream and downstream slopes.

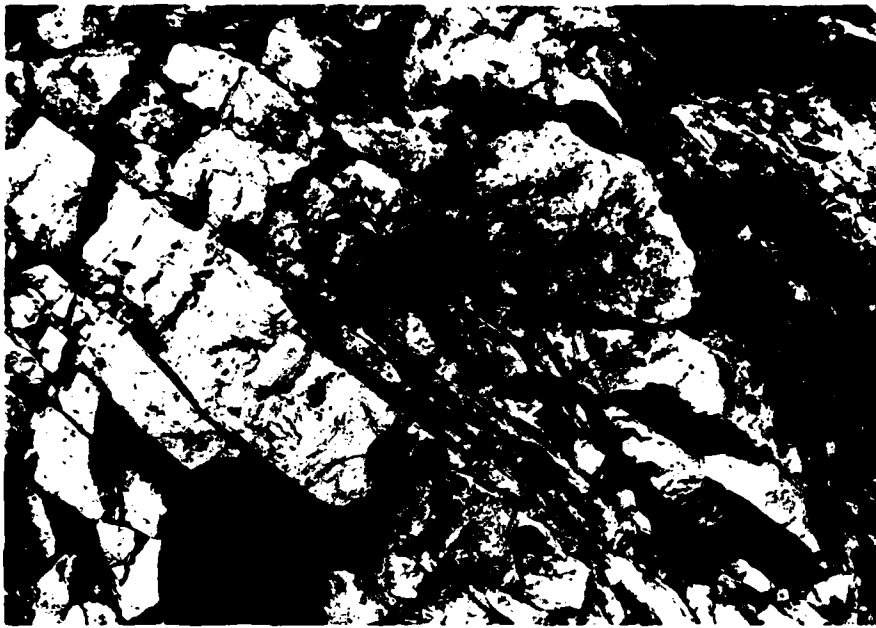
7. Jointed bedrock in discharge channel.
