**DUCK CREEK STATE WILDLIFE
REFUGE — POND #2
STODDARD COUNTY, MISSOURI
MO 48893**

**PHASE 1 INSPECTION REPORT
NATIONAL DAM SAFETY PROGRAM**

DUCK CREEK STATE WILDLIFE REFUGE - POND 2
STODDARD COUNTY, MISSOURI
MISSOURI INVENTORY NO. 40093

PHASE I INSPECTION REPORT
NATIONAL DAM SAFETY PROGRAM

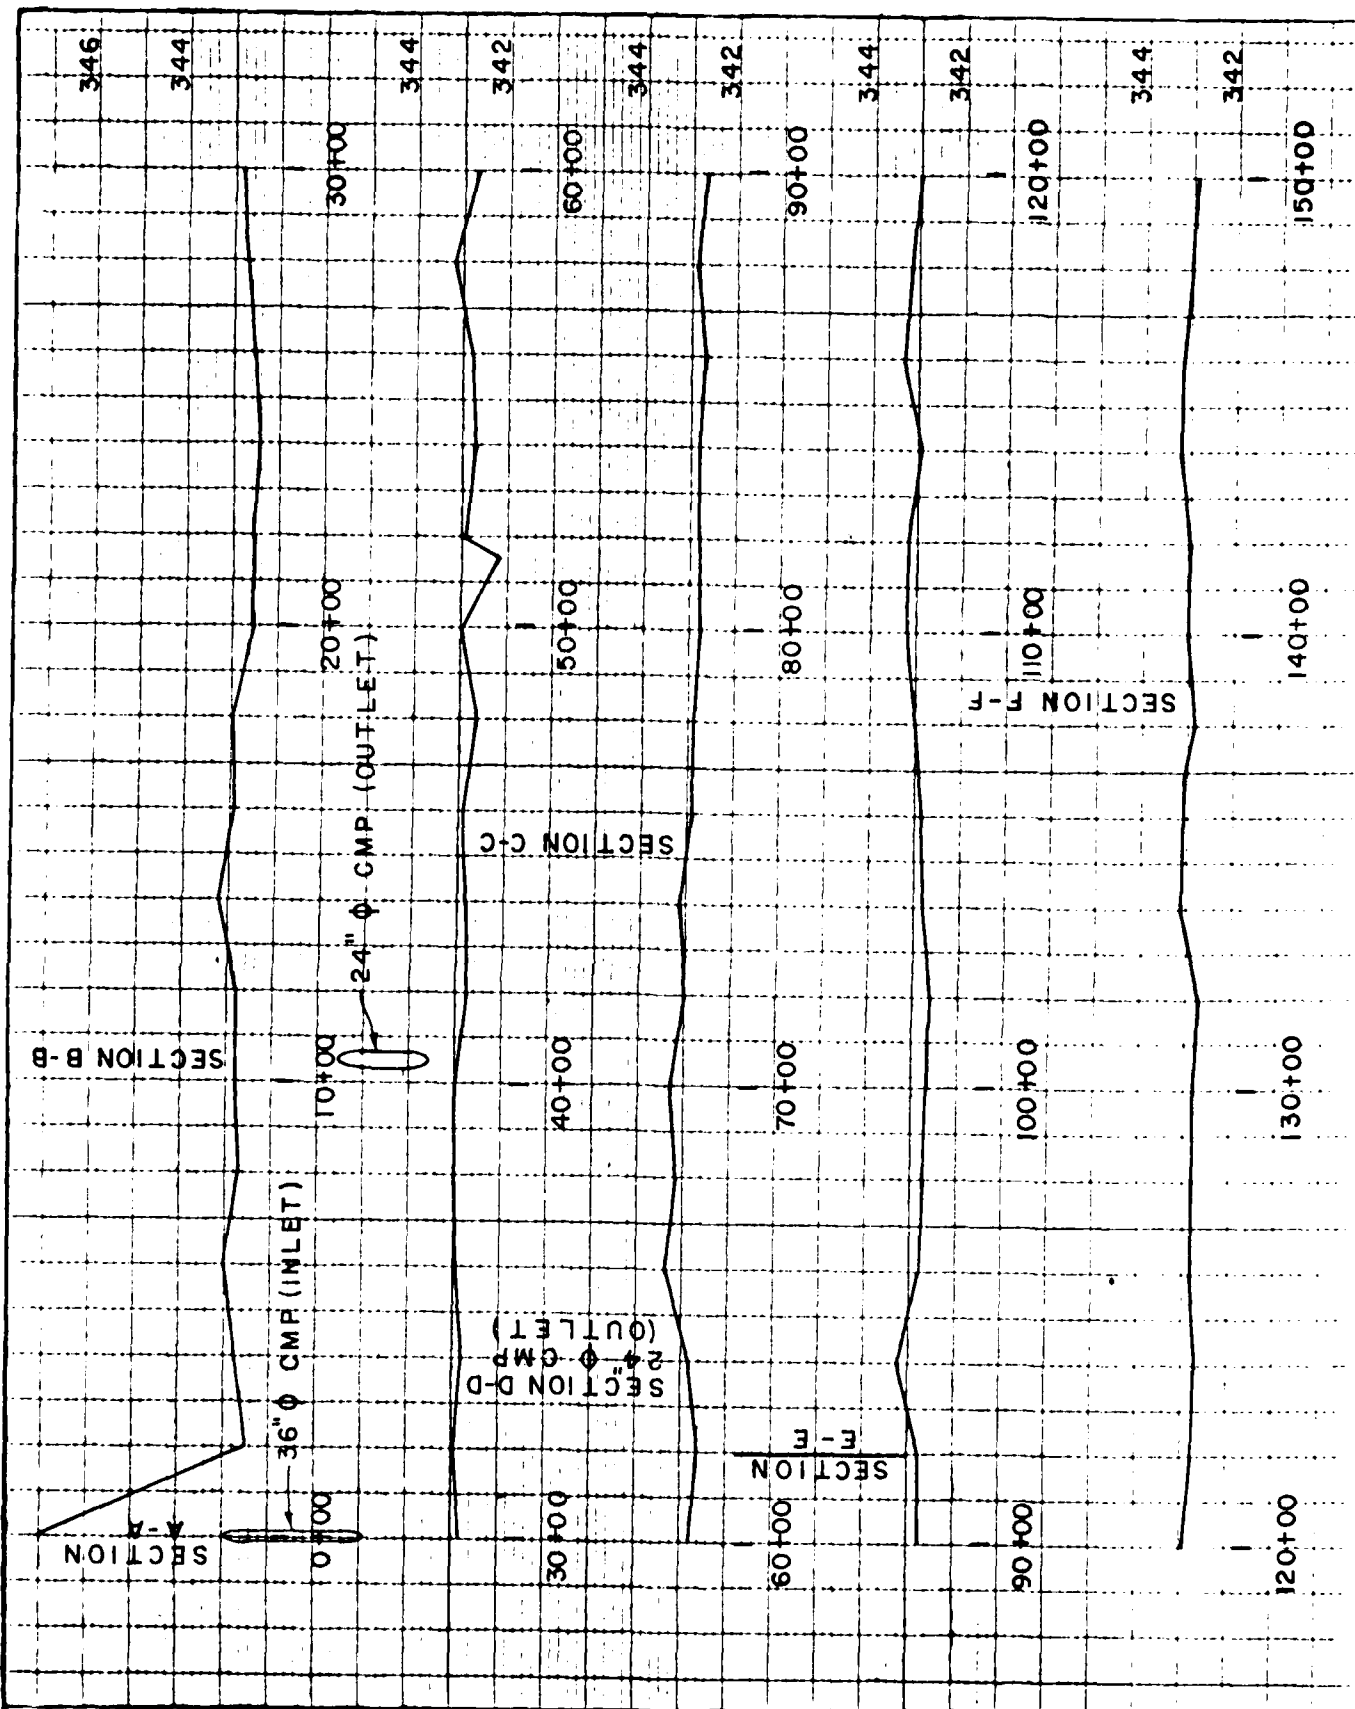
DUCK CREEK STATE WILDLIFE REFUGE #2
 STODDARD COUNTY, MISSOURI
 MO. I. D. No. 40093
PROFILE

The vertical alignment of the crest was generally good, with some irregularities of the profile observed (See Sheets 4 and 5 of Appendix A).
