**BLUES POND**

**PHELPS COUNTY, MISSOURI**

**MO 31538**

**PHASE 1 INSPECTION REPORT  
NATIONAL DAM SAFETY PROGRAM**

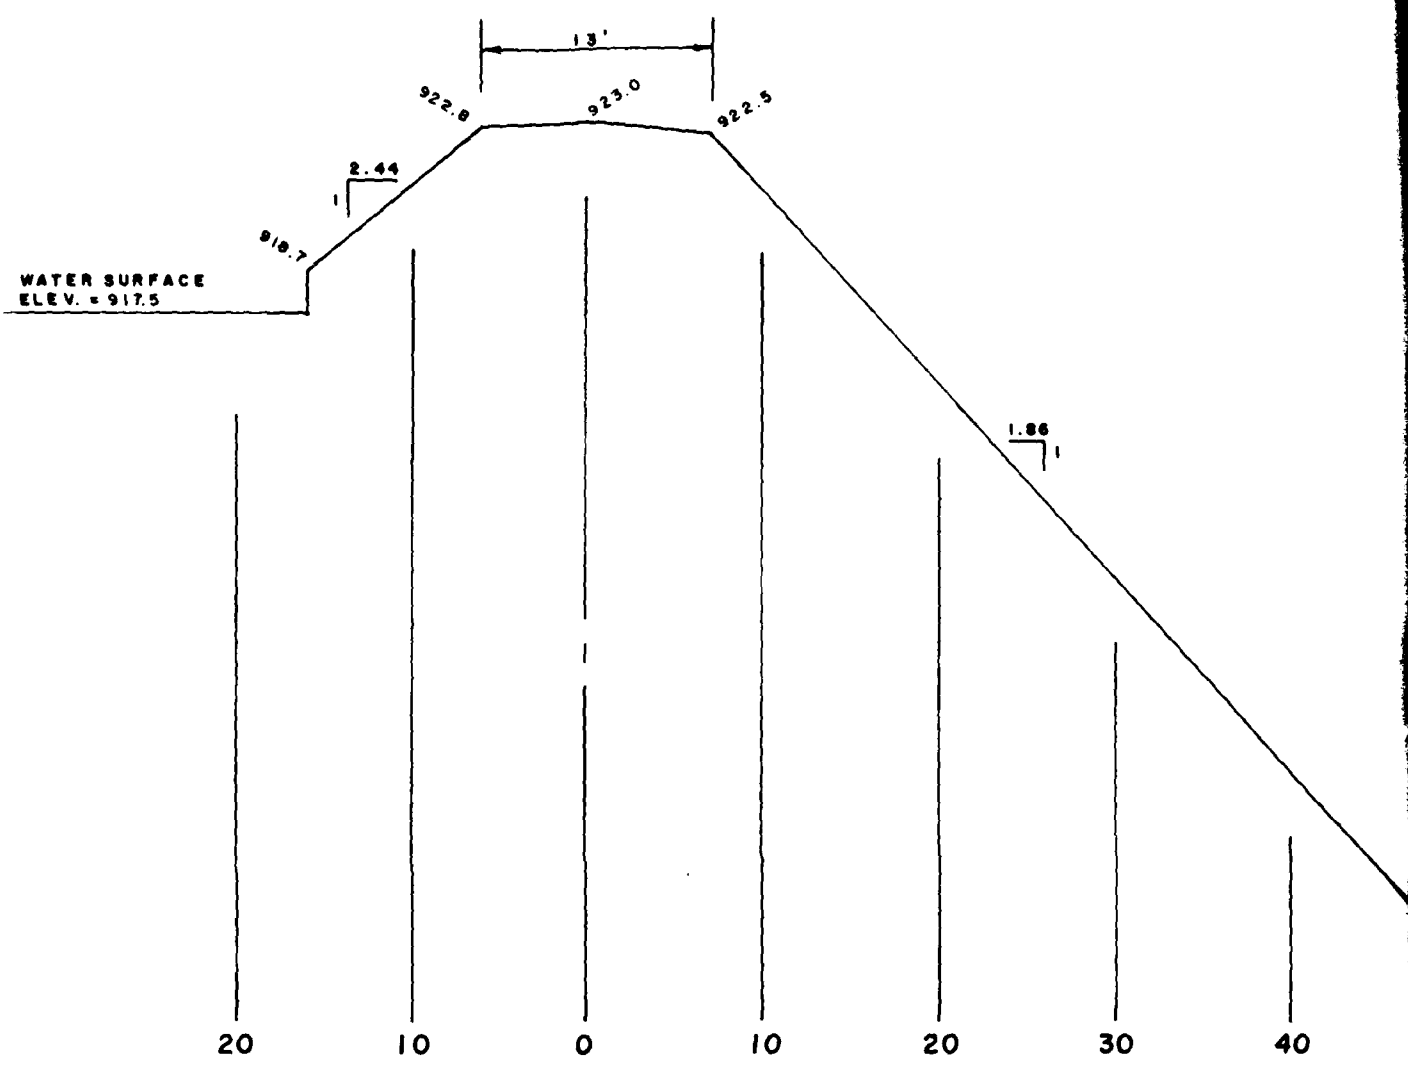
SECTION A-A STA 3+00

The downstream face is moderately covered with trees and brush and is fairly steep (survey indicates slopes between 1.7 and 2 horizontal to 1.0 vertical). A small slough was noted near the crest at approximate Station 3+00. A few small animal holes were noted. No seepage was noted at the base or through the dam. Shallow auger probes in the dam encountered a brown clayey silt to silty clay material (ML-CL). Photo No. 6 shows the downstream face. Sheet 5 of Appendix A presents a plan sketch of the dam showing observed features.

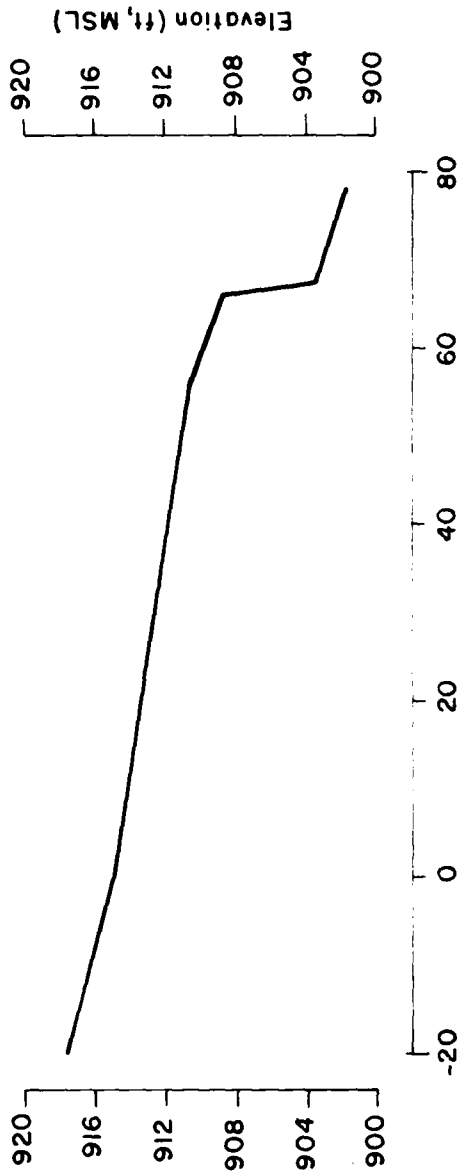
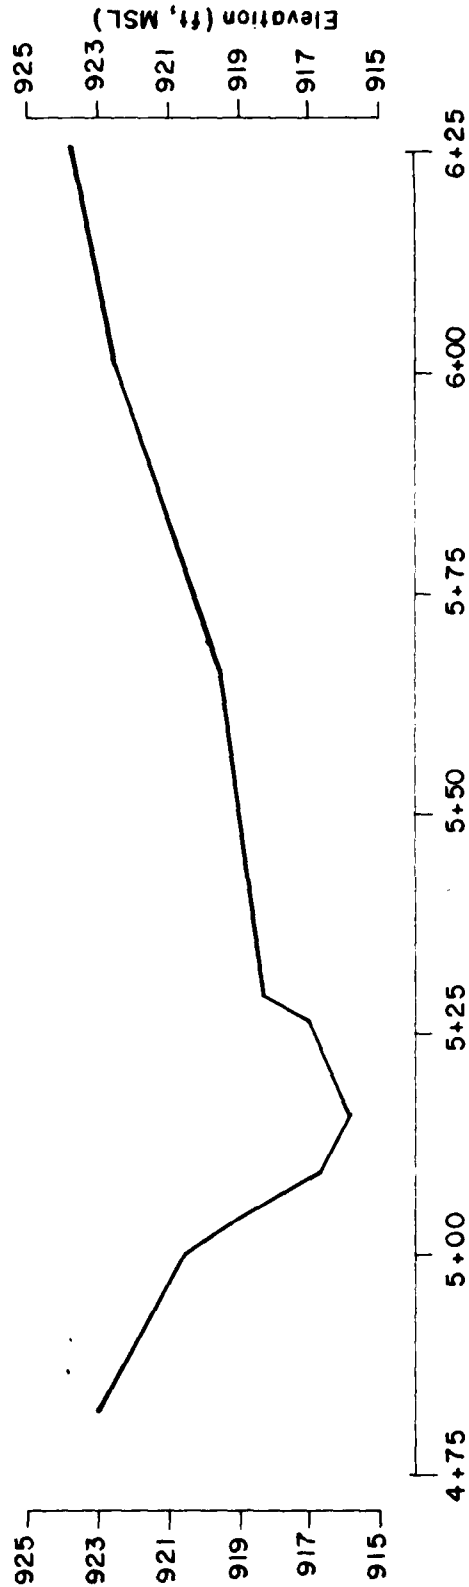
PROFILE & SECTION OF SPILLWAY

The spillway is a trapezoidal cut in the left abutment with concrete paving in the upper portions of the spillway (see Photos 7 through 15). The slab has experienced some cracking, and a hole in the slab was noted as shown in Photo No. 12. Apparently, water is entering the hole and causing some undermining of the slab. A pile of concrete rubble and rock was placed on the right side of the slab downstream of the hole (see Photo No. 13) in an apparent effort to reduce soil loss from under the slab. Some grading has been done recently in the approach area of the spillway on the dam side. This area would appear to be
