**G. GUNDAKER DAM  
FRANKLIN COUNTY, MISSOURI  
MO 30543**

# **PHASE 1 INSPECTION REPORT NATIONAL DAM SAFETY INSPECTION**

G. GUNDAKER DAM  
FRANKLIN COUNTY, MISSOURI  
MISSOURI INVENTORY NO. 30543

PHASE I INSPECTION REPORT  
NATIONAL DAM SAFETY PROGRAM

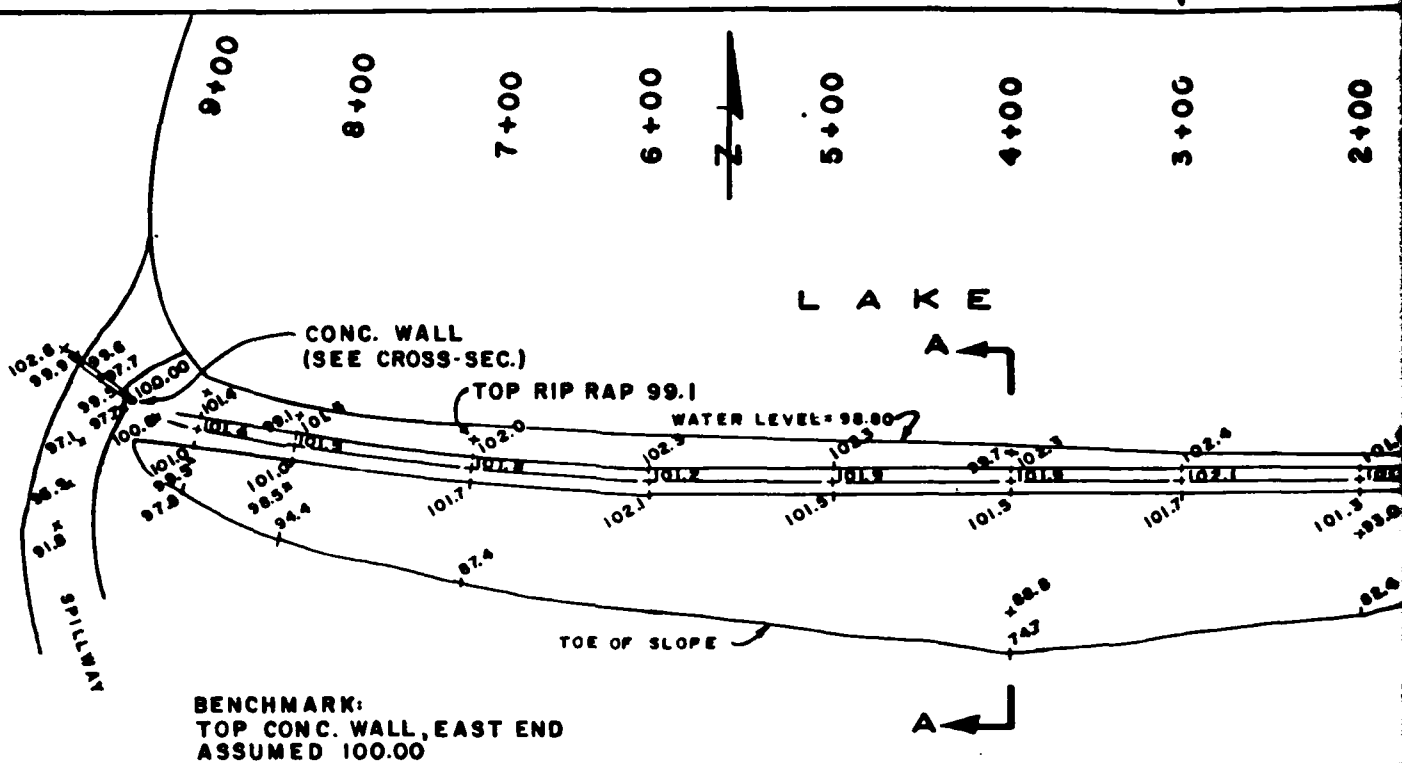
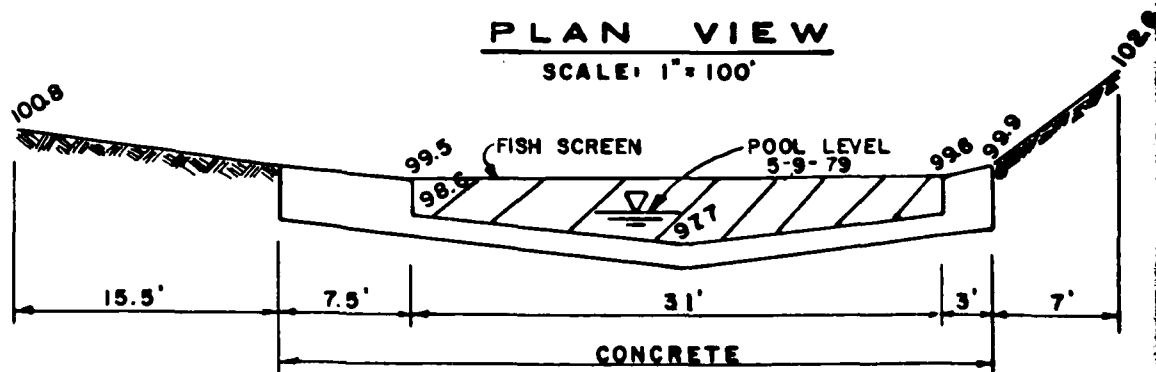
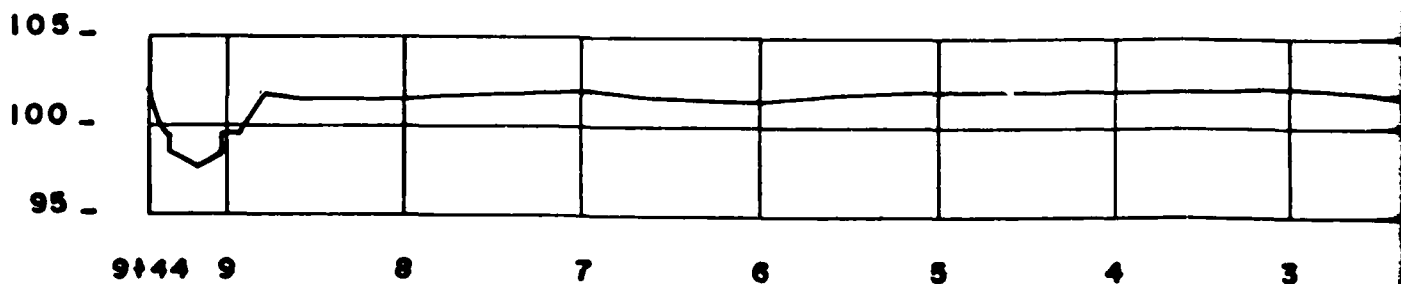
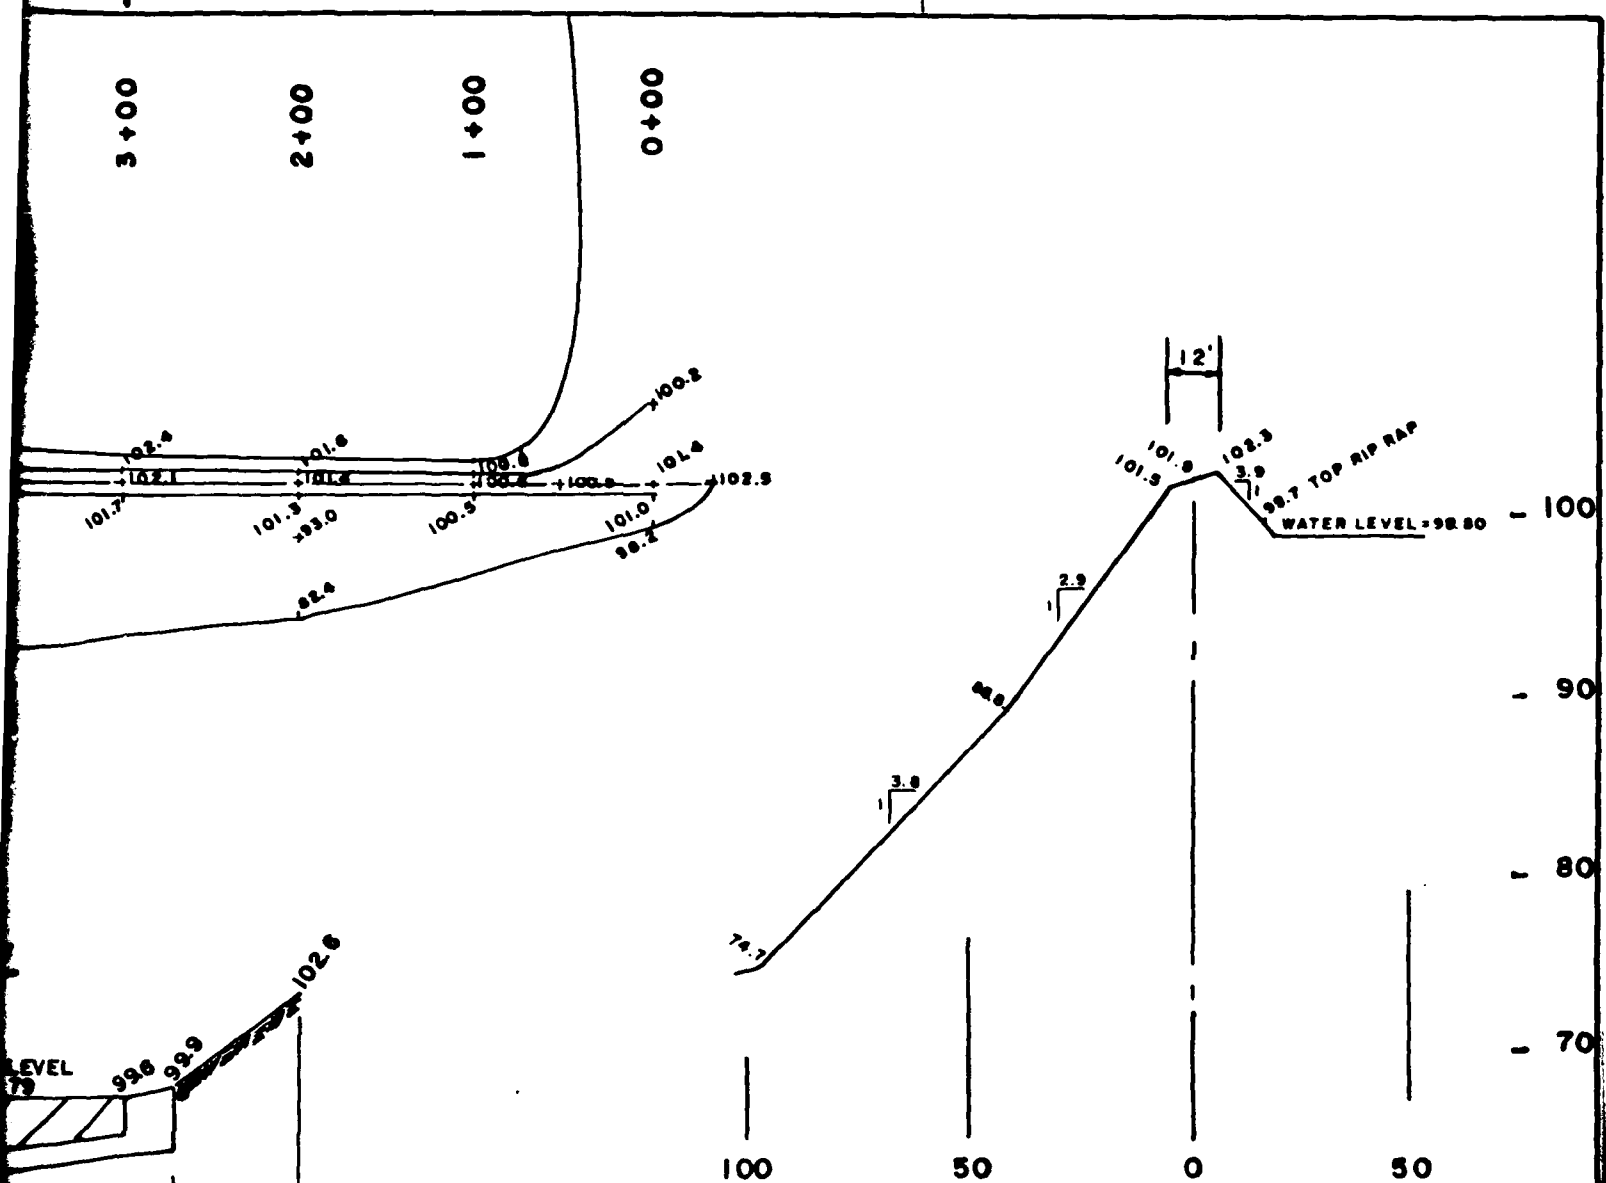
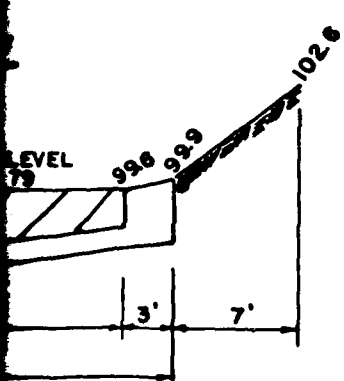
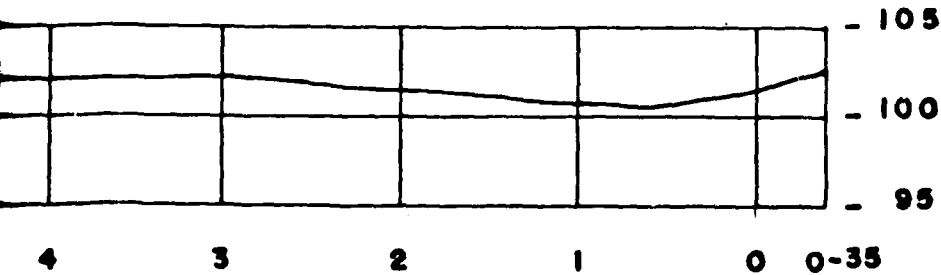
**Sheet 3 Appendix A**

- (1) Top of Dam: 101.4 (Low Point); 102.4 (High Point)
- (2) Principal Spillway Crest: 97.7 (low point - see Sheet 3, Appendix A)
- (3) Emergency Spillway Crest: 100.5
- (4) Principal Outlet Pipe Invert: None

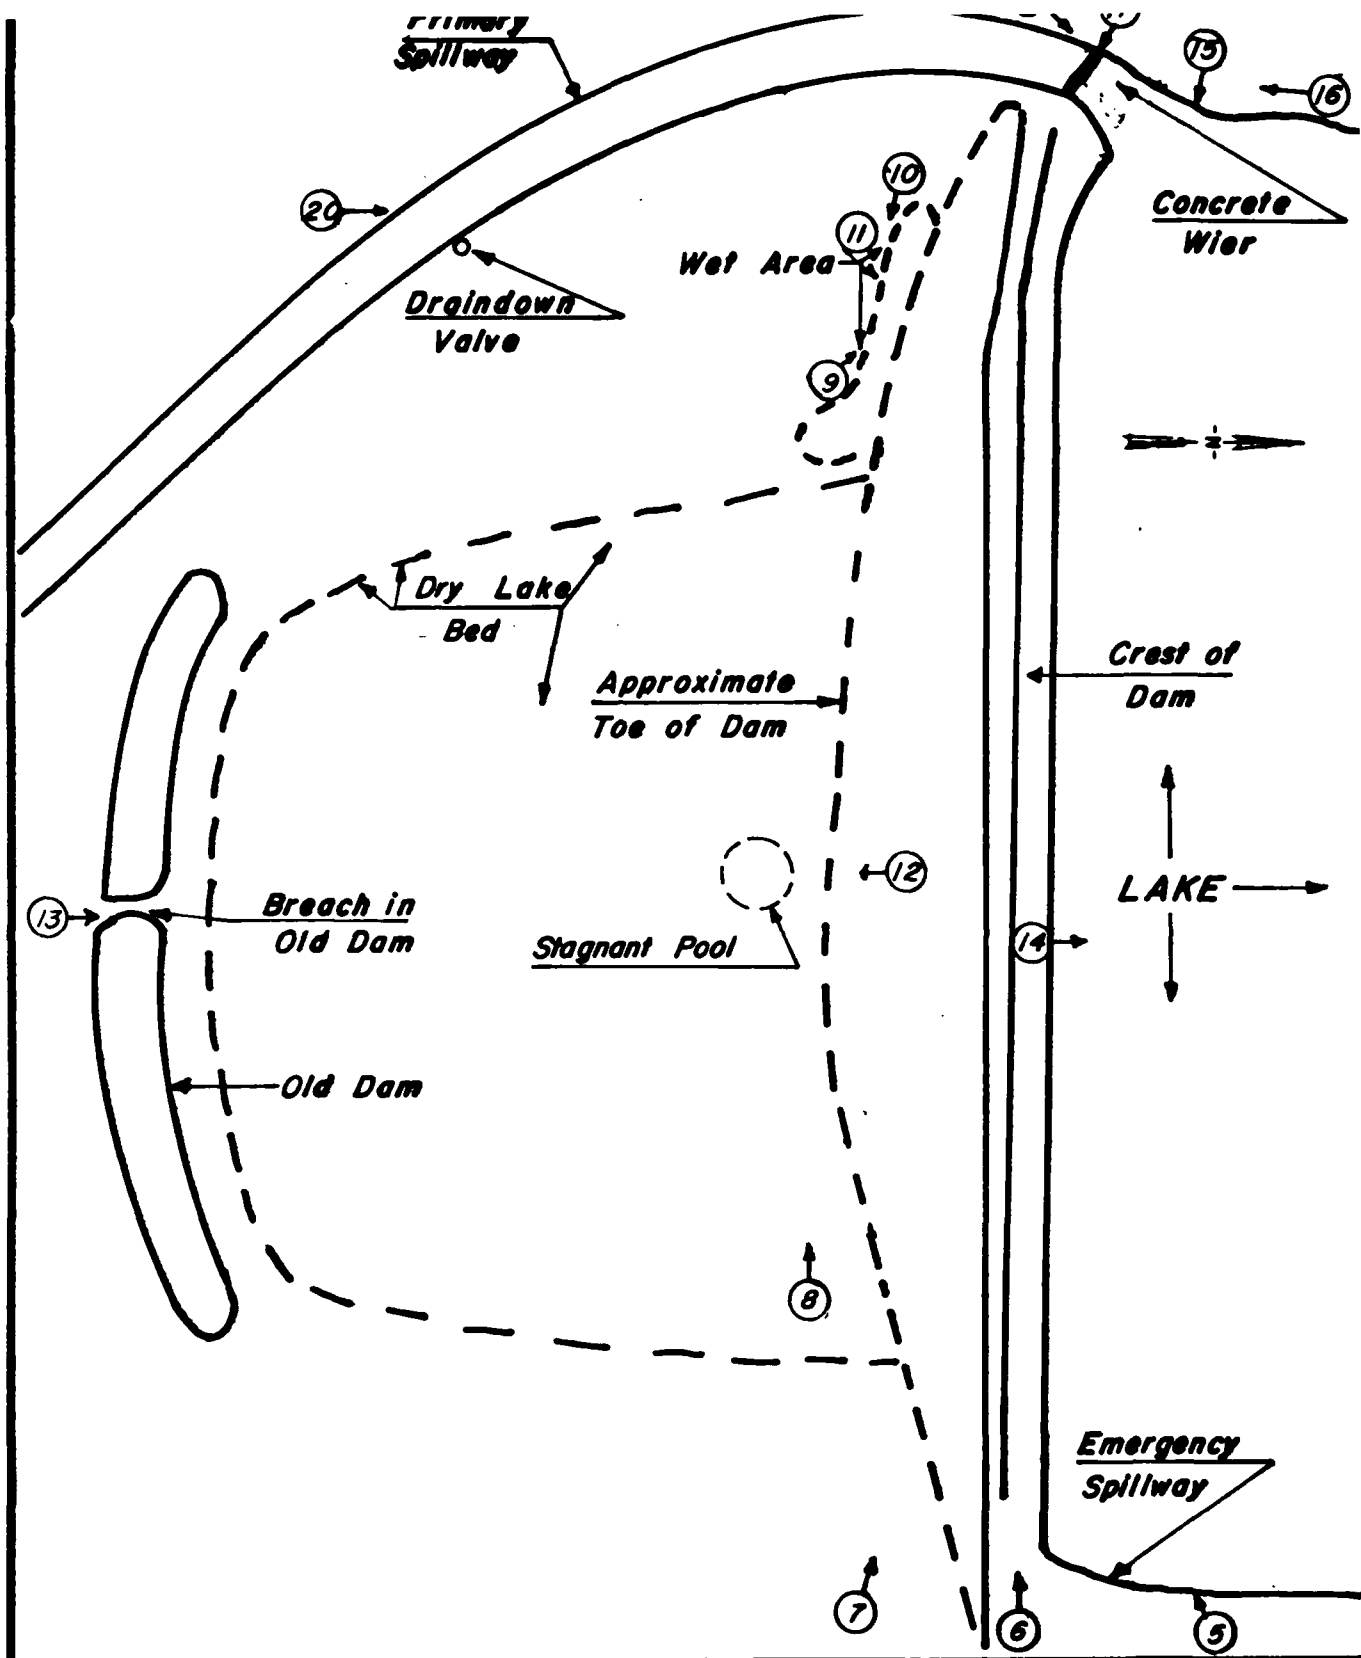
Plan Sketch  
 Key To Photographs  
 Sheet 2 Appendix D

There is an apparent area of seepage under the dam at the downstream contact on the west abutment side (see sheet 4 of Appendix A and photos 9, 10 and 11). The apparent seepage is manifested by wet, soft ground, cattails and small pools of rust-colored water. There is also a 30 ft diameter stagnant pool of water near the downstream toe at about the center of the dam. This appears to be near the area described as the starting point of the bored draindown pipe and could represent a depressed area due to sunken backfill or possible seepage under the dam along the pipe. The middle of the floodplain downstream (old pond area - probable location of original streambed) was wet and soft. A noticeable but small stream of water was flowing out of this area through the breach in the old dam below the main dam (see photos 12 and 13). To our knowledge, there had been no rain in recent days. The caretaker indicated there had been a 5 in. rain about three weeks before our site inspection.
