HERMIT HOLLOW DAM
FRANKLIN COUNTY, MISSOURI
MISSOURI INVENTORY NO. 31054

PHASE I INSPECTION REPORT
NATIONAL DAM SAFETY PROGRAM

PHASE I REPORT
NATIONAL DAM SAFETY PROGRAM

Name of Dam: Hermit Hollow Dam
State Located: Missouri
County Located: Franklin
Stream: Lartto Creek
Date of Inspection: May 7, 1979

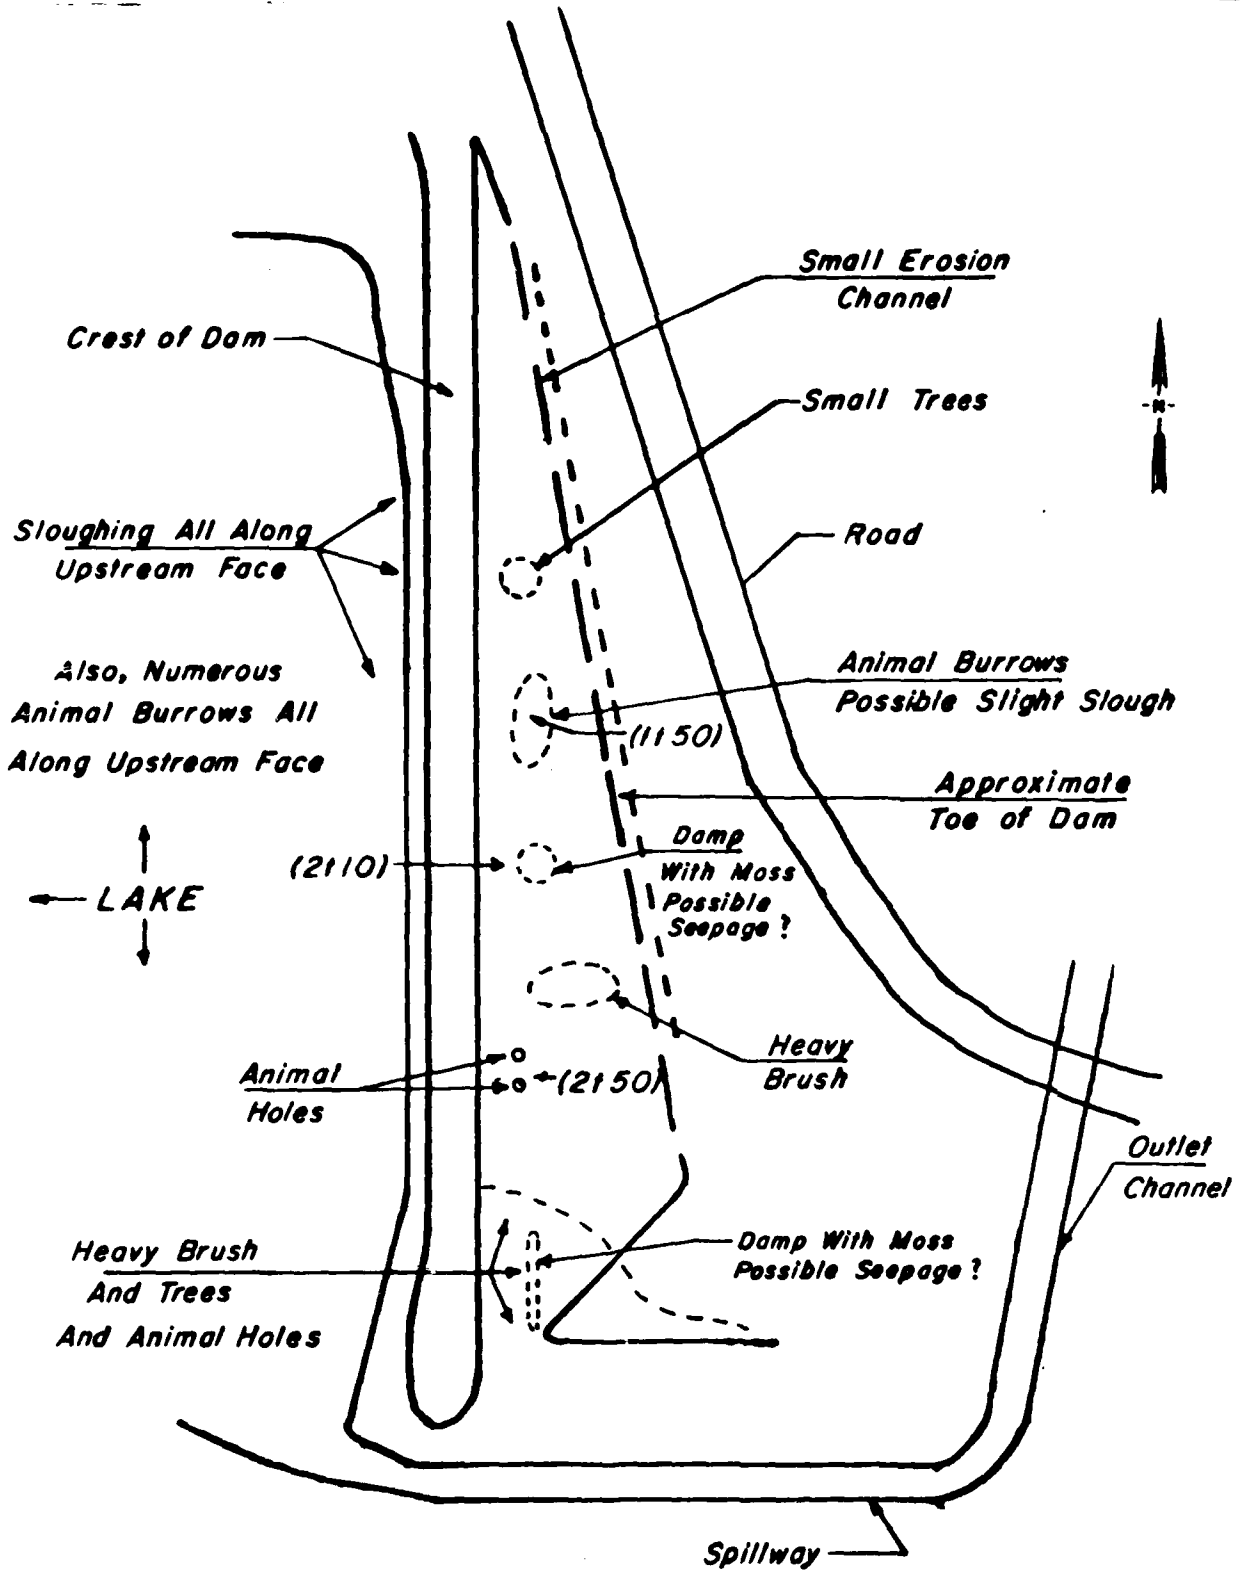
The downstream face was fairly free of heavy vegetation, except for a few localized areas as indicated on sheet 4 of Appendix A. Animal holes were also noted, two of which were fairly large (Station 2+50 and 2+75 - holes 2 ft diameter and 3 ft deep). One 15 ft area at approximate station 1+50 had a considerable number of small animal holes and was disturbed to the extent that it appeared as if it could have been a slight slough. The area was not wet at the time of inspection.

No obvious seepage was noted except for two areas (see sheet 4 of Appendix A) which were damp and growing moss. The downstream face of the dam was fairly free of erosion.

- (4) Animal holes should be repaired on both faces of the dam.
- (5) Trees and brush, as indicated in those areas as shown on sheet 4 of Appendix A, should be removed. This should be done under the guidance of a professional engineer experienced in the design and construction of dams. Indiscriminate clearing methods could jeopardize the safety of the dam.
