CATES DAM

MONTGOMERY COUNTY, MISSOURI

PHASE 1 INSPECTION REPORT
NATIONAL DAM SAFETY PROGRAM.

CATES DAM
MONTGOMERY COUNTY, MISSOURI
MISSOURI INVENTORY NO. 10172

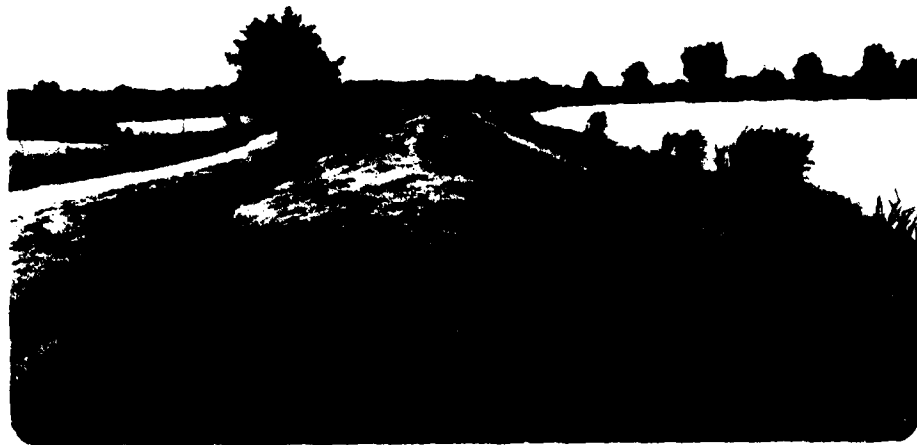
(3) Crest. The crest is well vegetated with adapted grasses. A few small (1/8" wide x 2' long) cracks parallel with the axis of the dam were observed on both sides of the principal spillway. The cracks appear to be the result of desiccation. No rodent holes or deformations were noted on the crest. The crest and downstream slope had been recently mowed.

Drying cracks observed on the upstream berm and crest of the dam should not affect the stability of the dam.

PHOTO NO. 3 - CREST FROM LEFT END

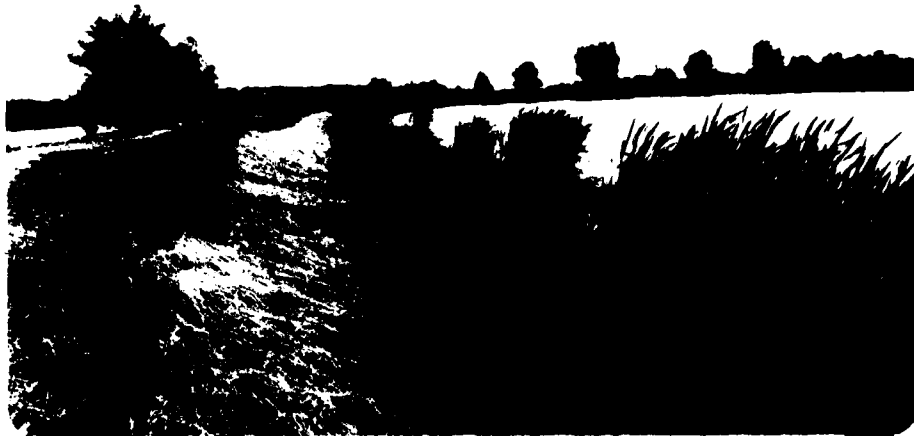
(2) Upstream Slope. The upstream slope is well vegetated with adapted grasses and reeds. A few small willows are growing along the water line. There appears to be a berm at or near the principal spillway elevation. The water surface was just below the berm elevation when inspected. A few small (1/8" wide x 2' long) drying cracks were noted in the berm on both sides of the principal spillway inlet. No deformation was noted on the upstream slope. Some very minor erosion was noted toward the west (right) end of the dam at the junction of the berm and upstream slope.

PHOTO NO. 4 - UPSTREAM SLOPE FROM LEFT END

- (2) Minor erosion on the upstream slope should be corrected.
- (3) A program of periodic inspection and maintenance should be initiated to control tree growth and erosion on the embankment and appurtenant channels.

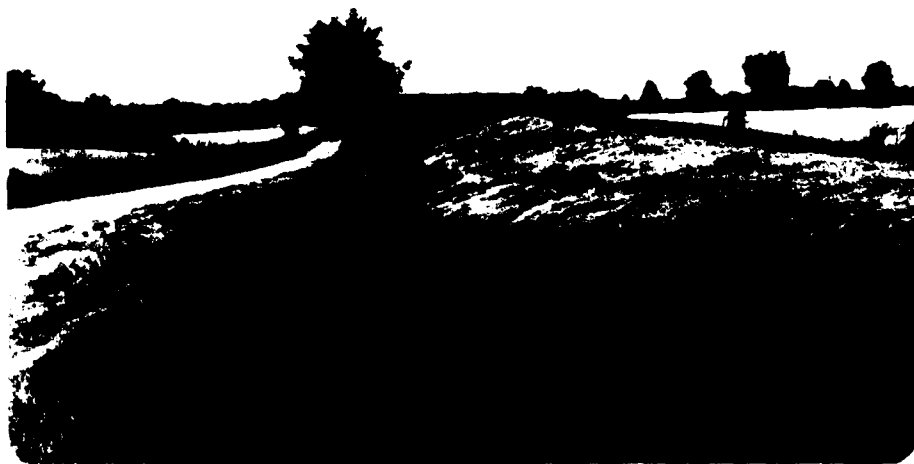
- (4) Downstream Slope. The downstream slope is very well vegetated with adapted grasses. No cracks, rodent holes or deformations were observed. There was no sign of seepage on the slope or along the toe of the dam.
- (5) Miscellaneous. The excellent vegetative cover and the apparent materials in the embankment indicate that this structure could withstand considerable overtopping without serious damage.

PHOTO NO. 5 - DOWNSTREAM SLOPE FROM LEFT END

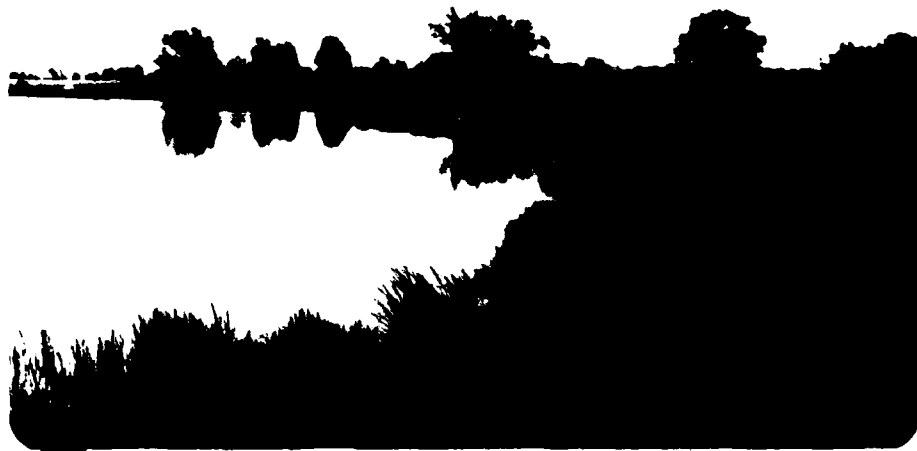
Minor erosion on the upstream slope toward the right end of the dam could ultimately impair the integrity of the structure and should be corrected.

PHOTO NO. 7 - UPSTREAM SLOPE FROM RIGHT ABUTMENT.

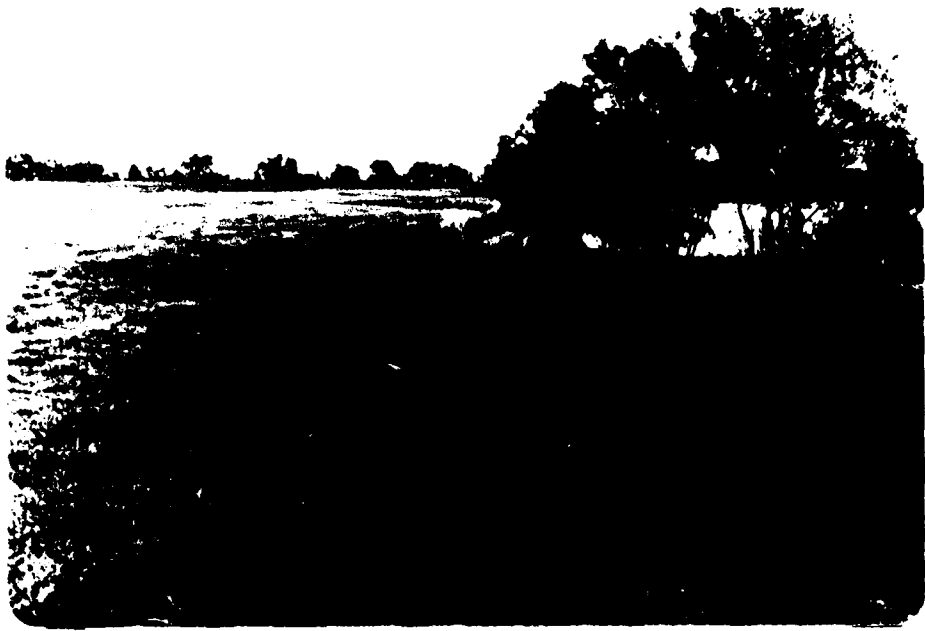
A few small trees are growing in the inlet to the spillway.

PHOTO NO. 8 - LOOKING UPSTREAM IN EMERGENCY SPILLWAY ON RIGHT
END

The dam and emergency spillway had been recently mowed. Maintenance, in general, seems to be good. The few trees on the dam and in the spillway channels should be removed.
