ONLY WAY LAKE DAM

SALINE COUNTY, MISSOURI

**PHASE 1 INSPECTION REPORT
NATIONAL DAM SAFETY PROGRAM**

Only Way Lake Dam (MO 10111),
Missouri - Kansas City Basin,
Saline County, Missouri. Phase I Inspection
Report.

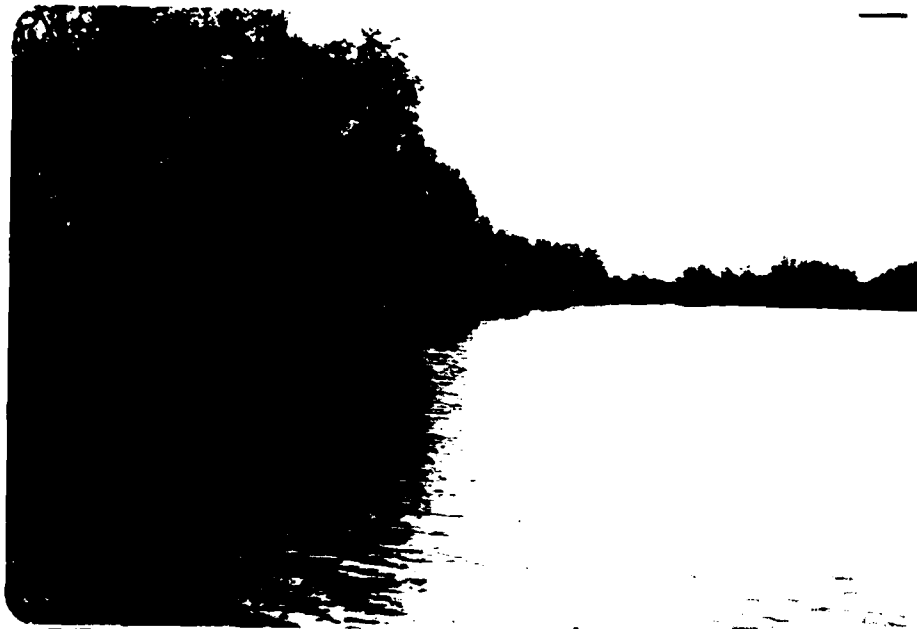
- (2) Upstream Slope. The upstream face is nearly vertical from the crest to the waterline and is plated with concrete slabs, rubble and limestone cobbles. Very little erosion was noted along the face. Several good sized trees are growing on the upstream crest and slope. No slides or abnormal deformations were noted on the slope.

PHOTO NO. 3 - UPSTREAM FACE OF DAM TAKEN FROM DIVING PLATFORM
LOOKING TO RIGHT

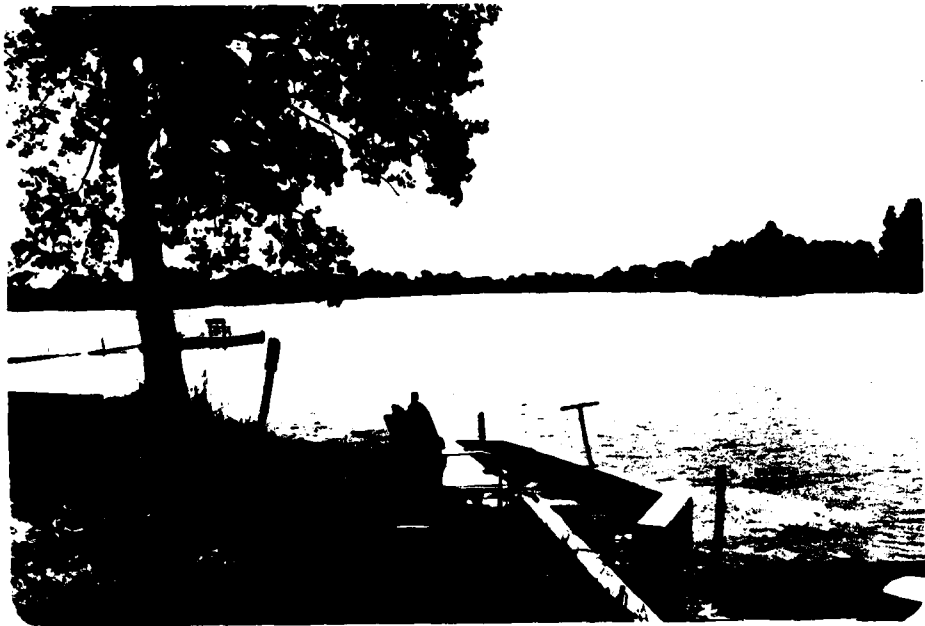
PHOTO NO. 14 - PRINCIPAL SPILLWAY HEADWALL. AUGER SET IN
CRACK IN CONCRETE

- (4) The headwall of the principal spillway should be repaired to prevent further deterioration.
- (5) A program of regular inspection and maintenance should be initiated.
