**HOLIDAY LAKE DAM
CRAWFORD COUNTY, MISSOURI
MO 30587**

**PHASE 1 INSPECTION REPORT
NATIONAL DAM SAFETY PROGRAM**

Name of Dam: Holiday Lake Dam
State Located: Missouri
County Located: Crawford
Stream: Shoal Creek
Date of Inspection: 26 June 1979

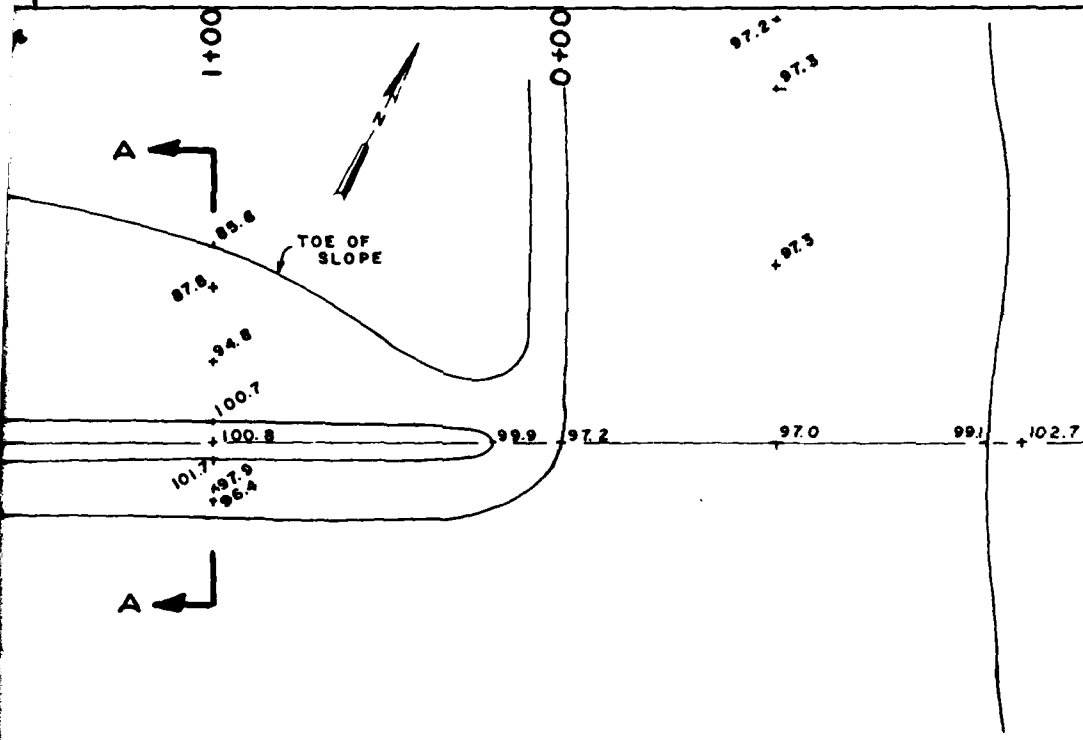
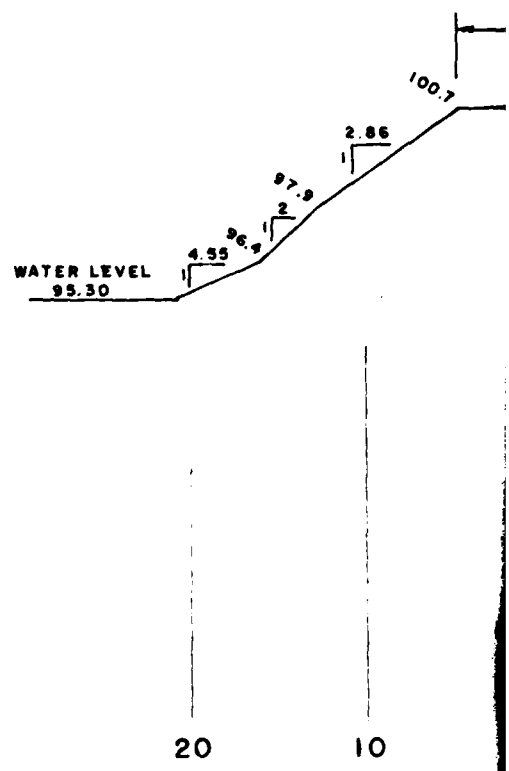
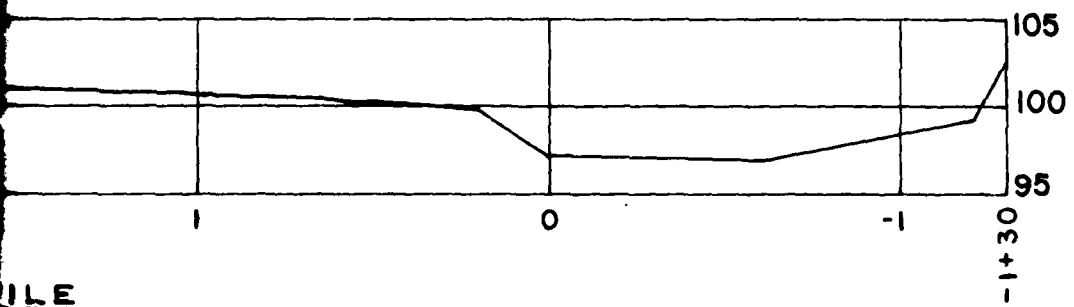
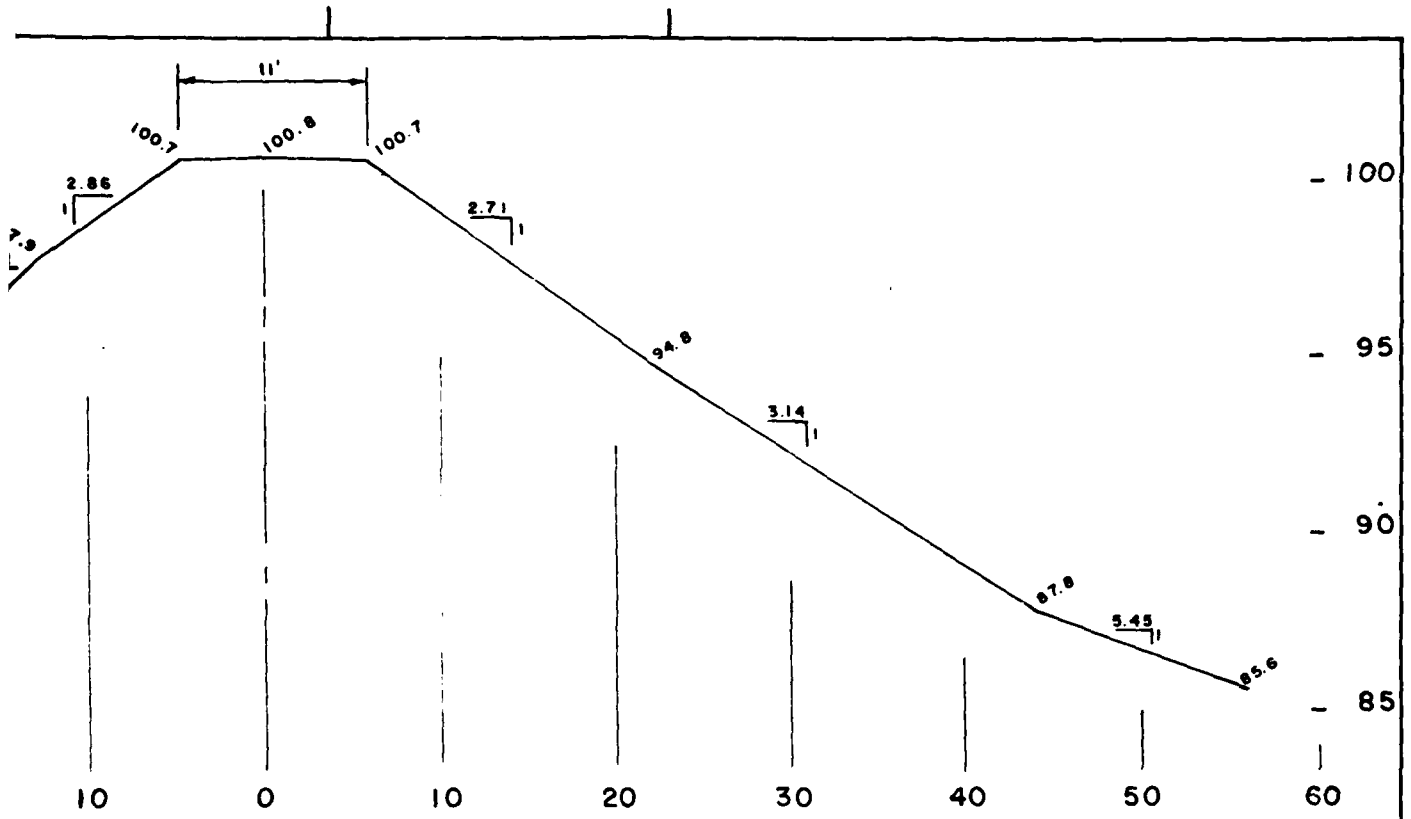
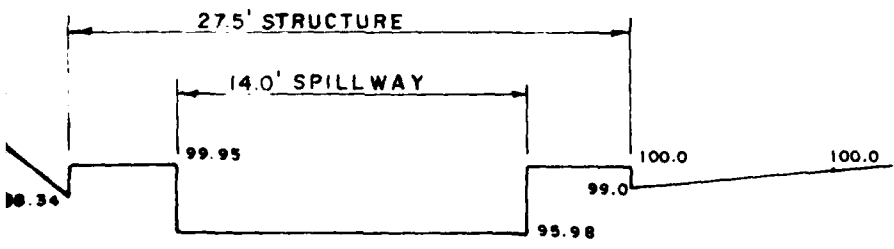
It should be noted that a sewer line apparently passes through the west end of the embankment at or near the west abutment in a general north-south direction. The location of a manhole associated with this sewer is shown on Sheet 3, Appendix A.

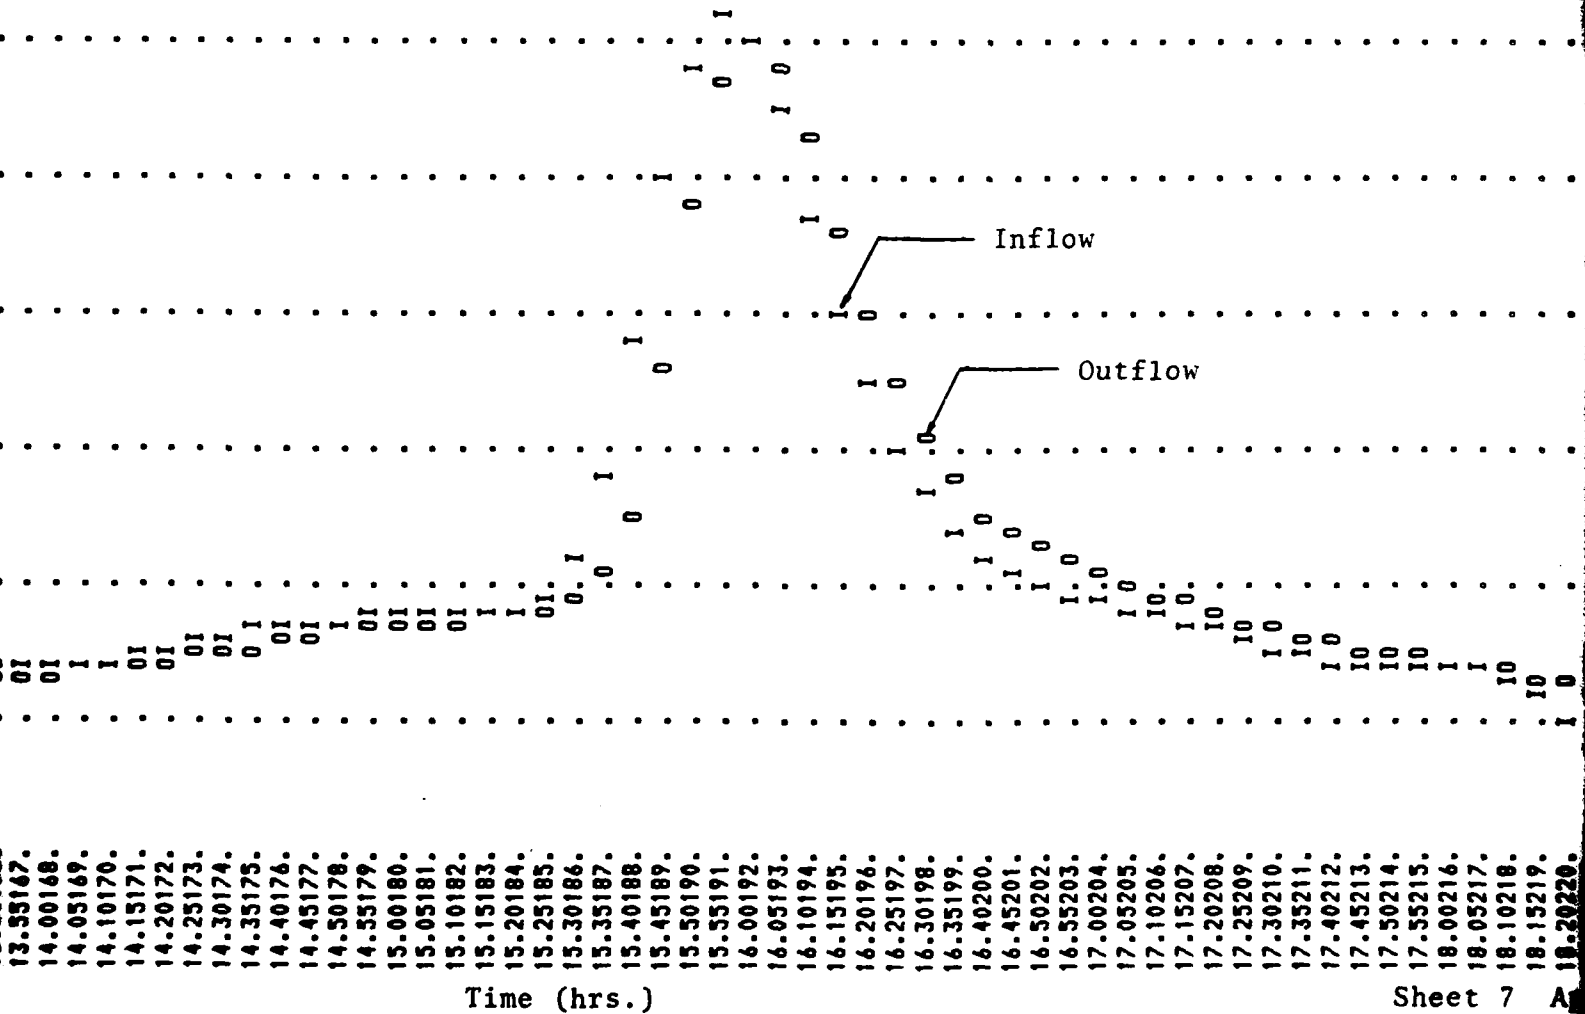
INFLOW - OUTFLOW
HYDROGRAPH
FOR 50% P.M.F.

The routing of 50 percent of the PMF through the spillways and dam indicates that the dam will be overtopped by 1.34 ft at elevation 1073.14. The duration of the overtopping will be 0.92 hours, and the maximum outflow will be 6006 cfs. The maximum discharge capacity of the spillways is 2538 cfs. Overtopping of an earthen embankment could cause serious erosion and could possibly lead to failure of the structure.

- (1) Spillway size and/or height of dam should be increased to pass 50 percent of the PMF. In either case, the spillway should be protected to prevent erosion.
- (2) Seepage and stability analyses comparable to the requirements of the recommended guidelines should be performed by an engineer experienced in the construction of dams.
- (3) The wing walls of the primary spillway control structures should be extended into the abutment and embankment to prevent future erosion around the ends of the structure.
- (4) The sloughing of the upstream embankment face should be repaired, and additional wave protection should be provided.
- (5) A specially designed energy dissipator and proper erosion protection of the primary spillway outlet channel should be provided.
