LAS BRISAS LAKE DAM  
FRANKLIN COUNTY, MISSOURI  
MO 30541

PHASE 1 INSPECTION REPORT  
NATIONAL DAM SAFETY INSPECTION

LAS BRISAS LAKE DAM  
FRANKLIN COUNTY, MISSOURI  
MISSOURI INVENTORY NO. 30541

PHASE I INSPECTION REPORT  
NATIONAL DAM SAFETY PROGRAM

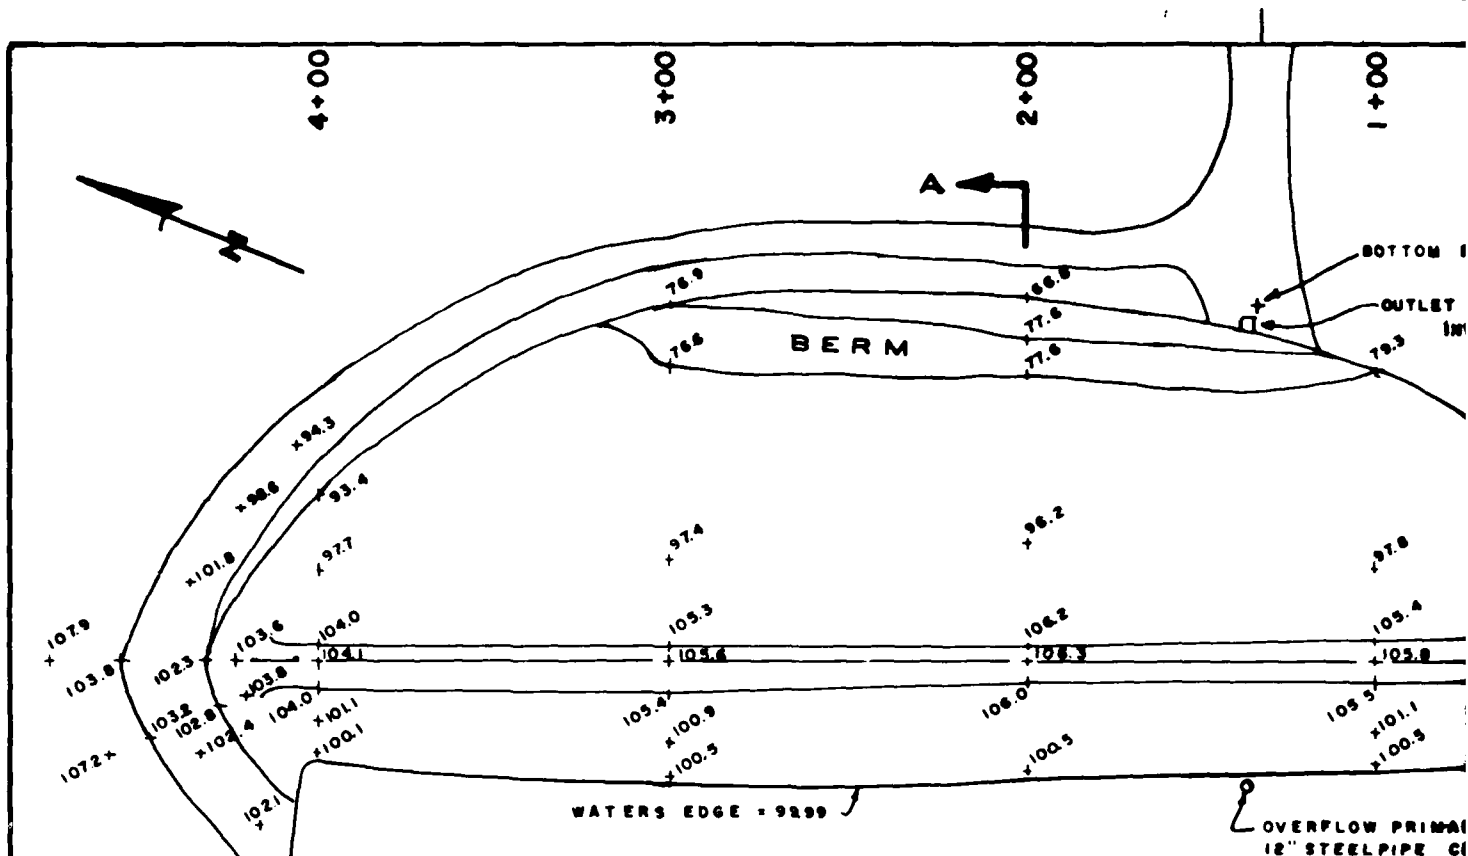
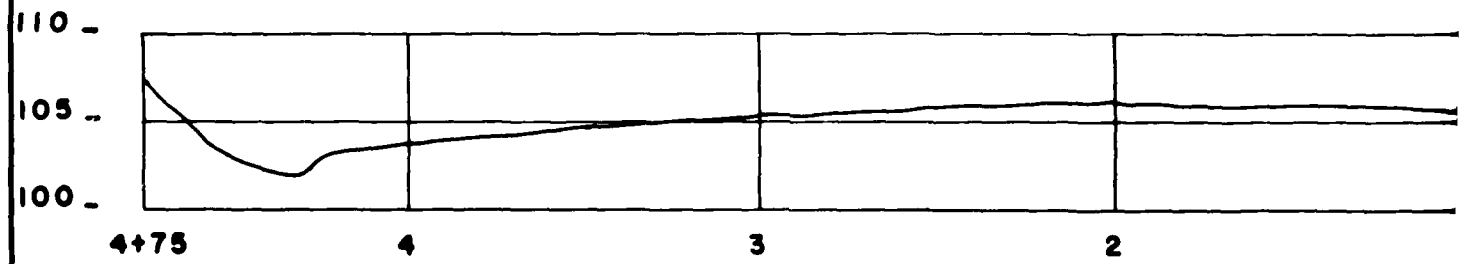
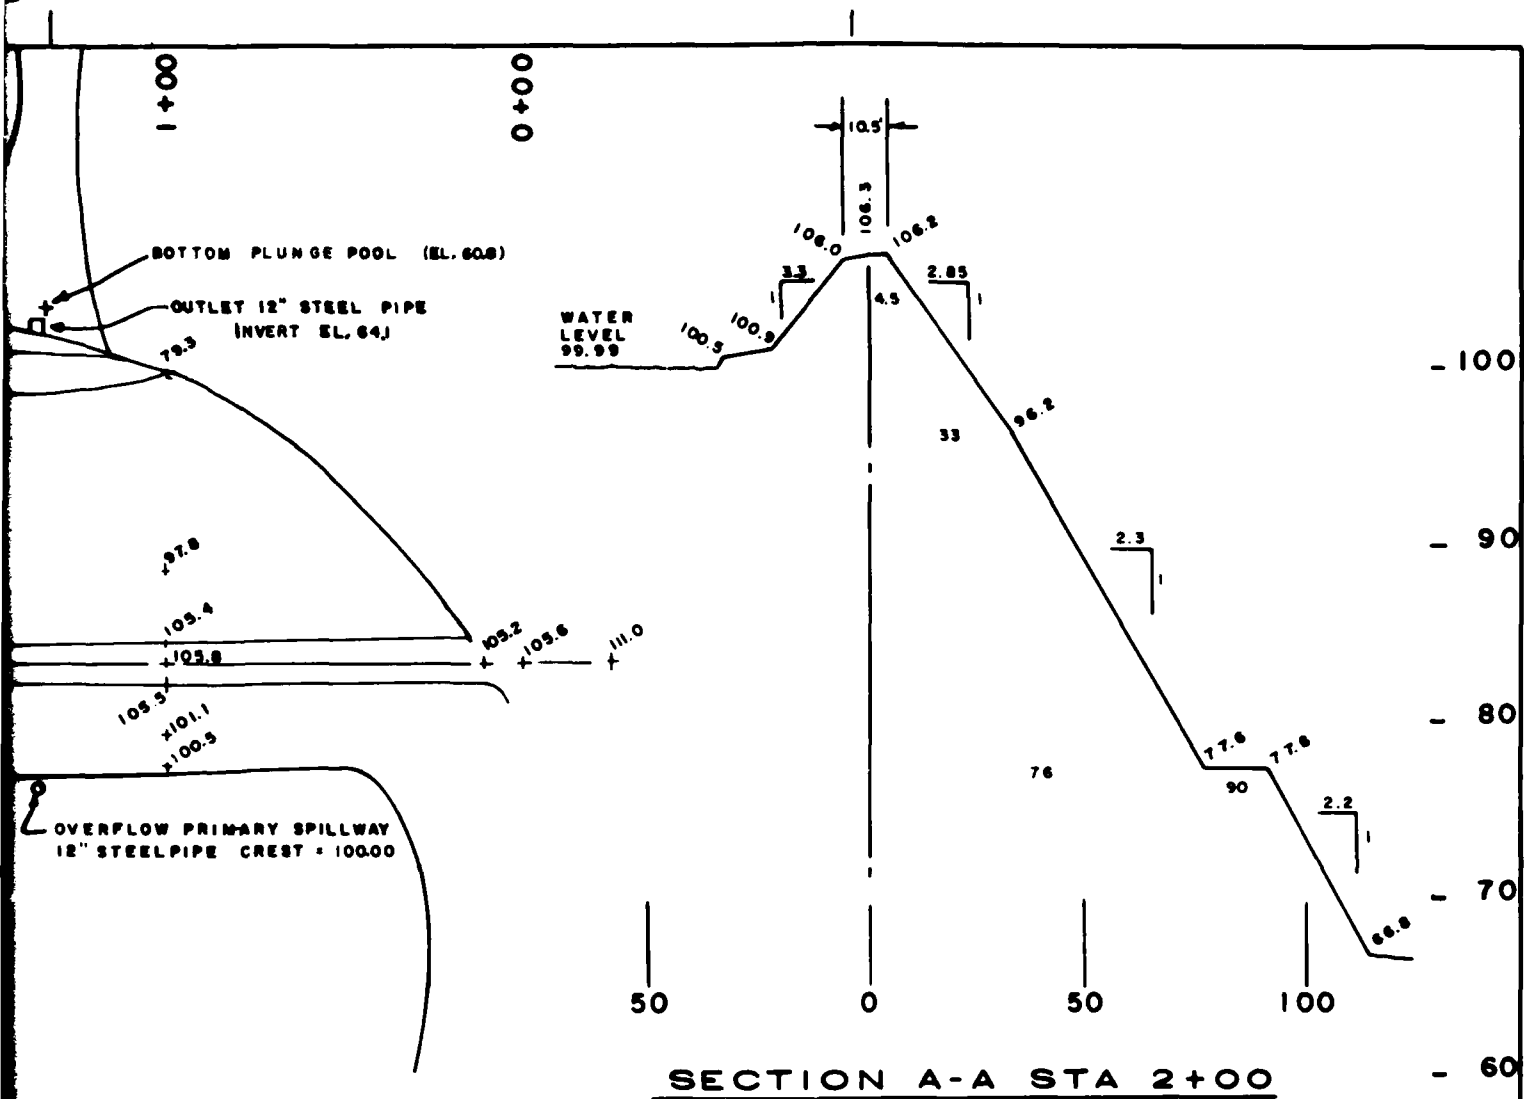
**LAS BRISAS LAKE**  
 MO. No. 30541  
**PLAN & PROFILE**

All elevations are consistent with an assumed elevation of 100.00 for the crest of the primary spillway at Station 1+36 (see Sheet 3, Appendix A).

- (1) Location: Station 1+36 (See Sheet 3 of Appendix A)
- (2) Type: 18 in. Diameter Steel Pipe Drop Inlet with 12 in. Diameter Steel Pipe Through Dam

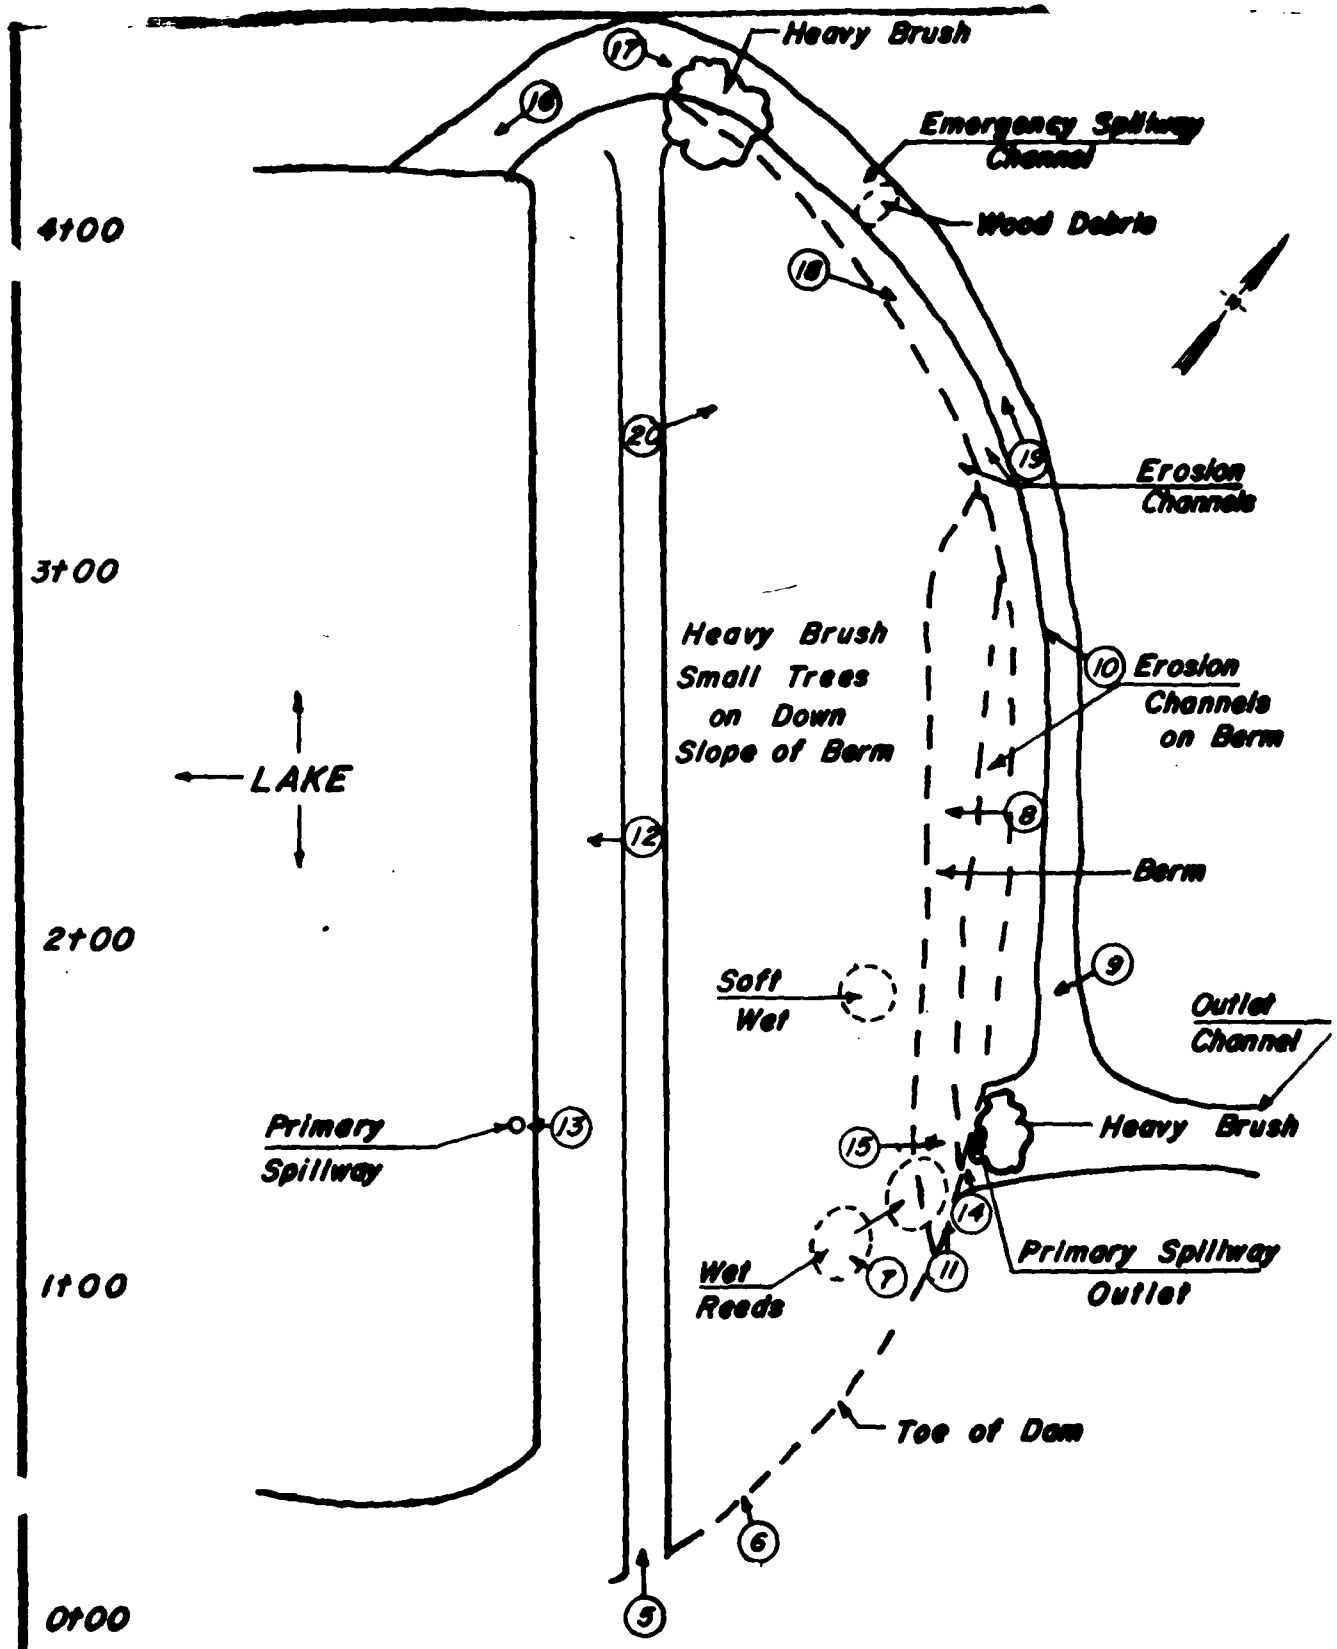
Plan Sketch  
 Key To Photographs

Several apparent seepage areas were noted on the downstream face above the berm level between Stations 1+00 and 2+00 and between elevations 80 and 90. This seepage is manifested by wet, soft areas growing cattails and reeds (See Sheet 4 of Appendix A and Photo 7). No obvious flows were evident, so that an estimate of seepage quantity was not possible.

- (5) The seepage areas noted on the downstream face should be investigated by an engineer experienced in the design and construction of dams. Remedial measures may be required. As a minimum, these areas should be inspected periodically in an effort to detect an increase in the quantity of seepage or any indication that soil particles are being carried by the water. In this event, an engineer should be contacted immediately.
