SUBJECT: Burton Duenke No. 1 Lake Dam Phase I Inspection Report

BURTON DUENKE NO. 1 LAKE DAM

MISSOURI INVENTORY NO. 31610

PHASE I INSPECTION REPORT  
NATIONAL DAM SAFETY PROGRAM

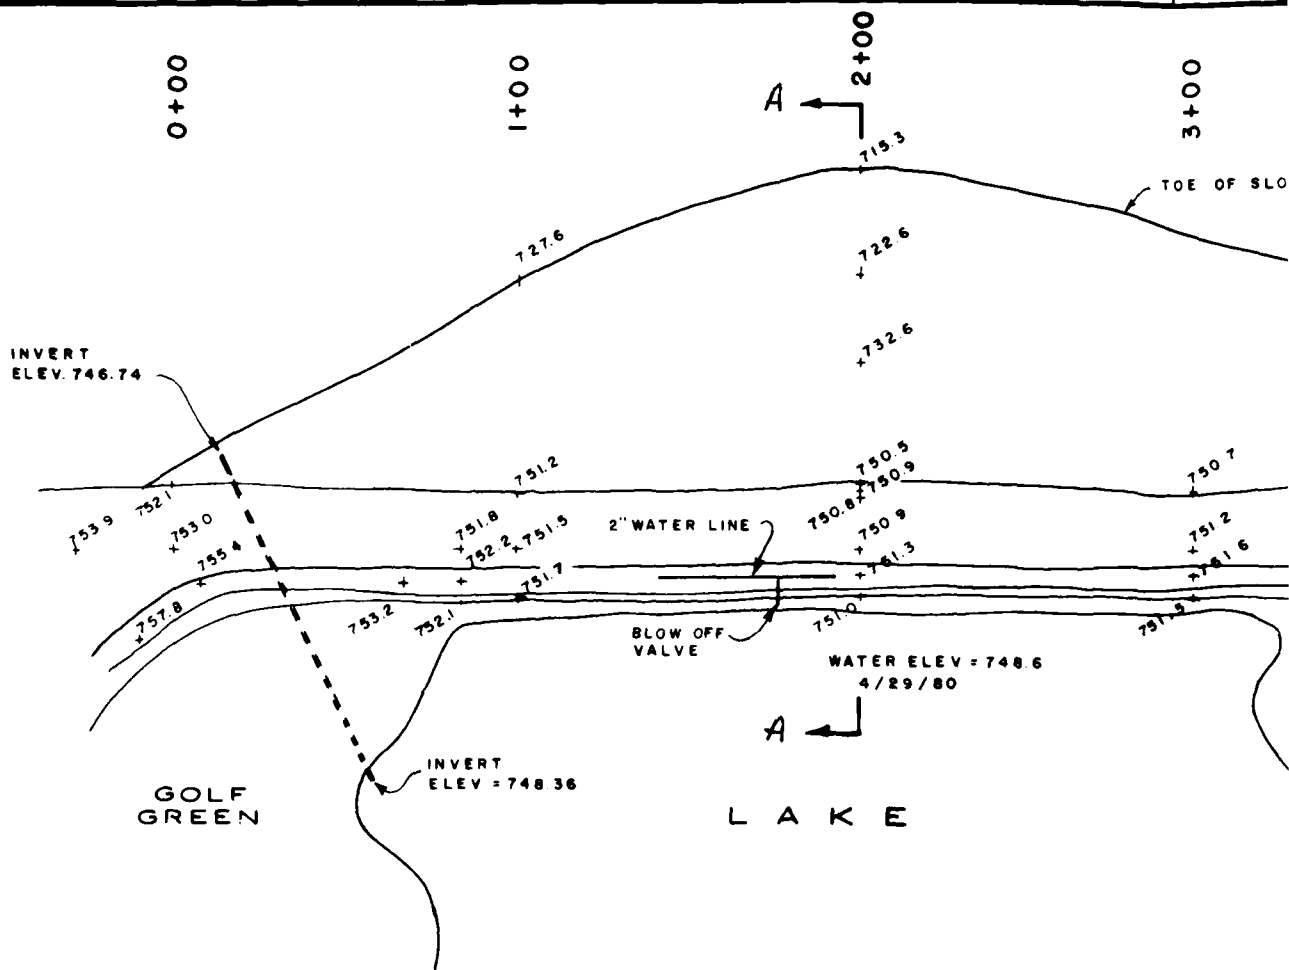
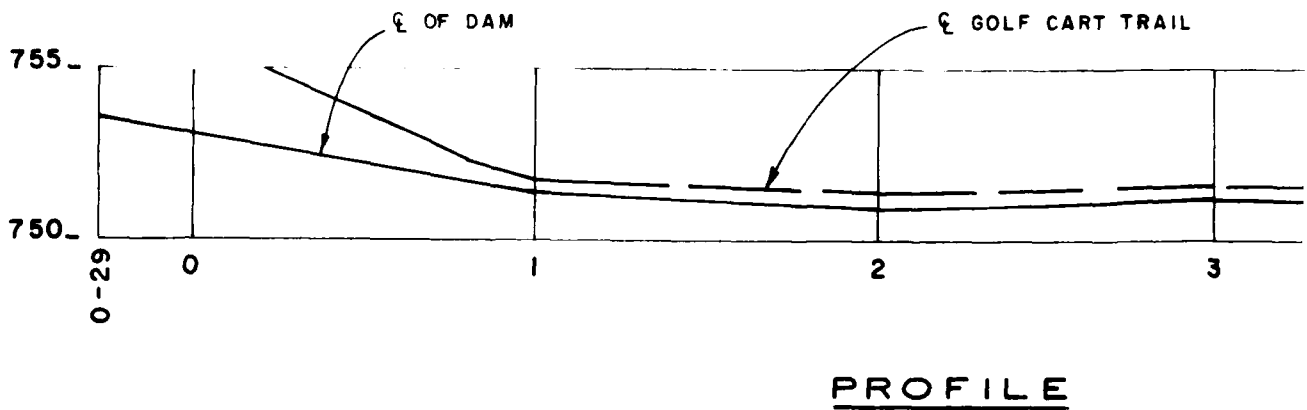
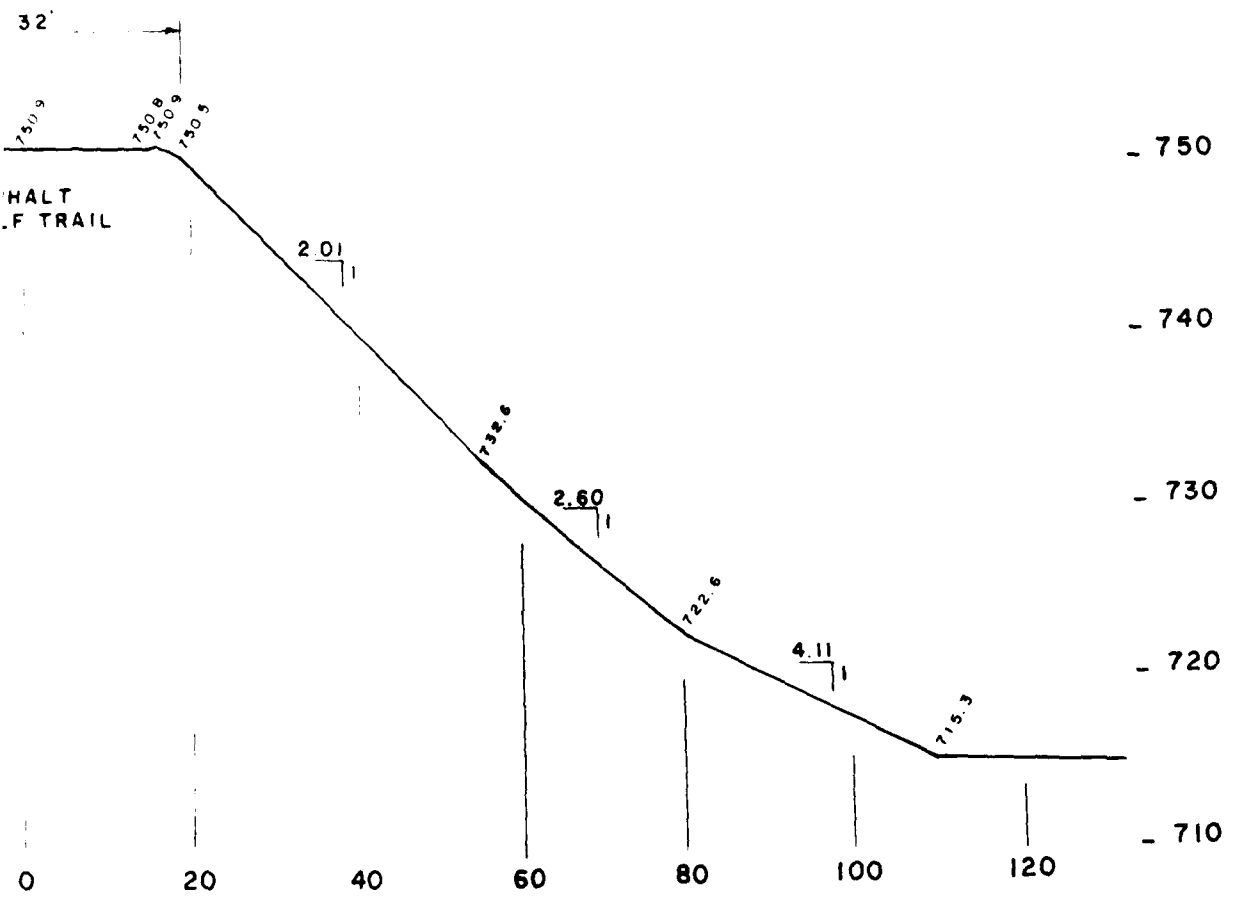
SHEET 3 APPENDIX A

Sheet 3 of Appendix A shows a plan profile and typical section of the embankments.
