**ROLLING HILLS ESTATE LAKE DAM  
BUTLER COUNTY, MISSOURI  
MO 48077**

**PHASE 1 INSPECTION REPORT  
NATIONAL DAM SAFETY PROGRAM**

PHASE I REPORT  
NATIONAL DAM SAFETY PROGRAM  
SUMMARY

Name of Dam: Rolling Hills Estates Lake Dam  
State Located: Missouri  
County Located: Butler  
Stream: Tributary of Kenner Spring Branch  
Date of Inspection: July 18, 1980

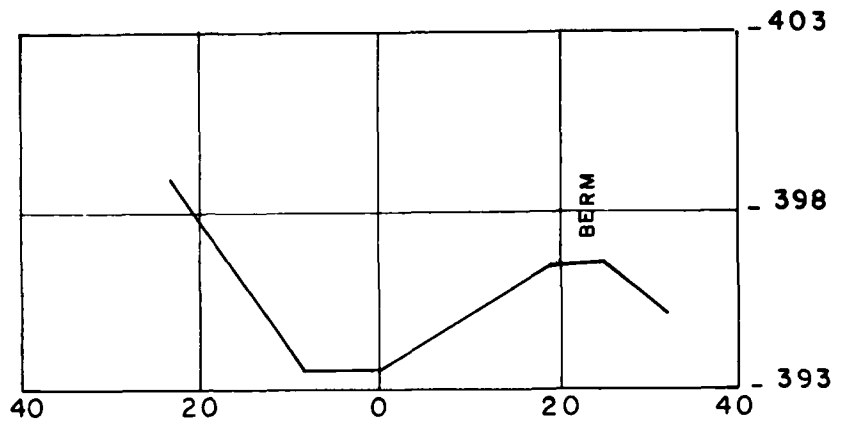
SPILLWAY SECTION  
100 FT DOWNSTREAM  $\phi$  DAM

The principal spillway is an earth cut channel located at the west abutment. A growth of cattails and light brush was noted at the spillway inlet. Some erosion of the channel was noted. There was an intentional partial blockage of the channel about 150 feet downstream of the centerline of the dam. This consisted of a wire mesh screen erected in the channel (see Photograph No. 9). Silt and debris accumulated on the upstream side of the screen. The spillway channel is well separated from the embankment.

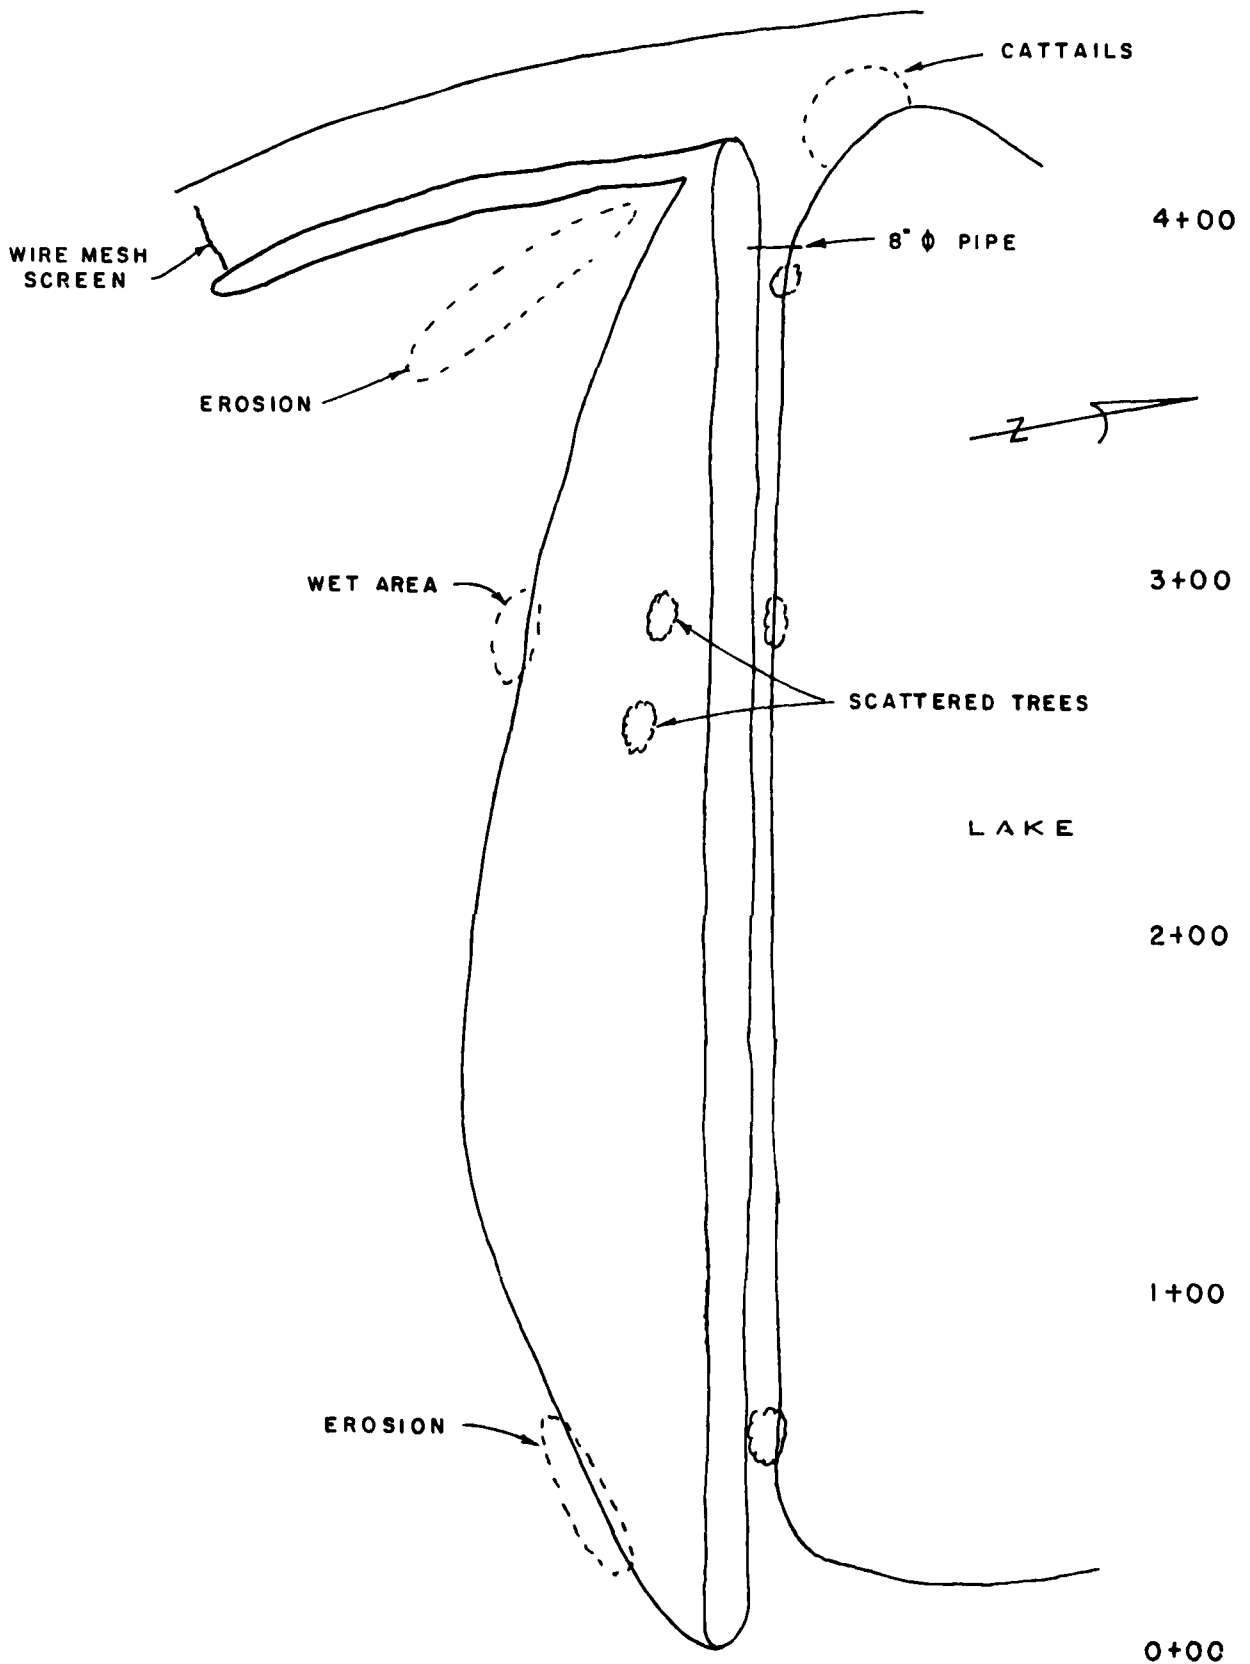
PLAN SKETCH OF DAM  
 ROLLING HILLS ESTATES LAKE DAM  
 MO. No. 40077

The dam appears to be in good condition. Deficiencies visually observed by the inspection team were: (1) brush and tree growth along upstream and downstream slopes; (2) apparent seepage area at Station 2 + 75 near the toe of the embankment; (3) no wave protection for the upstream face; (4) spillway channel has obstructions at its inlet and outlet; and (4) minor erosion in the spillway channel.
