GUDAITIS LAKE DAM
Washington County, Missouri
Missouri Inventory No. 30702

Phase I Inspection Report
National Dam Safety Program

Woodward-Clyde Consultants
Chicago, Illinois

for
Governor of Missouri
November 1980

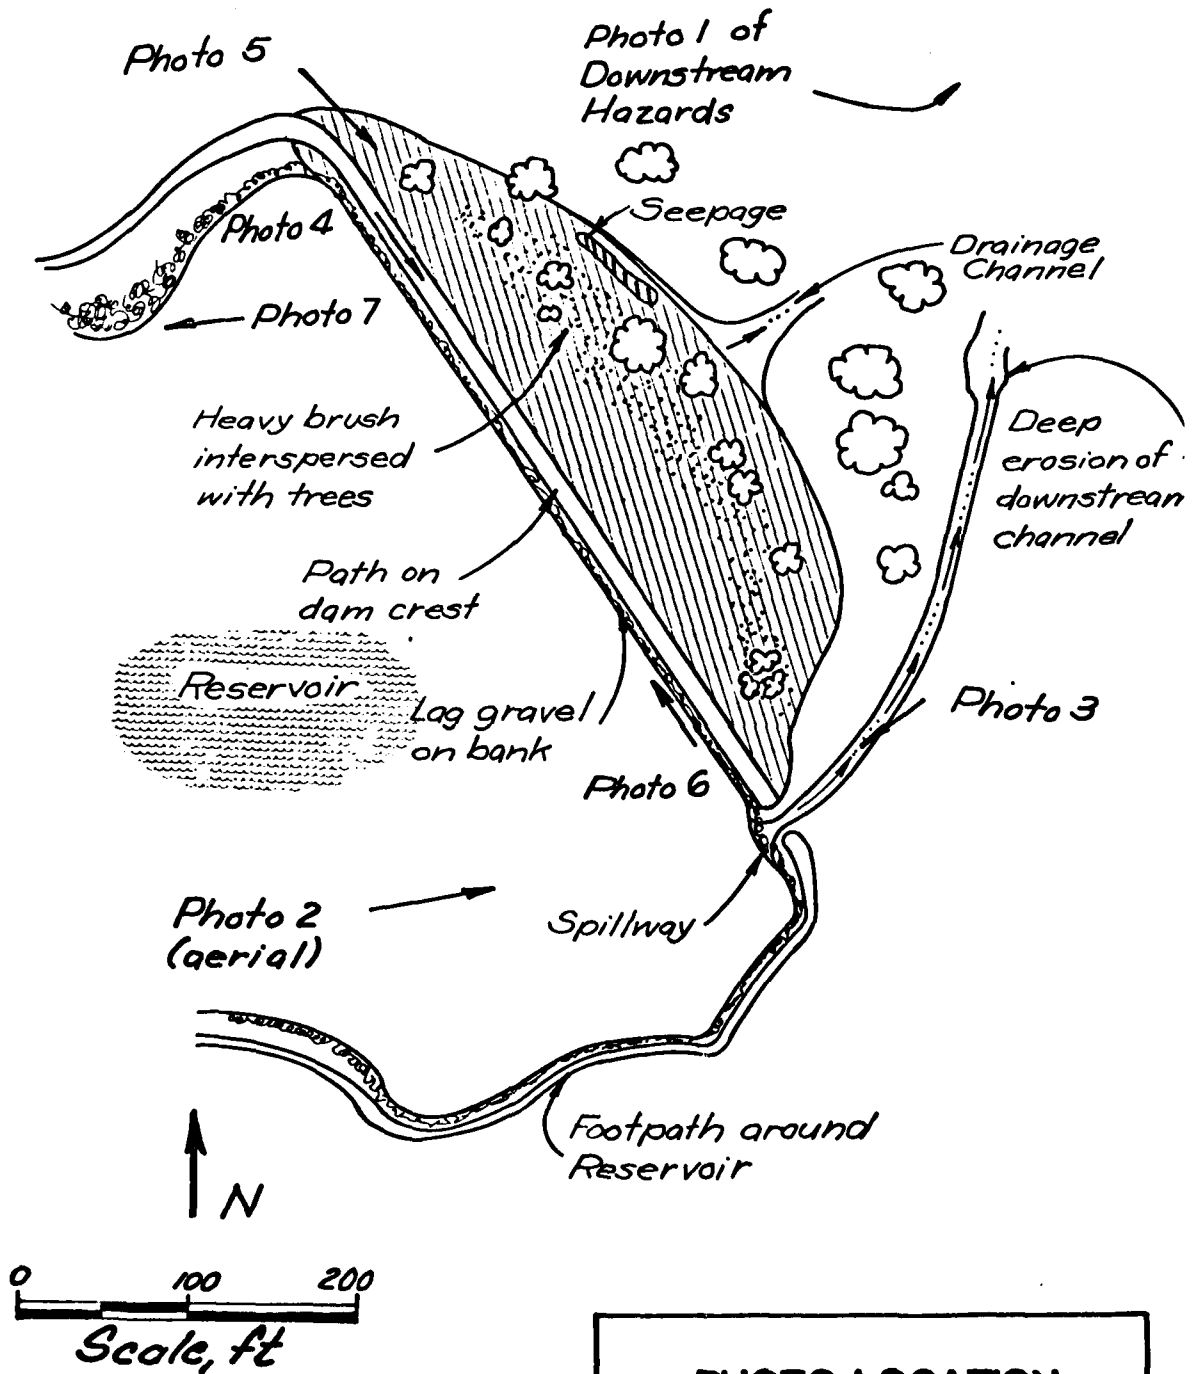
PHOTO LOCATION SKETCH	
GUDAITIS LAKE DAM	
MO 30702	Fig. A-1

Seepage of approximately 1 to 2 gallons per minute was noted along the toe of the dam for about 40 ft, as shown in Fig A-1. The seepage is collected in a 1 ft wide, drainage ditch that runs along the dam toe. The ground in the area of seepage was spongy and swampy but very little movement of water was observed. The seepage did not appear to be transporting any soil particles.

The spillway discharge channel is in relatively good condition in the area near the dam. It is expected however, that erosion will continue in the downstream area indicated in Fig A-1, Appendix A. The channel is moderately erodible, and should therefore have erosion protection in the zone near the dam. The spillway and the discharge channel should be enlarged to carry the design flood, and the channel and spillway should be protected against erosion.
