PURINA LAKE DAM  
FRANKLIN COUNTY MISSOURI  
MISSOURI IDENTIFICATION NO. MO 31497

PHASE I INSPECTION REPORT  
NATIONAL DAM SAFETY PROGRAM

PREPARED BY  
HOSKINS-WESTERN-SONDEREGGER, INC.  
CONSULTING ENGINEERS  
LINCOLN, NEBRASKA

OCTOBER, 1980

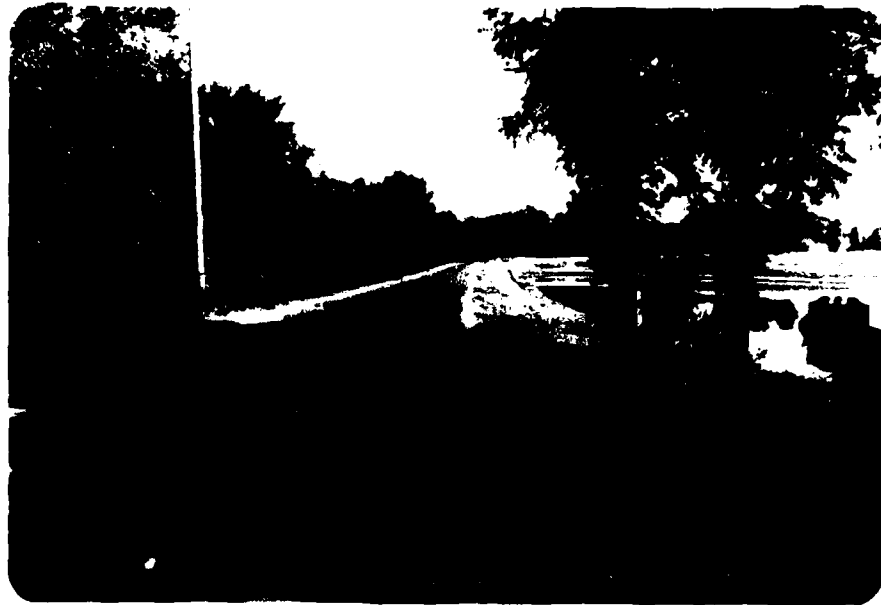
- (3) Crest. The crest of the dam serves as a roadway and is paved with asphalt. The profile of the crest is quite uniform at about elevation 574 except for a section about 80 feet long on the right end which serves as the emergency spillway. No cracks, deformations, trees or rodent activity were observed on the crest. Photo 2 shows the crest. There was no evidence to indicate that the dam has ever been overtopped.

PHOTO NO. 2 - CREST TAKEN FROM LEFT ABUTMENT

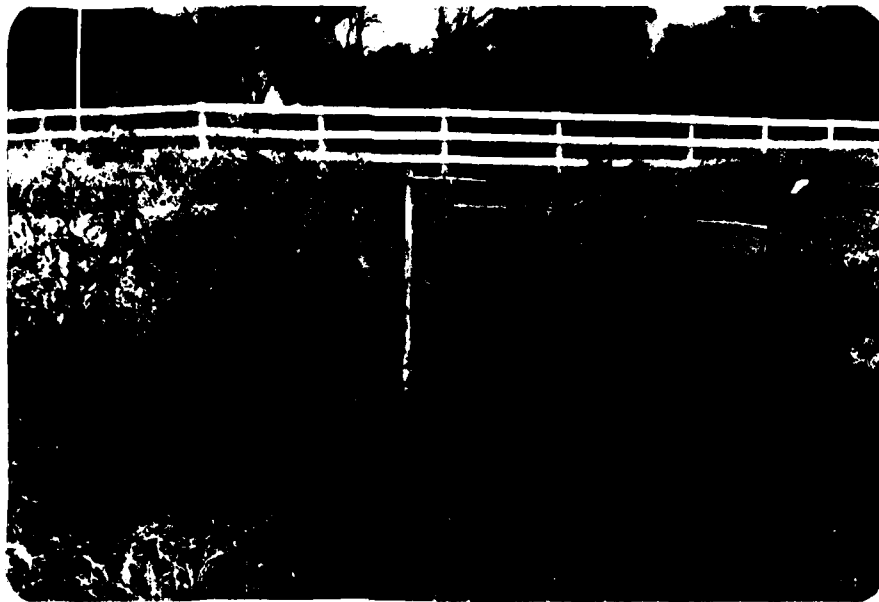
- (1) Principal Spillway. The principal spillway, located in the right abutment, consists of two 18-inch corrugated metal pipe culverts with a concrete headwall. The headwall and pipes appeared to be in good condition. There was no evidence of any recent flows through the spillway. No erosion was observed at the outlet of the spillway. Photos 10 and 11 show the principal spillway.

- (2) Emergency Spillway. The asphalt surfaced road is in good condition with no visible signs of distress. The approach area from the reservoir is open with no obstructions and is well vegetated. The runoff section from the downstream edge of the asphalt is well vegetated. There was no evidence of recent flow through the spillway, and there was no evidence of erosion in the spillway exit channel. Photo 10 shows the roadway over the culverts.

PHOTO NO. 10 - INLET END OF PRINCIPAL SPILLWAY CONSISTING OF TWO 18-INCH CORRUGATED METAL PIPE CULVERTS AND CONCRETE HEADWALL. PAVED ROAD CROSSING CULVERTS IS THE EMERGENCY SPILLWAY
