**OLD MINES TAILINGS DAM  
WASHINGTON COUNTY, MISSOURI  
MO 30706**

**PHASE 1 INSPECTION REPORT  
NATIONAL DAM SAFETY PROGRAM**

Name of Dam	Old Mines Tailings Dam
State	Missouri
County	Washington
Stream	Mud Town Creek
Date of Inspection	24 August 1979

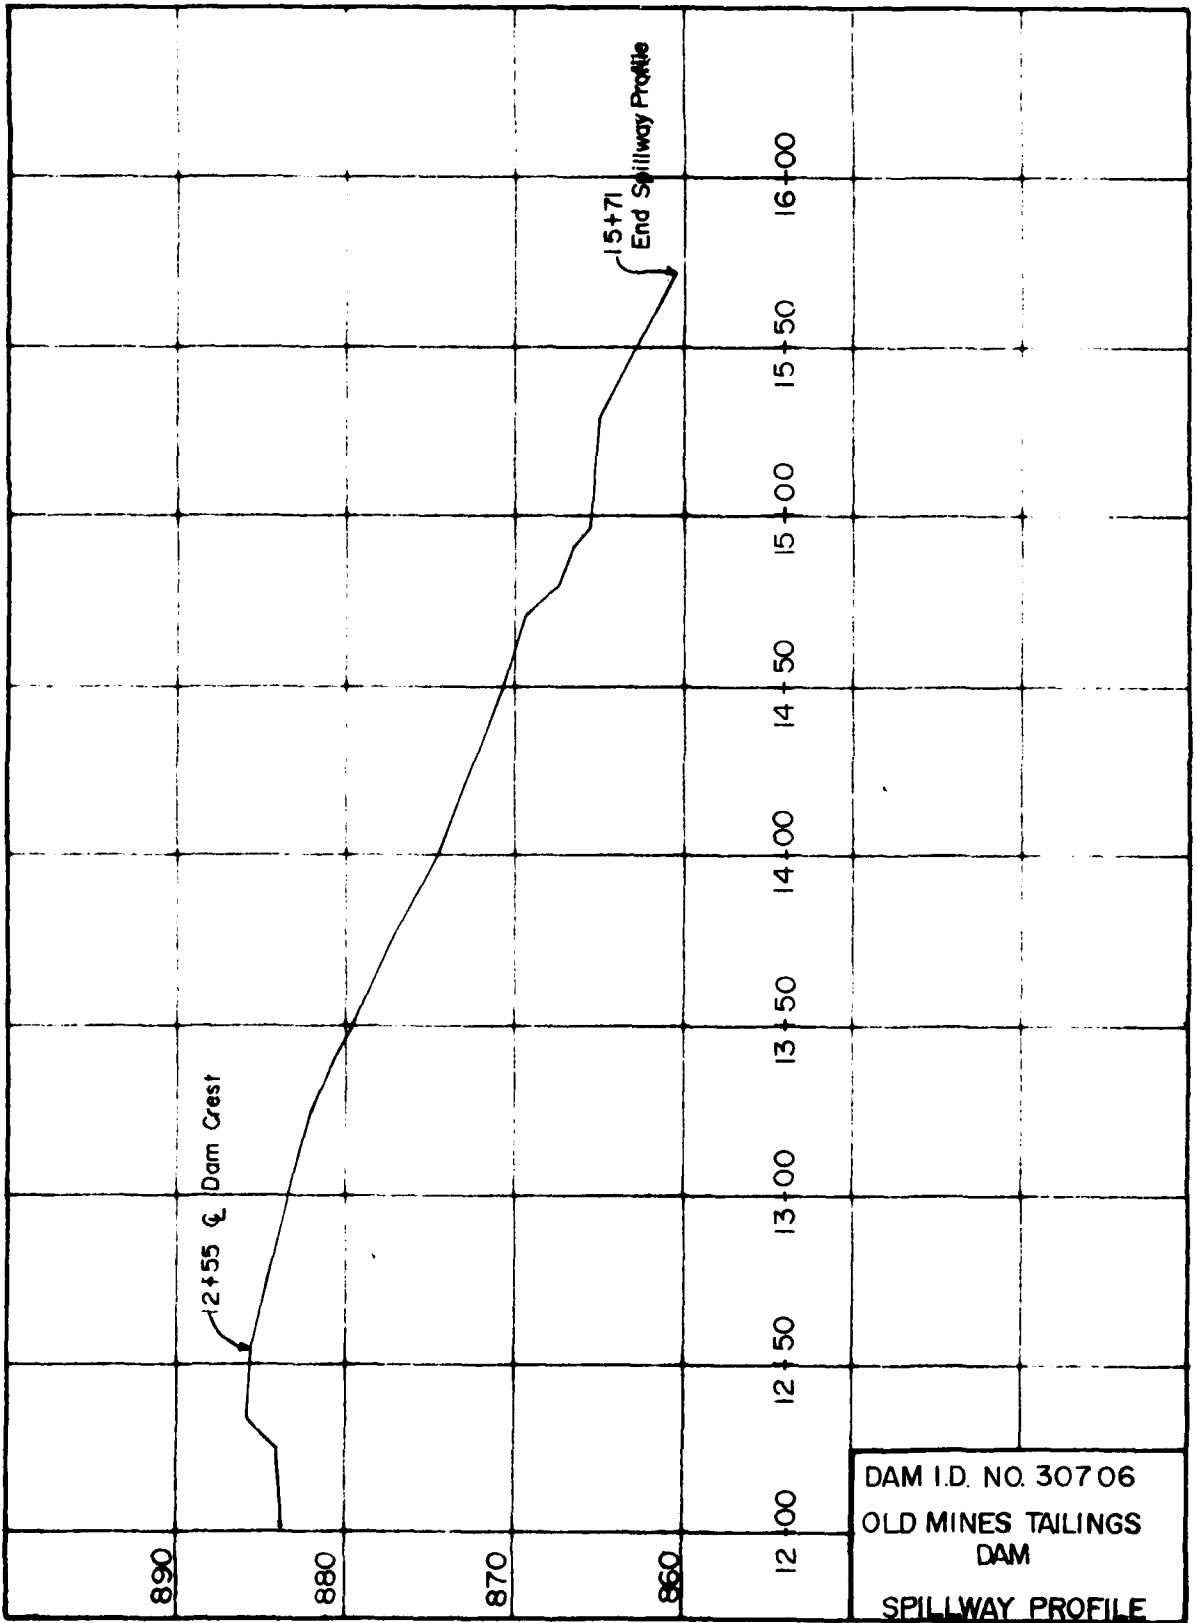
DAM I.D. NO. 307 06  
 OLD MINES TAILINGS  
 DAM  
 SPILLWAY PROFILE  
 PLATE 6B

The channel downstream of the spillway crest is a shallow stripped section consisting of freshly cut clumps of clayey soil along the downstream toe, which terminates on the right abutment hillside. The profile is shown on Plate 6B. At the location where the channel rounds the dam crest to proceed down the abutment, the channel bottom slopes toward the toe of the dam. Beyond the point where the cleared section terminates, flow would pass over the natural ground and would be channeled through erosion gullies caused by seepage and through sections of open cut trapezoidal channels which appear to have been associated with earlier spillways, meandering down the right abutment hillside adjacent to the dam to the natural stream channel. No erosion was observed in the spillway or spillway approach channel; however, these channels were recently constructed and had probably not functioned prior to inspection.
