**BLACKBURN POND DAM**

**SALINE COUNTY, MISSOURI**

**MO. IO656**

**PHASE 1 INSPECTION REPORT  
NATIONAL DAM SAFETY PROGRAM**

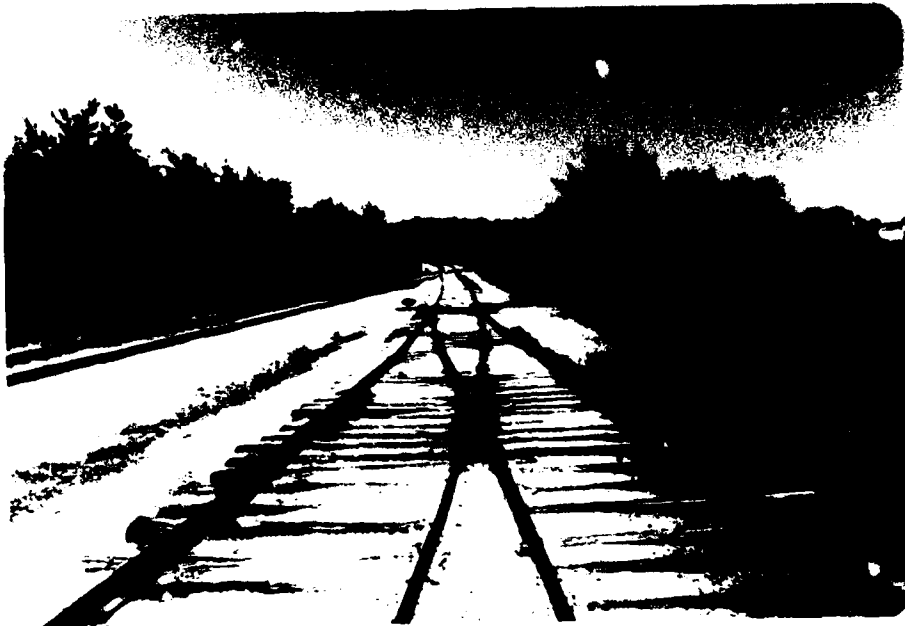
- (2) Upstream Slope. The upstream slope is quite steep (1.5 to 1 was the usual railroad grade slope) and partially covered with trees and brush. Portions of the slope are covered with concrete rubble and other rock riprap. No serious erosion was observed. Photos 2 and 3 show the upstream slope.
- (3) Crest. The crest serves as the grade of the railroad. The profile of the crest shown in Plate C-1, Appendix C, slopes from the right to the left abutment with a maximum elevation difference of about 9 feet. The crest is covered with ballast. No cracks or deformations were noted. Photo No. 4 shows the crest.

PHOTO NO. 4 - CREST FROM LEFT END
