BERNDT LAKE DAM

MERCER COUNTY, MISSOURI

MO 10472

PHASE 1 INSPECTION REPORT  
NATIONAL DAM SAFETY PROGRAM

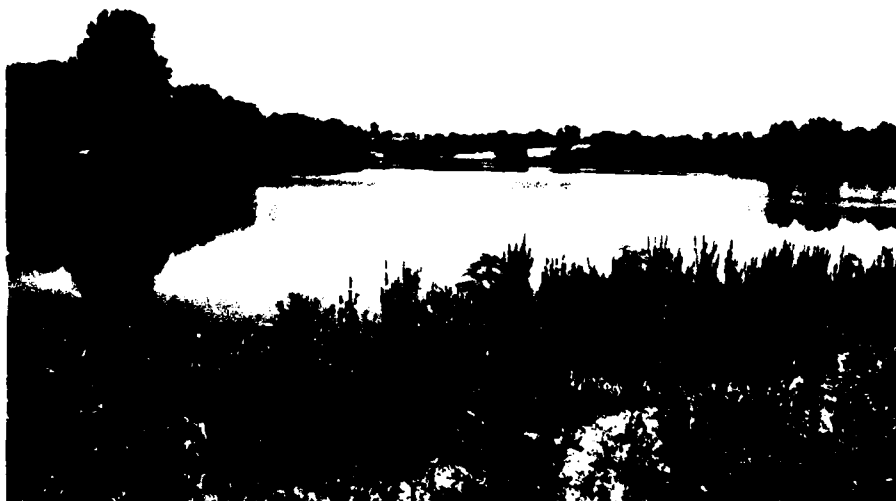
PHOTO NO. 5  
LOOKING NORTH  
ACROSS LAKE  
TAKEN FROM  
STA. 7+00
