TWIN LAKE DAM  
MERCER COUNTY, MISSOURI  
MO 10476

PHASE 1 INSPECTION REPORT  
NATIONAL DAM SAFETY PROGRAM

PREPARED BY: HOSKINS-WESTERN-SONDEREGGER, INC.  
FOR: STATE OF MISSOURI

JULY, 1978

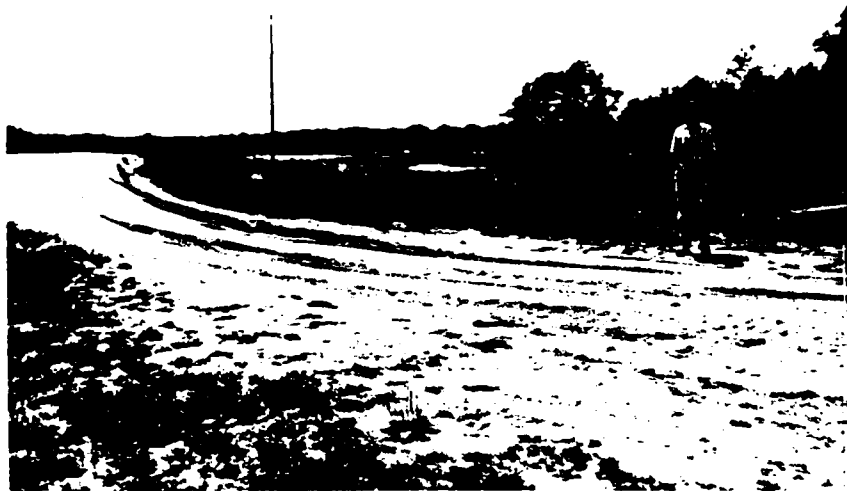
(2) A secondary spillway is cut into glacial till on the right (west) abutment. The access road to the dam provides the control section for this spillway with a crest elevation of  $962\pm$ . A small farm pond is located near the south end of the exit channel for this spillway (about 165 ft. downstream from  $\frac{1}{2}$  of dam). The crest elevation of the embankment for the farm pond is 960 feet  $\pm$  with the water level at about  $958\pm$ . The north end of a large sewage lagoon (700 feet  $\pm$  long-north to south and 365 feet  $\pm$  wide-east to west) is located immediately east and down slope from the farm pond. The crest elevation of the dike around the lagoon is at 957 feet  $\pm$ . Water surface in the lagoon is at elevation 954 feet  $\pm$ . Two smaller lagoons are located southeast of the large lagoon. The water surface in these lagoons is reported to be 2 feet and 6 feet lower than the large lagoon. Rough measurements and sketches of the secondary spillway and adjoining ponds are shown in Appendix C.

Rough measurements along the centerline of the secondary spillway indicate that most flows will be carried around the right end of Twin Lake Dam and discharged eastward into a small drainageway passing between the roadway along the toe of the dam and the dike forming the sewage lagoon. It appeared that high flows of sustained duration could cause significant erosion along the toe of Twin Lake Dam and along the base of the lagoon dike.

PHOTO NO. 3  
LOOKING DOWN RIGHT  
SPILLWAY FROM 140'  
NORTH OF CENTERLINE  
OF DAM

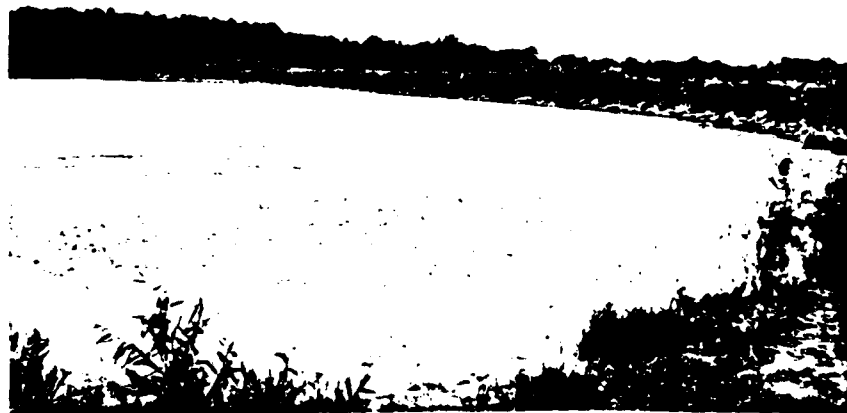
b. Dam. The dam looks very good. The upstream slope is riprapped to an elevation about 3 feet below the crest of the dam. The riprap appeared to be in good shape. No slips or significant erosion were noted on the upstream face. The crest and downstream slope is well vegetated with grass and well maintained. Materials on the surface of the dam consist of lean clay and sandy clay (CL and SC). No slides, significant erosion, or deformations were noted on the downstream slope.

PHOTO NO. 4  
UPSTREAM SLOPE  
FROM RIGHT SPILLWAY

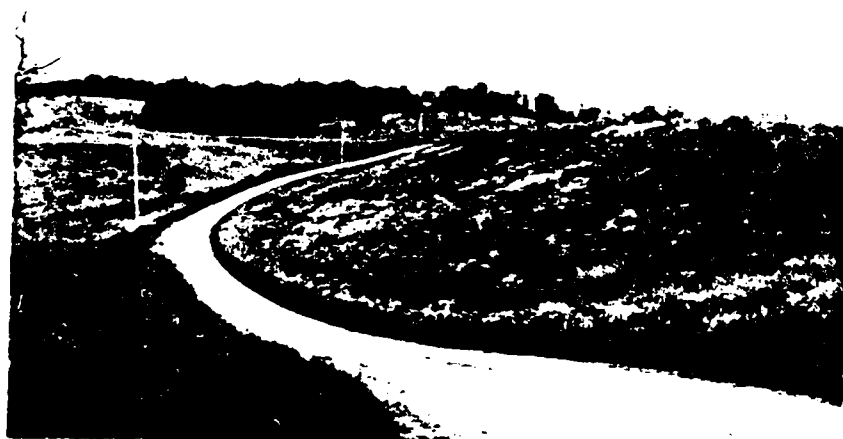
No seepage or evidence of the phreatic line outcropping was observed on the downstream slope. A small seep area was observed at the toe of the dam opposite about centerline station 4+00.

Abutment materials consist of fine grained plastic glacial till. No seeps, other than downstream from  $\pm$  station 4+00 $\pm$ , slides or significant erosion were noted in the abutments.

PHOTO NO. 6  
SEEP AT STA. 4+00

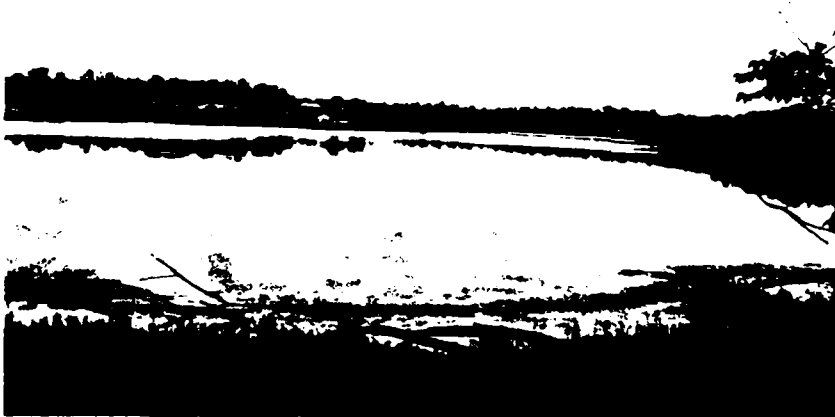
PHOTO NO. 8  
ALONG CENTERLINE  
FROM LEFT  
ABUTMENT.
