**FRANK MILNE DAM**

**HOLT COUNTY, MISSOURI**

**MO. 11029**

**PHASE 1 INSPECTION REPORT  
NATIONAL DAM SAFETY PROGRAM**

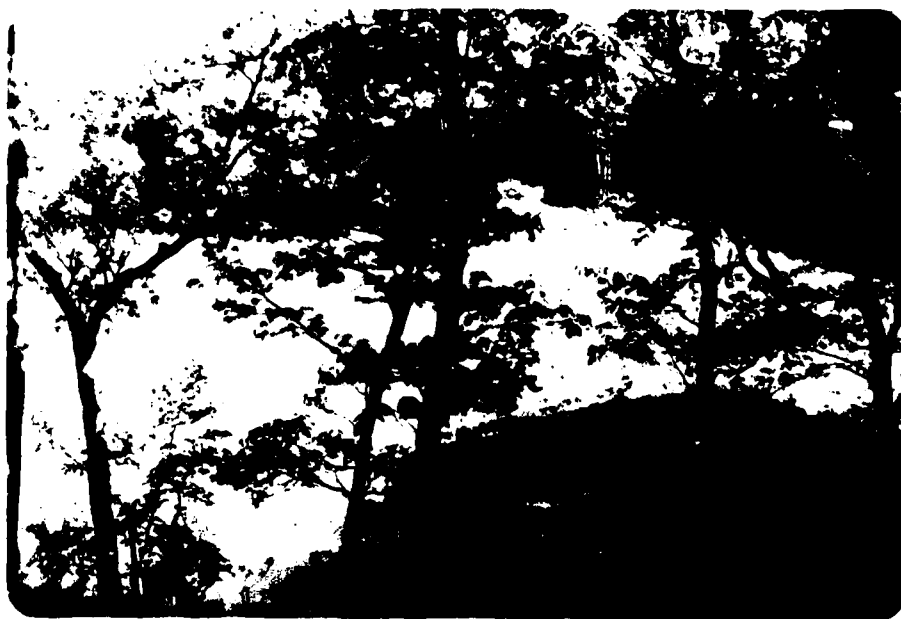
The upstream slope is well vegetated with adapted grasses. Very little erosion was noted along the water line. No rodent holes, cracks or abnormal deformation were observed.

PHOTO NO. 11 - UPSTREAM SLOPE FROM RIGHT END
