BETHANY NEW CITY RESERVOIR
HARRISON COUNTY, MISSOURI
MO 10071

PHASE 1 INSPECTION REPORT
NATIONAL DAM SAFETY PROGRAM.

Bethany New City Reservoir Dam (MO 10071),
Missouri - Grand - Chariton Basin,
Harrison County, Missouri. Phase I Inspection
Report.

JUL 1978

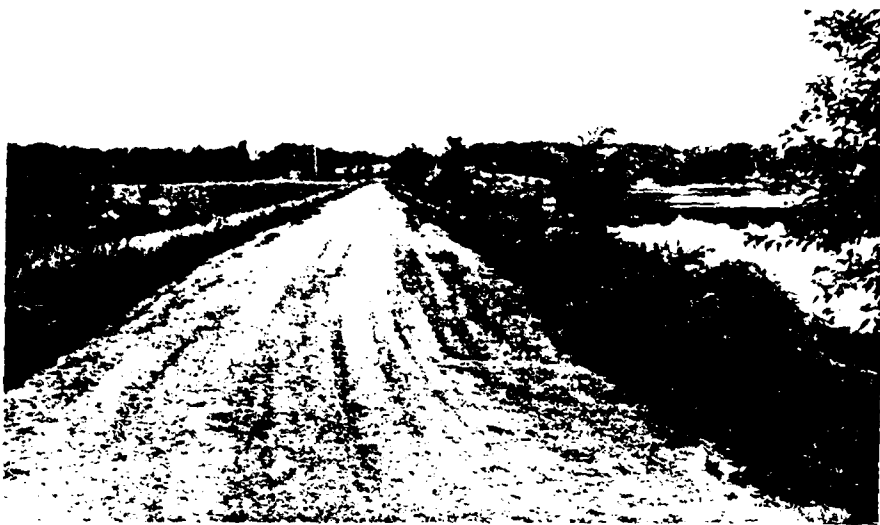
PHOTO NO. 2
TOP OF DAM.
LOOKING WEST
FROM EAST END.

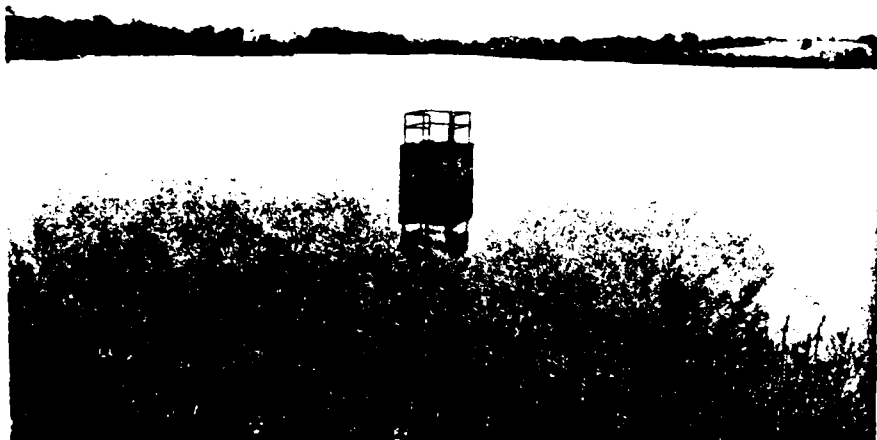
The concrete gate tower looked good and it is assumed that all valves and gates are operable since this reservoir supplies water to the City of Bethany.

PHOTO NO. 5
GATE TOWER FROM
CENTERLINE OF
DAM LOOKING
UPSTREAM.

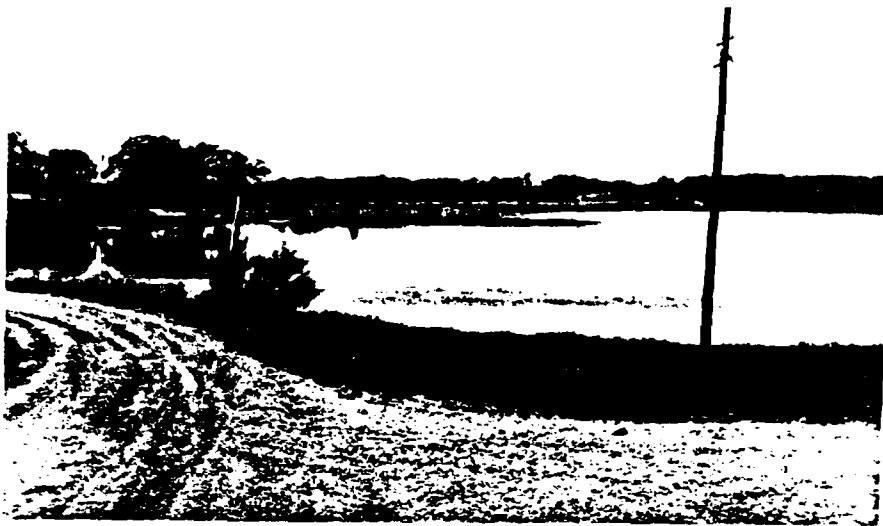
PHOTO. NO. 8
OVERVIEW FROM
ROAD ENTRANCE
ON EAST SIDE
OF LAKE.
