BETHANY CITY RESERVOIR
HARRISON COUNTY, MISSOURI
MO 10051

PHASE 1 INSPECTION REPORT NATIONAL DAM SAFETY PROGRAM

Bethany City Reservoir Dam (MO 10051),
Missouri - Grand - Chariton Basin,
Harrison County, Missouri. Phase I Inspection
Report.

JULY 1978

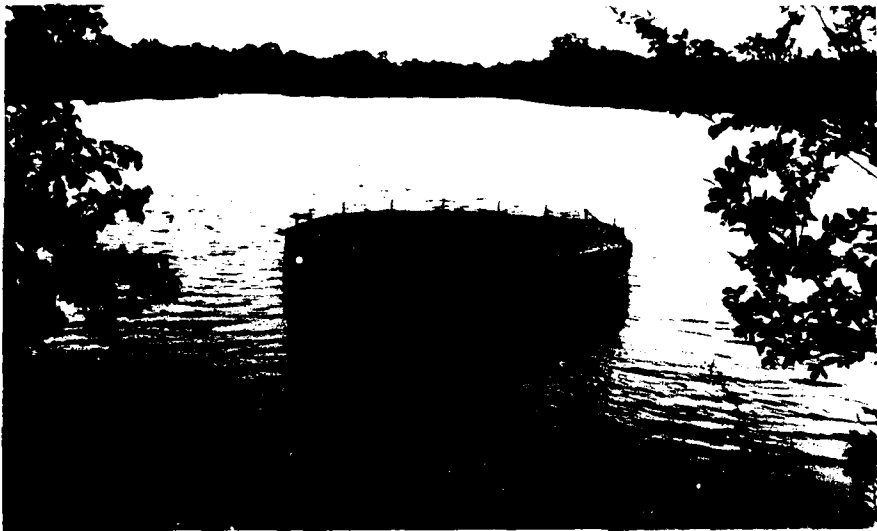
A notation of elevation 130 is also shown on Sheet 4 on the elevation view of the spillway (see Appendix C). It is the opinion of the inspection team that this is the as-built elevation of the spillway instead of the 128 as originally designed. At some later date, the crest of the spillway was raised another two feet ± by the addition of a vertical sided concrete cap which covers the original lip of the spillway. (See Photo No. 3, Appendix B.)

PHOTO. NO. 3
SPILLWAY TAKEN
FROM DAM LOOKING
NORTHEAST.

(3) If the concrete cap on the spillway is to remain the areas where spalling is occurring should be repaired.

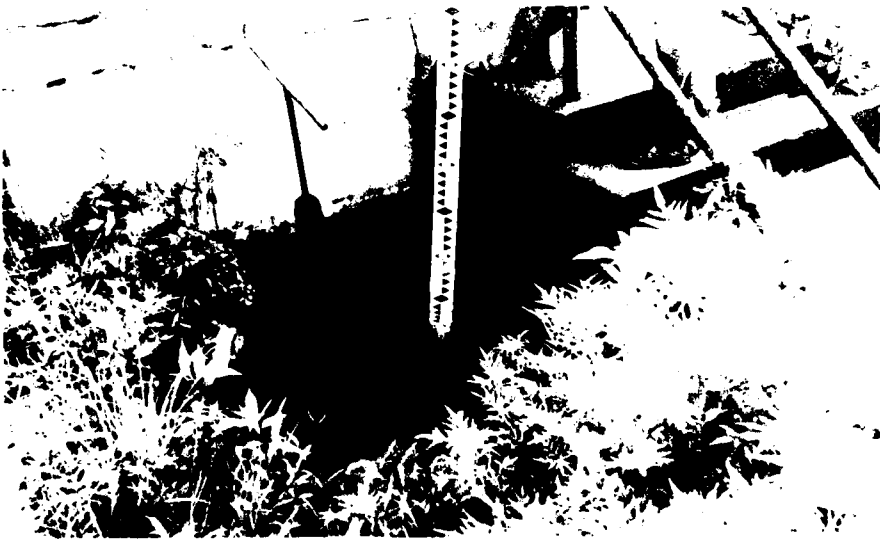
As discussed in paragraph 3.1a, above, a water supply line entering the pump house is broken and discharging water at the rate of about 2 gal/min.

PHOTO. NO. 6
POND AND BOIL
UNDER PUMPHOUSE
STEP. DOWNSTREAM
FROM C STA. 4+20±.

(2) The leak in the water supply line near the toe of the dam should be repaired in the near future. This leaky pipeline could lead to serious potential of failure of the dam. Regular inspections of the water supply system should be scheduled to assure the integrity of the system.

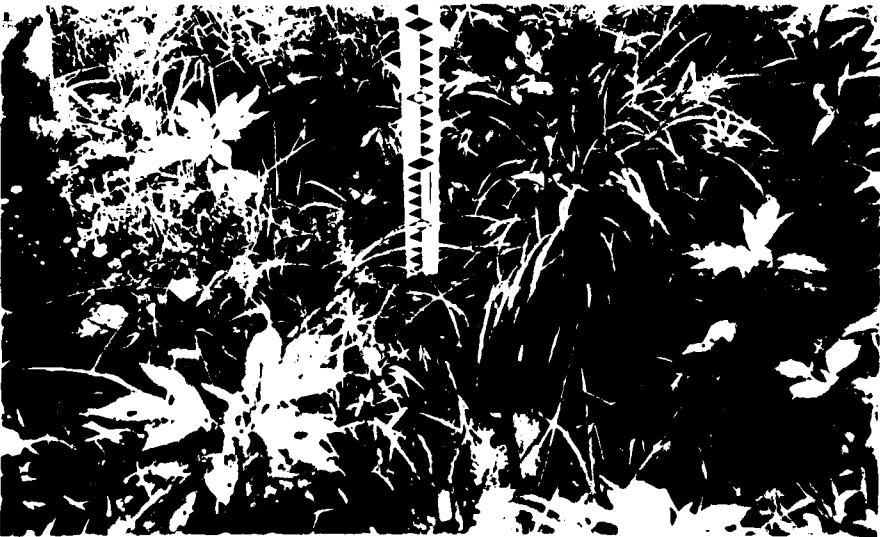
PHOTO. NO. 7
FLOW FROM BOIL
AT PUMPHOUSE.

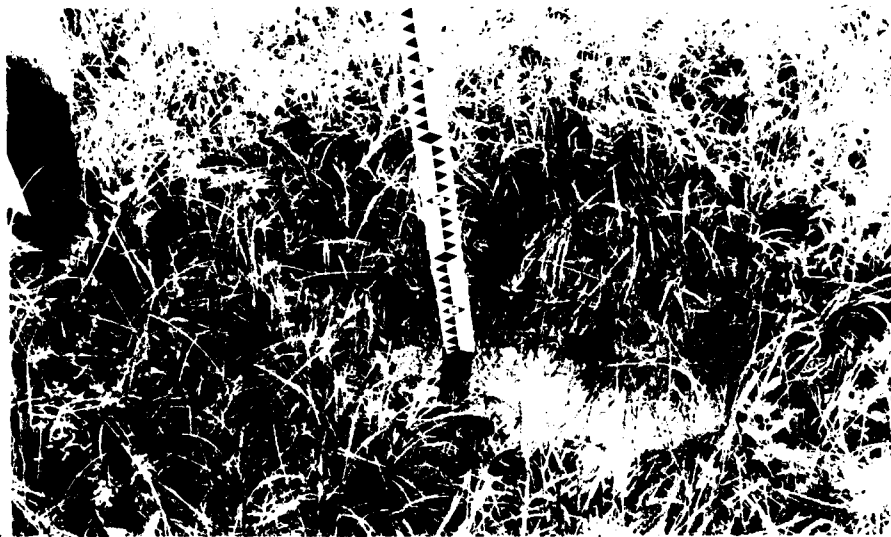
Seepage was existing along the north section of the downstream toe of the dam from about centerline stations 3+00 to 5+00 (see photo 12). The seepage discharge was clear and estimated at about 0.25 gal/min. No seepage was observed along the toe south of the pumphouse in the area where the concrete cutoff had been installed. A boil adjacent to the pumphouse was discharging an estimated 2 gal/min (see photo 6). The effluent was clear. It was reported by Mr. Roscoe that this boil results from a broken water line entering the pump station. There was no evidence of other boils or piping on the downstream slope or toe.

PHOTO. NO. 12
SEEP BELOW
CENTERLINE
STATION 4+50.

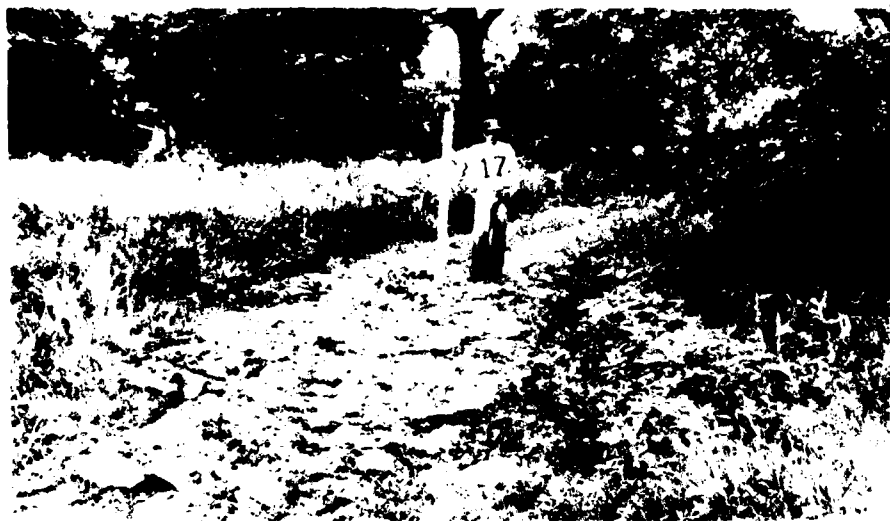
Fractured limestone bedrock was exposed in the north abutment above the crest elevation of the dam. The south abutment was mantled with CL soil.

PHOTO. NO. 15
LIMESTONE ON
NORTH ABUTMENT.
STA. 6+90⁺.
