LAC BENET DAM

ST. FRANCOIS COUNTY, MISSOURI

MO 30281

**PHASE 1 INSPECTION REPORT  
NATIONAL DAM SAFETY PROGRAM**

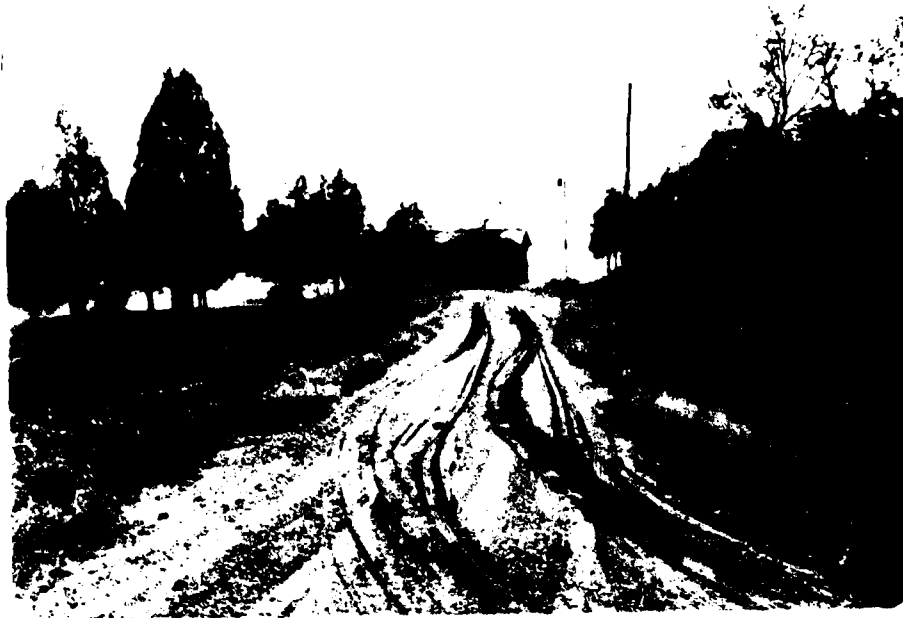
Aerial photographs of the downstream damage zone of this dam were taken in October, 1980. These photographs were used as reference in the field observations of the damage zone which were made during the inspection. Based on the field observations and on the referenced guidelines this dam is in the High Hazard Potential Classification. The estimated damage zone extends approximately one mile downstream of the dam. Within the damage zone are three dwellings and a lake and dam. Photos 17, 18 and 19 show the downstream damage area.

PHOTO NO. 18 - DOWNSTREAM HAZARD JUST ABOVE LOWER LAKE
