MISCELLANEOUS PAPER SL-81-21

**CONDITION SURVEY  
REPAIR AND REHABILITATION  
LOCK AND DAM NO. 24, MISSISSIPPI RIVER**

**Richard L. Stowe, Henry T. Thornton, Jr.**

**August 1981**

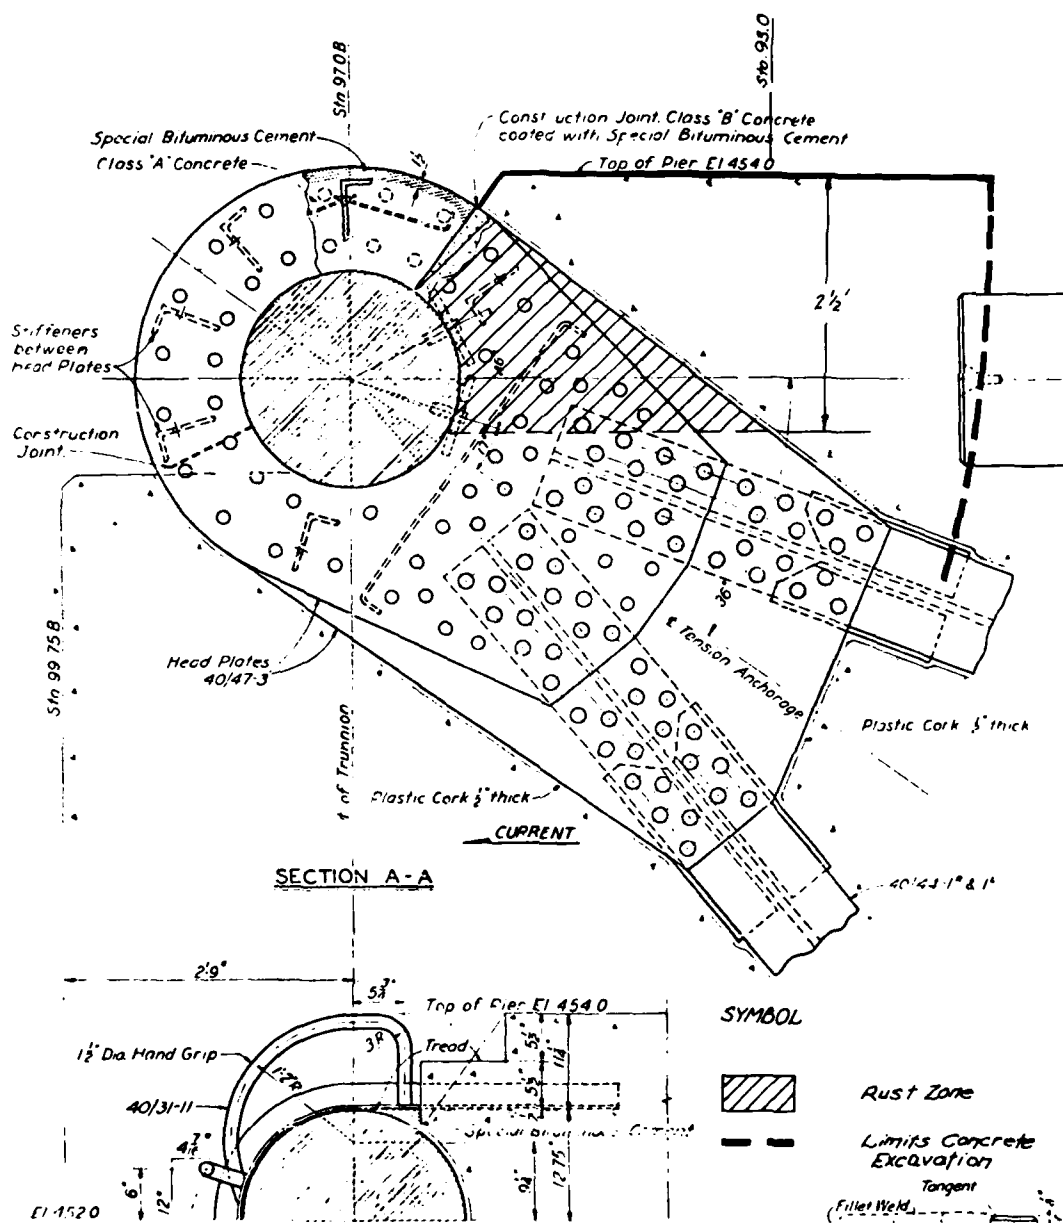
Detail showing rusted zone on anchorage collar and approximate extent of excavated concrete. Reference M-124 40/45.1

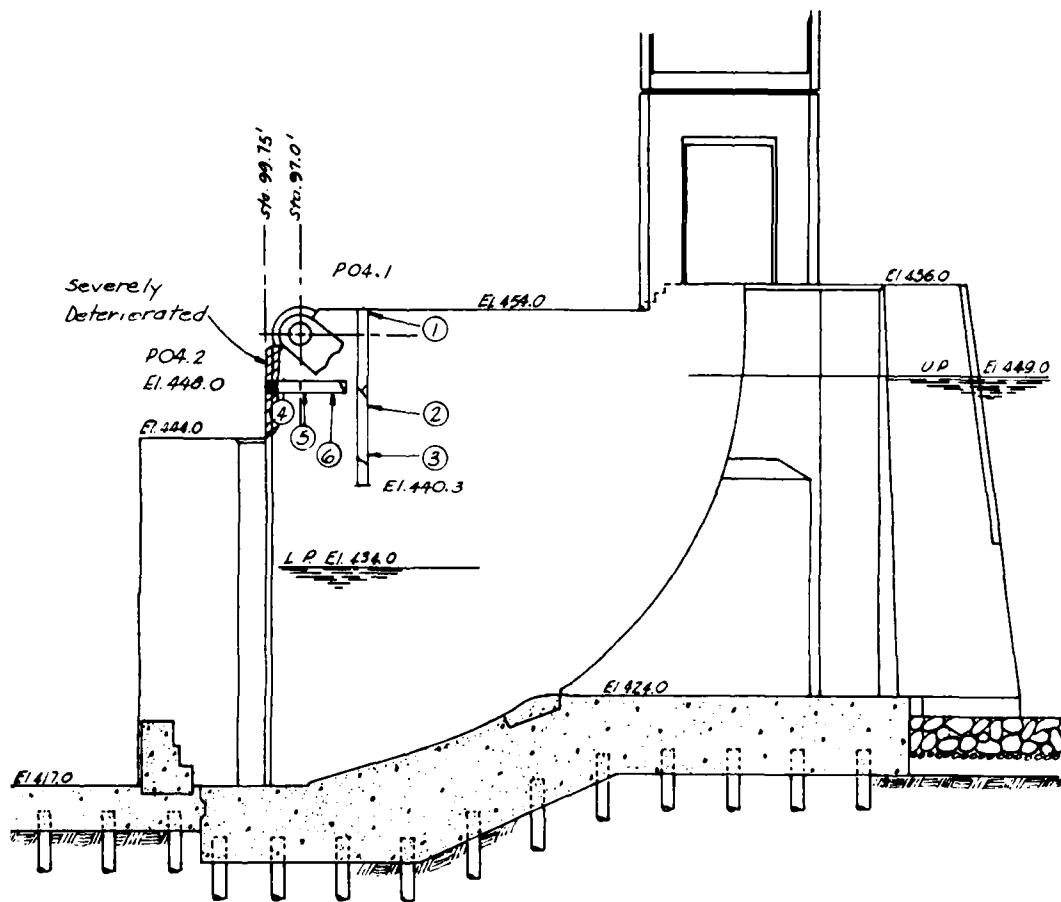
CROSS SECTION PIER #4

37. Cross sections for the three piers (No. 4, No. 9, and No. 15) in which vertical and horizontal borings were drilled are presented in Plates 12, 13, and 14. A small zone of severely deteriorated concrete exists below and downstream of the trunnion shaft for the full 10-ft

width of the pier. The zone extends from station 99.75 ft to a maximum depth at station 98.5 ft in pier No. 4. In pier No. 9 the zone is 0.9 ft deep and in pier No. 15 the zone is 0.4 ft deep. The depth of the zone could be deeper in the piers not drilled. Major cracks in the core recovered from the piers are presented on these three cross sections. The cracks help to explain some of the "no readings, NR," in the downstream portions of the piers.<sup>3</sup> Plate 13b shows the location of the ultrasonic velocity measurements taken on pier No. 9 and the cracks observed in borings S WES P09.1 and P09.3. The uppermost crack in P09.1 could account for the "no reading" at stations No. 6 and 7. This plate also indicates that other "no readings" are accounted for by the anchor-  
age steel; the interface between the concrete, plastic cork, and the steel would attenuate the transmitted pulse. The in-place velocities obtained by Thornton<sup>3</sup> compare well with the velocities recorded on the laboratory test specimens.

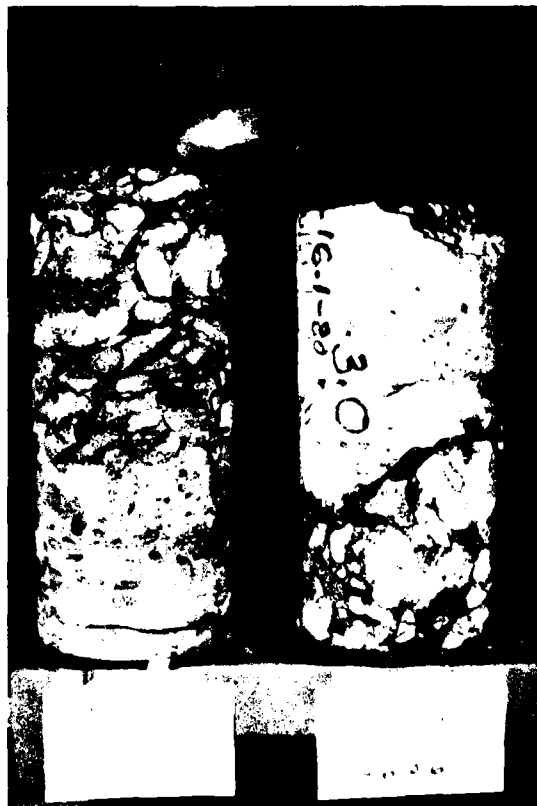
Photograph of SWES C16.1S showing damaged concrete core  
representing the outside and backside of column No. 1  
on pier 16
