HENRY SEVER DAM  
KNOX COUNTY, MISSOURI  
MO 10110

**PHASE I INSPECTION REPORT  
NATIONAL DAM SAFETY PROGRAM**

DECEMBER 1978

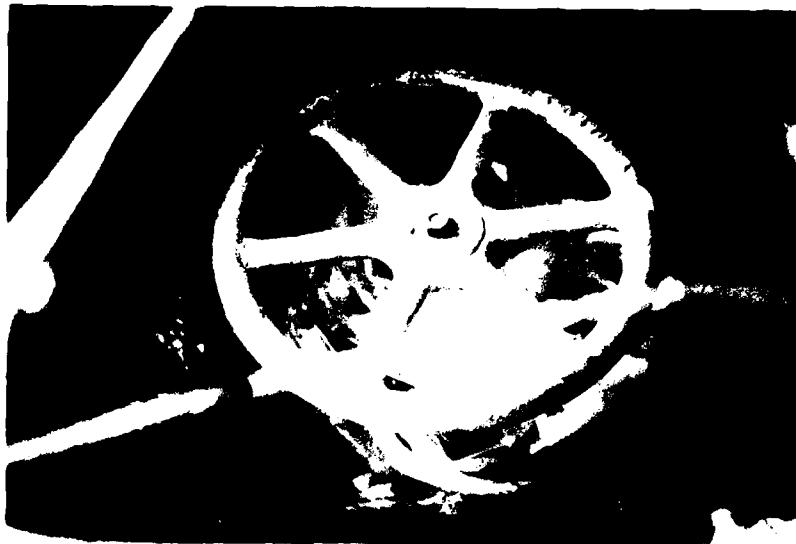
The low level outlet valve is the only operating facility at the damsite. This gate is operated very infrequently. The gate appeared to be maintained well, and in satisfactory operating condition.

Photo 7 - Picture of gate and handwheel in pit shown in previous picture.
