GOLDEN EAGLE LAKE DAM

MONTGOMERY COUNTY, MISSOURI

MO. 10920

**PHASE 1 INSPECTION REPORT
NATIONAL DAM SAFETY PROGRAM**

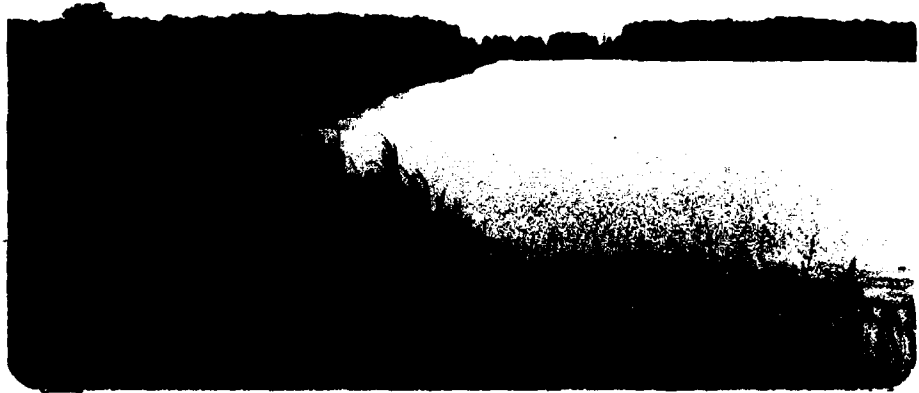
- (2) Upstream Slope. The upstream slope looks very good. It is well riprapped with durable limestone up to about elevation 820 (emergency spillway elev.). Nominal size of riprap is 8 to 12 inches. The slope is well vegetated above the riprap. A few small trees are growing at the water's edge. No rodent holes, slides or deformations were noted on the upstream face.

PHOTO NO. 2 - UPSTREAM SLOPE FROM LEFT END

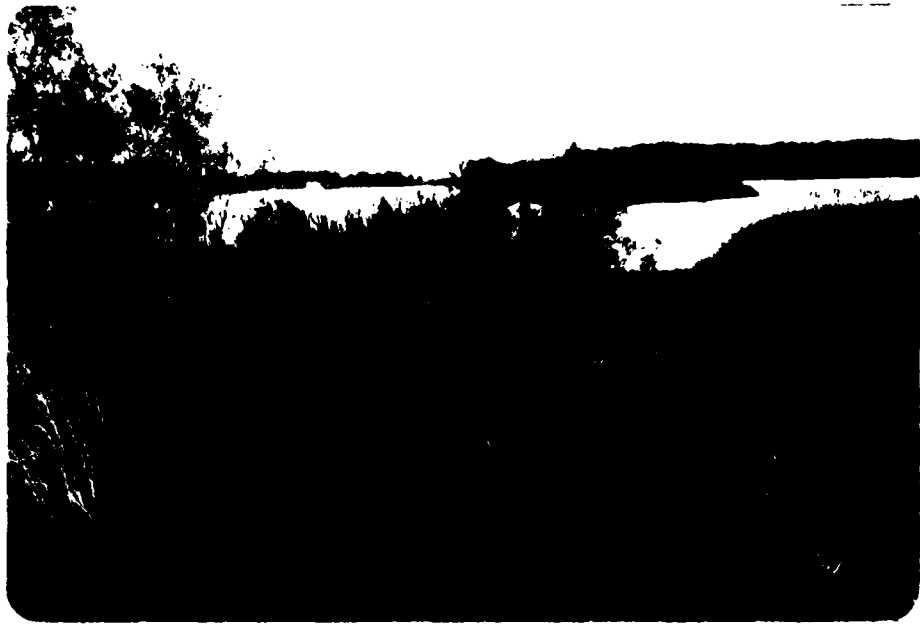
- (2) The emergency spillway is very well vegetated throughout its length. There are a few small trees and brush growing in the inlet to the spillway. No slips, slides or erosion was apparent in the spillway bottom or on the sides. Clay (CH) soils are present in the outside channel bank. The trash line in the entrance channel indicates that the reservoir level has approached spillway operation. Discharge from the emergency spillway should not endanger the safety of the dam. There was no evidence of flows through the spillway.

PHOTO NO. 6 - LOOKING UPSTREAM IN EMERGENCY SPILLWAY

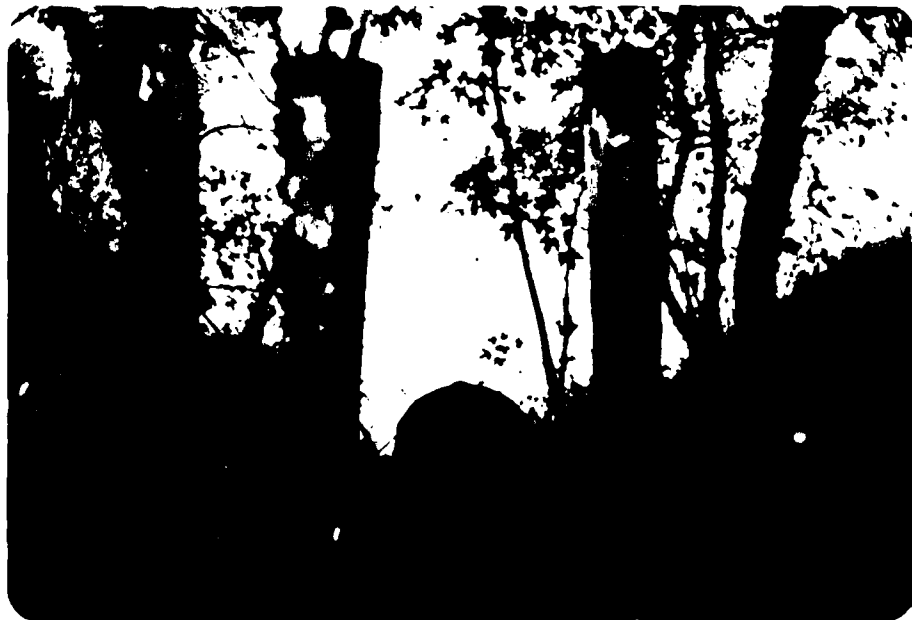
- (1) Principal spillway. No deterioration was noted in the steel riser or the outlet pipe. The inlet was clear and open without trash. The scour hole at the outlet end was eroded into CL or CH soil and appeared to be stable. The reservoir level was about 4 inches below the inlet elevation of the riser when inspected.

PHOTO NO. 9 - OUTLET END OF PRINCIPAL SPILLWAY AND
SCOUR HOLE

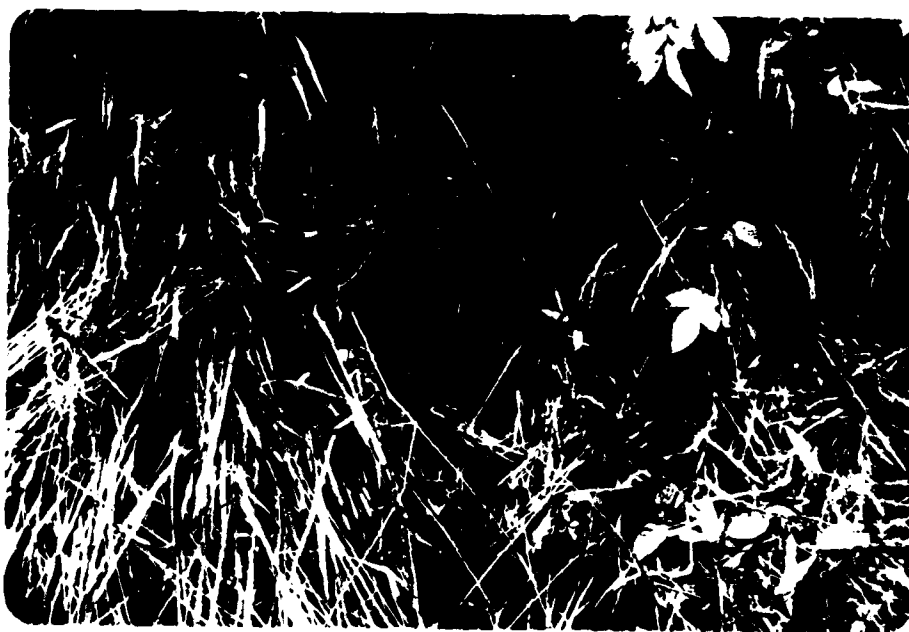
- (3) Drawdown facilities consist of a 6 inch diameter cast iron pipe passing through the embankment just left (west) of the principal spillway pipe. A valve is located at the lower end. The valve appeared to be operable and was barely dripping.

PHOTO NO. 11 - OUTLET END OF DRAWDOWN PIPE
