EARL RESERVOIR DAM

ORANGE COUNTY, NEW YORK  
INVENTORY NO. N.Y. 203

PHASE I INSPECTION REPORT  
NATIONAL DAM SAFETY PROGRAM

JUNE 1981

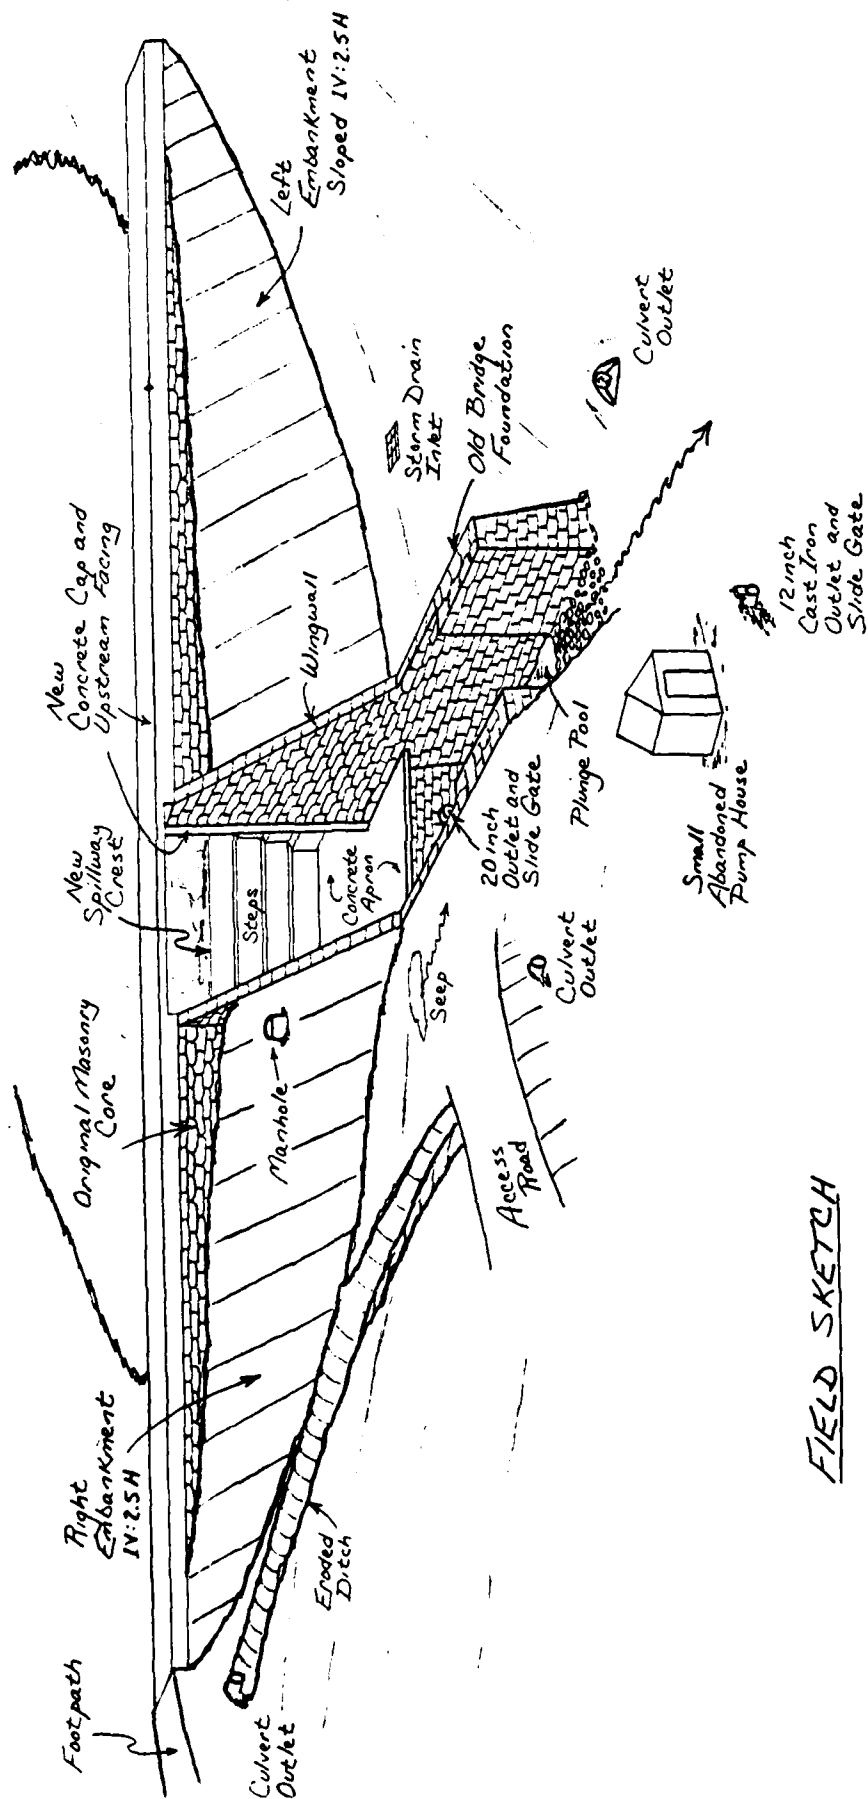
PLATE 1

Because of the occurrence of several significant leaks during the 1970's, apparent piping of embankment materials, and plugging of the 24-inch drain, the dam was recently rehabilitated, principally for recreational purposes. Rehabilitation consisted of installation of a larger three-sided concrete spillway (110 feet total length) on the upstream side of the dam to act as a discharge "culvert" (Photo 3). The upstream side and crest of the original core wall were faced with 2 feet of concrete bonded to the masonry work with epoxy cement to reduce leakage (Photo 3). In addition, a clay blanket was placed on most of the upstream side of the rehabilitated structure and adjacent impoundment area. New intake structures were constructed for the existing 24-inch reservoir drain and 12-inch water supply pipe. A new 20-inch pipe was placed within the 24-inch pipe. The original slide gate controls were eliminated and new slide gate controls were placed in a manhole on the right downstream side of the spillway discharge channel. A Field Sketch, which illustrates present dam conditions, is included as Plate 1 in Appendix E.
